Contract #: 04-0120F4Cty: SF/ALA Rte: 80 PM: 13.2/13.9File #: 69.28**WELDING INSPECTION REPORT****Resident Engineer:** Pursell, Gary**Address:** 333 Burma Road**City:** Oakland, CA 94607**Report No:** WIR-000877**Date Inspected:** 16-Nov-2007**Project Name:** SAS Superstructure**OSM Arrival Time:** 630**Prime Contractor:** American Bridge/Fluor Enterprises, a JV**OSM Departure Time:** 1530**Contractor:** Zhenhua Port Machinery Company, Ltd (ZPMC), Changxing Island **Location:** Changxing Island**CWI Name:** Arthur Peterson**CWI Present:** Yes No**Inspected CWI report:** Yes No N/A**Rod Oven in Use:** Yes No N/A**Electrode to specification:** Yes No N/A**Weld Procedures Followed:** Yes No N/A**Qualified Welders:** Yes No N/A**Verified Joint Fit-up:** Yes No N/A**Approved Drawings:** Yes No N/A**Approved WPS:** Yes No N/A**Delayed / Cancelled:** Yes No N/A**Bridge No:** 34-0006**Component:** OBG Deck Plate Trail**Summary of Items Observed:**

Caltrans Quality Assurance (QA) Inspector, Larry Viars was present to perform welding inspection of Orthotropic Box Girder (OBG) Deck Plate Panel Mock-up, for the San Francisco Oakland Bay Self Anchored Suspension Bridge, at Zhenhua Port Machine

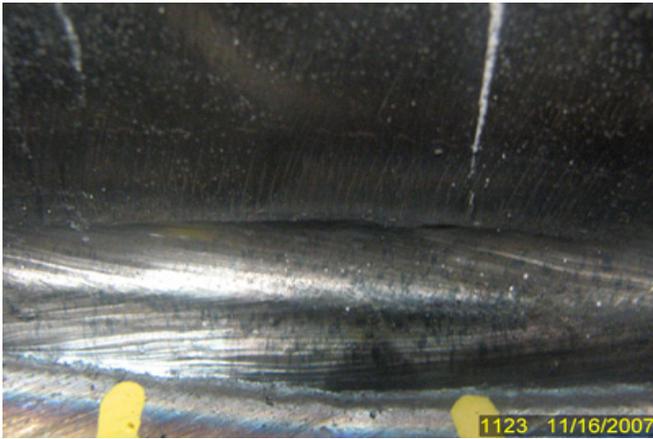
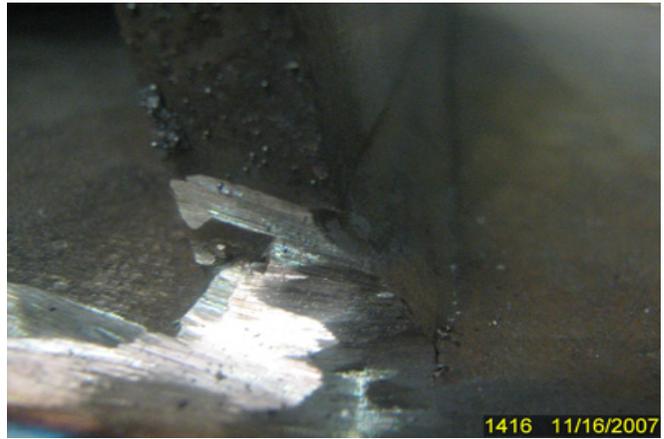
Caltrans QA Inspector Viars and Caltrans QA Inspector Croff performed random visual observations of the Submerged Arc Welding (SAW) cover pass welds on the OBG Deck Plate Panel Trial closed ribs. Visual observations were performed on 13 and 1.7 meter deck plate panel closed ribs welds. ZPMC Quality Control (QC) personnel performed 100% visual inspection prior to Caltrans random observation. American Bridge Flour (ABF) performed random observations of the cover pass prior to Caltrans observations. The following welding anomalies were noted during the random visual inspection; undercut that exceeded 0.25 mm, overlap, undersized weld and areas of incomplete fusion. These areas were marked on the deck plate adjacent to area of interest. Mapping and locations were recorded by the above mentioned Caltrans QA Inspectors. Overlap was evaluated with a steel rule butted up to the bottom plate to weld toe while artificial lighting at induced 90° to the steel rule. Areas where the overlap exceeded a 90° angle and light was visible from the toe of the weld with a no visible light noticeable from the bottom of the rule were marked as overlap. Areas where the overlap was suspect and a light leak was present under the rule were recorded but not marked as overlap. The following pictures below shows an area of undercut at the weld to U Rib toe on the (bottom left photo), and an area of underfill on the 1.7 meter Deck Plate Panel where the runoff tab begins (bottom right photo).

Panel mock-up. The SAW cover pass welding of the U Ribs did not appear to meet AWS D1.5 requirements.
