**DEPARTMENT OF TRANSPORTATION**

Contract #: 04-0120F4Cty: SF/ALA Rte: 80 PM: 13.2/13.9File #: 69.28**WELDING INSPECTION REPORT****Resident Engineer:** Pursell, Gary**Address:** 333 Burma Road**City:** Oakland, CA 94607**Report No:** WIR-000905**Date Inspected:** 18-Nov-2007**Project Name:** SAS Superstructure**OSM Arrival Time:** 630**Prime Contractor:** American Bridge/Fluor Enterprises, a JV**OSM Departure Time:** 1530**Contractor:** Zhenhua Port Machinery Company, Ltd (ZPMC), Changxing Island **Location:** Changxing Island**CWI Name:** Lujian Ping**CWI Present:** Yes No**Inspected CWI report:** Yes No N/A**Rod Oven in Use:** Yes No N/A**Electrode to specification:** Yes No N/A**Weld Procedures Followed:** Yes No N/A**Qualified Welders:** Yes No N/A**Verified Joint Fit-up:** Yes No N/A**Approved Drawings:** Yes No N/A**Approved WPS:** Yes No N/A**Delayed / Cancelled:** Yes No N/A**Bridge No:** 34-0006**Component:** OBG, 89 and 114**Summary of Items Observed:**

# WELDING INSPECTION REPORT

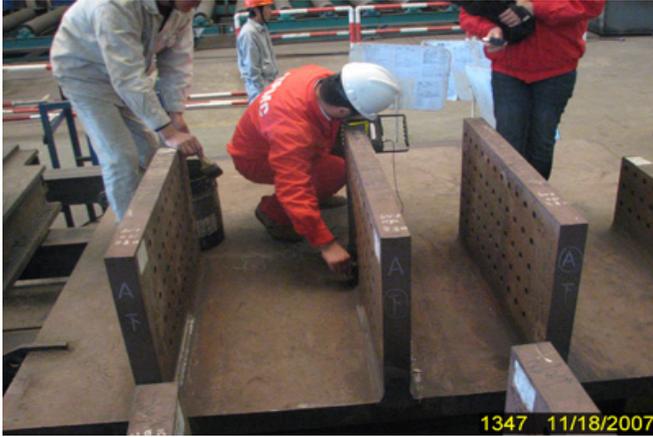
Caltrans QA Inspector observed ZPMC QC Ultrasonic technicians Mr. Li Liming and Ms. E Shuiqin performing Ultrasonic Testing on Mock-up # 114.00 Skin A upper and lower sections Complete Joint Penetration (CJP) welds for the longitudinal stiffener welds. Ultrasonic Testing was for the second repair of the upper and lower sections. Mock-up 114 Skin A Lower had repair areas on weld # 2 and 3. Mock-up 114 A upper section had repair areas on welds # 3, 5 and 7. Ms. E Shuiqin performed 70 degree shear wave testing from the A and B surfaces on the above mentioned weld joints. Mr. Liming performed straight beam testing and 45 degree shear wave from the A and B surfaces. Testing from surface C was not completed by the end of the shift. No preliminary test results were given by ZPMC personnel. Mr. Shen Xue Jun stated, this was the second repair for the 114 Meter Mock-up Skin Plate A upper and lower sections and that testing would be completed on the following shift. Please see the attached photo below that illustrates Mr. Liming performing UT.

Ultrasonic Testing of Mock-up # 114.00 Skin plate A upper and lower sections. Caltrans QA Inspector observed that the testing appeared to be in general conformance with AWS D1.5 2002 requirements. See MT report TL6028 generated on this date for further information.
