**DEPARTMENT OF TRANSPORTATION**

Contract #: 04-0120F4Cty: SF/ALA Rte: 80 PM: 13.2/13.9File #: 69.28**WELDING INSPECTION REPORT****Resident Engineer:** Pursell, Gary**Address:** 333 Burma Road**City:** Oakland, CA 94607**Report No:** WIR-000942**Date Inspected:** 28-Nov-2007**Project Name:** SAS Superstructure**OSM Arrival Time:** 630**Prime Contractor:** American Bridge/Fluor Enterprises, a JV**OSM Departure Time:** 1530**Contractor:** Zhenhua Port Machinery Company, Ltd (ZPMC), Changxing Island **Location:** Changxing Island

## WELDING INSPECTION REPORT

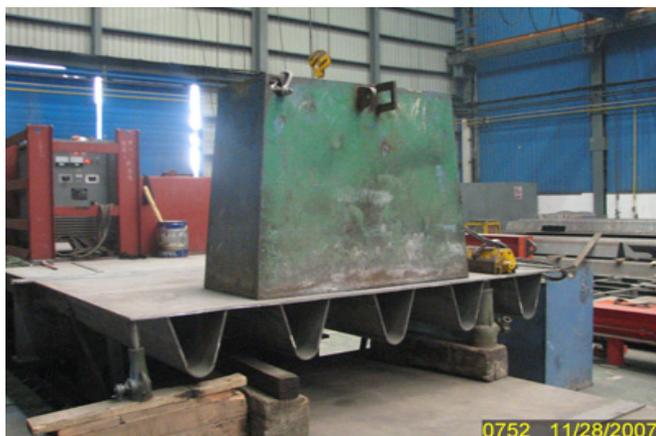
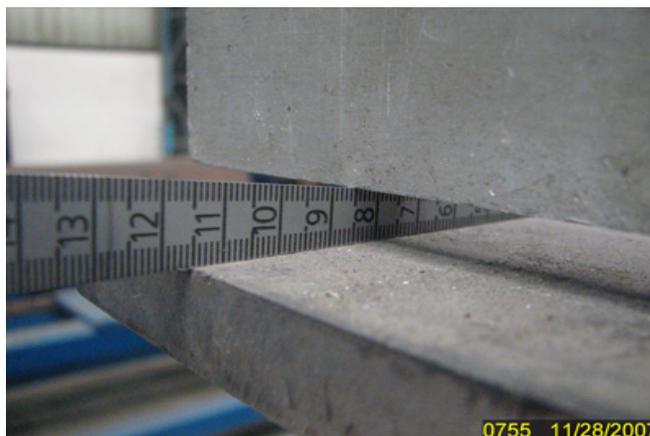
Caltrans QA Inspector Viars observed an area of the OBG deck plate trial that appeared to be warped at the 1.7 Meter section (left end) at U-rib U06 and U07. A weight was located on the backside of deck plate as well as hydraulic jacks under backing strip on the on the 1.7 meter section of the deck plate trial. Caltrans QA Inspector

Viars performed random flatness measurements of 1.7 meter panel section with a 1 meter straight edge rule. A transverse measurement of 8.5 mm was taken on the 1.7 meter section. Please see the attached photos below of OBG deck plate trial.
