Contract #: 04-0120F4Cty: SF Rte: 80 PM: 13.2/13.9File #: 1x.28**WELDING INSPECTION REPORT****Resident Engineer:** Pursell, Gary**Address:** 333 Burma Road**City:** Oakland, CA 94607**Report No:** WIR-000959**Date Inspected:** 29-Nov-2007**Project Name:** SAS Superstructure**Prime Contractor:** American Bridge/Fluor Enterprises, a JV**Contractor:** American Bridge/Fluor Enterprises, a JV**OSM Arrival Time:****OSM Departure Time:****Location:** Benica, CA

Bridge No: 34-0006**Component:** Procedure Qualification Record (PQR) test**Summary of Items Observed:**

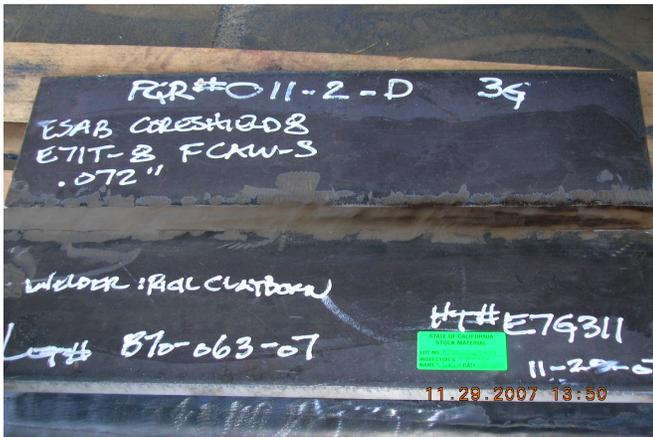
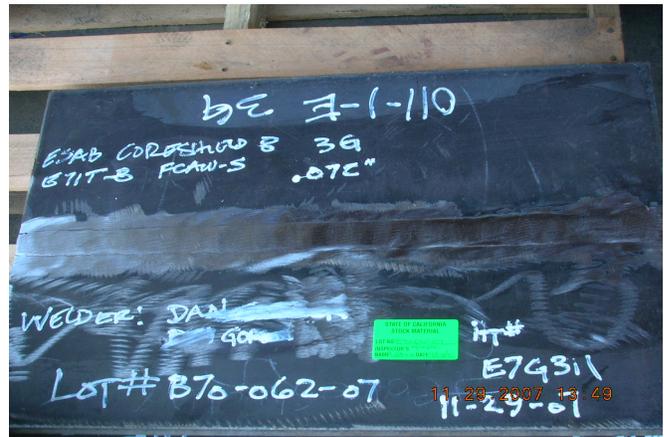
b) After cutting and grinding were completed the PQR test plates were visually inspected by QC Inspector William Norris. William Norris notified the QA Inspector the test plates were visually acceptable in accordance with AWS D1.5-2002. The QA Inspector performed visual verification and observed test plates appeared to be in general compliance with the project plans and specifications. Please see digital images below.
