DEPARTMENT OF TRANSPORTATION

Contract #: 04-0120F4Cty: SF/ALA Rte: 80 PM: 13.2/13.9File #: 69.28**WELDING INSPECTION REPORT****Resident Engineer:** Pursell, Gary**Address:** 333 Burma Road**City:** Oakland, CA 94607**Report No:** WIR-000971**Date Inspected:** 05-Dec-2007**Project Name:** SAS Superstructure**OSM Arrival Time:** 730**Prime Contractor:** American Bridge/Fluor Enterprises, a JV**OSM Departure Time:** 1500**Contractor:** Zhenhua Port Machinery Company, Ltd (ZPMC), Changxing Island **Location:** Shanghai, China**CWI Name:** See Below**CWI Present:** Yes No**Inspected CWI report:** Yes No N/A**Rod Oven in Use:** Yes No N/A**Electrode to specification:** Yes No N/A**Weld Procedures Followed:** Yes No N/A**Qualified Welders:** Yes No N/A**Verified Joint Fit-up:** Yes No N/A**Approved Drawings:** Yes No N/A**Approved WPS:** Yes No N/A**Delayed / Cancelled:** Yes No N/A**Bridge No:** 34-0006**Component:** OBG**Summary of Items Observed:**

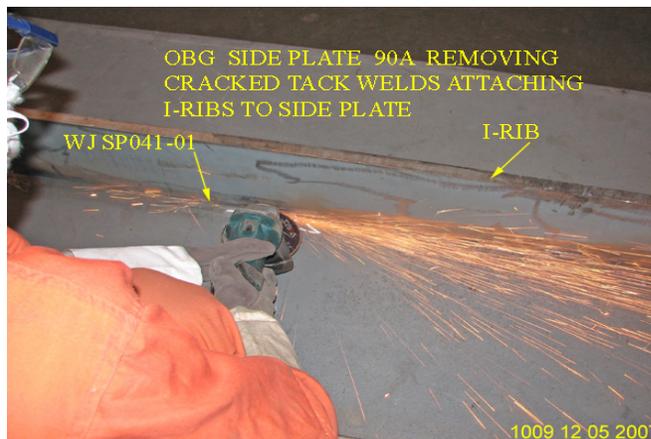
The QA Inspector randomly observed ZPMC welding personnel utilizing grinders to remove cracked tack welds attaching I-Ribs to Side Plates 87A and 90A. The attached photograph provides additional detail.

The QA Inspector was informed by ZPMC CWI Lee Chan Woo that the I-Ribs on Side Plate 90A with the cracked tack welds, had been welded without preheat and with FCAW. The 1 I-Rib that had no cracked tack welds had been welded with preheat and with the Shielded Metal Arc Welding (SMAW) Process. Mr. Woo also informed the QA Inspector that 3 out of 5 of the I-Ribs on Side Plate 87A had been welded with preheat and the other 2 had not. According to Mr. Woo, all I-Ribs had been welded with FCAW. The 2 I-Ribs that were welded without preheat had several tack welds with transverse cracks, longitudinal cracks and both transverse and longitudinal cracks. The 3 I-Ribs that had been welded with preheat contained only a total of 4 cracked tack welds. Mr. Woo further informed the QA Inspector that future welding of the I-Ribs would be done with preheat and with SMAW.
