DEPARTMENT OF TRANSPORTATION

Contract #: 04-0120F4Cty: SF/ALA Rte: 80 PM: 13.2/13.9File #: 69.28**WELDING INSPECTION REPORT****Resident Engineer:** Pursell, Gary**Address:** 333 Burma Road**City:** Oakland, CA 94607**Report No:** WIR-000975**Date Inspected:** 04-Dec-2007**Project Name:** SAS Superstructure**OSM Arrival Time:** 1400**Prime Contractor:** American Bridge/Fluor Enterprises, a JV**OSM Departure Time:** 2330**Contractor:** Zhenhua Port Machinery Company, Ltd (ZPMC), Changxing Island **Location:** Shanghai, China

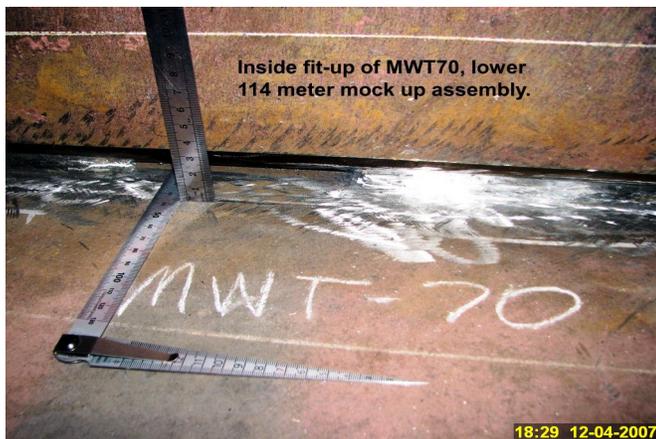
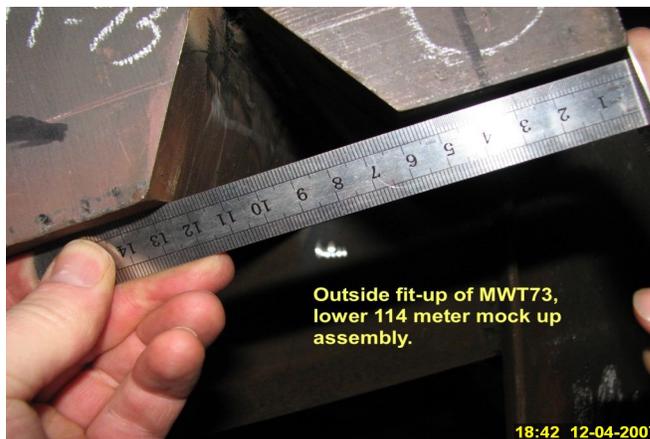
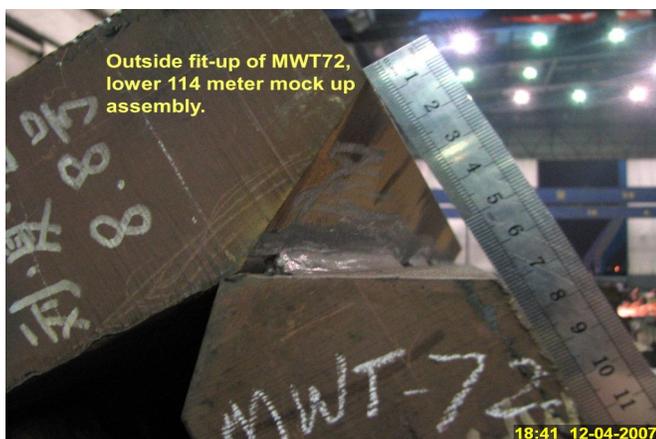
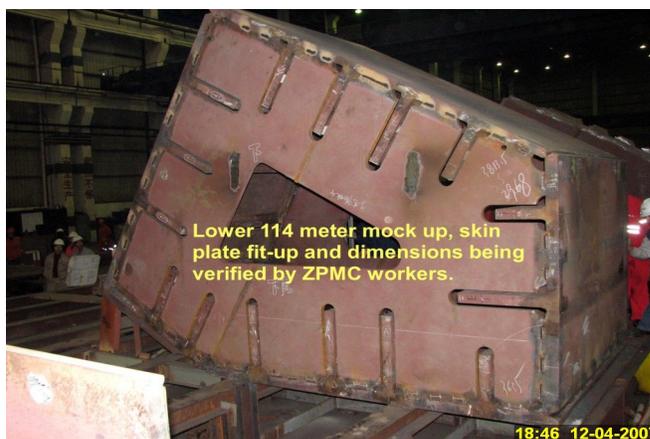
The QA inspector made random observations of fit-up of weld joints MWT70, MWT71, MWT72, MWT73 and MWT74 as they were being prepared on the lower 114 meter mock up assembly. The QA inspector observed that the bevel depths appear to be corresponding with the approved weld details. The QA inspector was unable to accurately observe the bevel angles of the weld joints. The QA inspector noted that all root openings appear to be 0mm at this time. The Quality Control Liaison (QCL) Lay Tau accompanied the QA inspector while these observations were being made. The QCL informed the QA inspector that ZPMC workers were still making dimensional verifications of the assembly. The QA inspector also observed that no weld tabs are currently attached at any of the ends of the complete joint penetration (CJP) welds. See the attached photos of some of these observations.
