DEPARTMENT OF TRANSPORTATION

Contract #: 04-0120F4Cty: SF/ALA Rte: 80 PM: 13.2/13.9File #: 69.28**WELDING INSPECTION REPORT****Resident Engineer:** Pursell, Gary**Address:** 333 Burma Road**City:** Oakland, CA 94607**Report No:** WIR-000979**Date Inspected:** 28-Nov-2007**Project Name:** SAS Superstructure**OSM Arrival Time:** 1400**Prime Contractor:** American Bridge/Fluor Enterprises, a JV**OSM Departure Time:** 2330**Contractor:** Zhenhua Port Machinery Company, Ltd (ZPMC), Changxing Island **Location:** Shanghai, China**CWI Name:** Cui Yi Ru**CWI Present:** Yes No**Inspected CWI report:** Yes No N/A**Rod Oven in Use:** Yes No N/A**Electrode to specification:** Yes No N/A**Weld Procedures Followed:** Yes No N/A**Qualified Welders:** Yes No N/A**Verified Joint Fit-up:** Yes No N/A**Approved Drawings:** Yes No N/A**Approved WPS:** Yes No N/A**Delayed / Cancelled:** Yes No N/A**Bridge No:** 34-0006**Component:** Floor Beam Diaphragms, 114 meter mock up**Summary of Items Observed:**

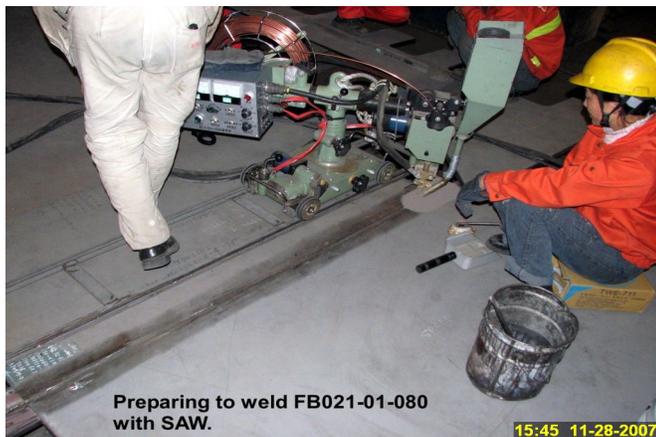
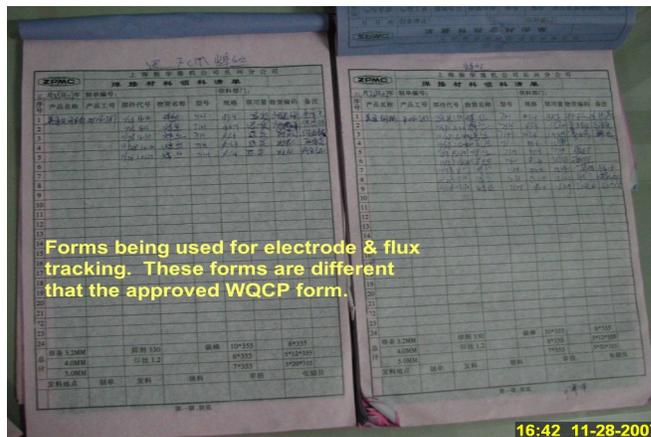
Bay 7: The QA inspector observed a submerged arc welding (SAW) machine being operated by Sun Guzuo. The QA inspector noted that a complete joint penetration (CJP) butt weld is being made on seismic performance critical material (SPCM) on Floor Beam diaphragm (FB)021-01, weld 080. The QA inspector observed the flux that is being used at this location is being stored in a plastic bucket. The QA inspector noted that this does not conform to the requirements stated in the approved welding quality control plan (WQCP) for SPCM welding. The QA inspector asked the Quality Control Liaison (QCL) "Ken" Zhang Jiadi why the flux was being kept in a plastic bucket. The QCL "Ken" relayed this question to the Quality Control (QC) inspector Cui Yi Ru, who is monitoring the work at this location. There was a conversation between the QCL, the QC inspector and several other ZPMC personnel who were nearby. The QA inspector did not receive an answer to that question. See the attached photos.

As noted above, the QA inspector Scott Croff had a conversation with the QCL "Ken" regarding the observed storage of flux used for SAW on the floor beam components. The QA inspector asked the QC inspector Cui Yi Ru, through the QCL "Ken" why the flux was not being stored as required in the approved WQCP? The QCL "Ken", the QC inspector Cui Yi Ru and several other ZPMC personnel conversed amongst themselves and the QA inspector repeated the question directly to the QCL "Ken". The QA inspector's question was not answered and does not know if ZPMC's QC inspectors are fully aware of the requirements of the approved WQCP. The QA inspector was then informed of the MT being conducted in Bay 2 and was directed to that location, as the SAW welding has been completed. Upon the arrival at Bay 2, the QA inspector was informed that PJP root welds #7 and #8 were inspected and accepted.
