DEPARTMENT OF TRANSPORTATION

Contract #: 04-0120F4Cty: SF/ALA Rte: 80 PM: 13.2/13.9File #: 69.28**WELDING INSPECTION REPORT****Resident Engineer:** Pursell, Gary**Address:** 333 Burma Road**City:** Oakland, CA 94607**Report No:** WIR-001004**Date Inspected:** 13-Dec-2007**Project Name:** SAS Superstructure**OSM Arrival Time:** 730**Prime Contractor:** American Bridge/Fluor Enterprises, a JV**OSM Departure Time:** 1500**Contractor:** Zhenhua Port Machinery Company, Ltd (ZPMC), Changxing Island **Location:** Shanghai, China

Bridge No: 34-0006**Component:** OBG**Summary of Items Observed:**

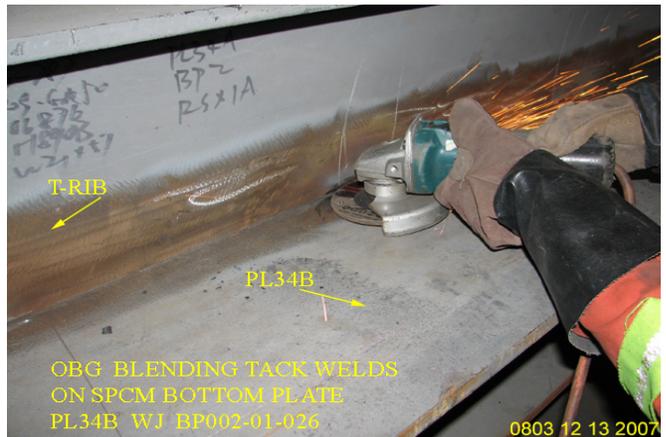
The QA Inspector randomly observed a ZPMC helper utilizing a grinder to blend tack welds attaching T-Ribs on Bottom Plate PL34B. The attached photograph provides additional detail.
