DEPARTMENT OF TRANSPORTATION

Quality Assurance and Source Inspection

Contract #: 04-0120F4Cty: SF/ALA Rte: 80 PM: 13.2/13.9File #: 69.28**WELDING INSPECTION REPORT****Resident Engineer:** Pursell, Gary**Address:** 333 Burma Road**City:** Oakland, CA 94607**Report No:** WIR-001017**Date Inspected:** 10-Dec-2007**Project Name:** SAS Superstructure**OSM Arrival Time:** 630**Prime Contractor:** American Bridge/Fluor Enterprises, a JV**OSM Departure Time:** 1730**Contractor:** Zhenhua Port Machinery Company, Ltd (ZPMC), Changxing Island **Location:** Shanghai, China**CWI Name:** Lu Jian Ping**CWI Present:** Yes No**Inspected CWI report:** Yes No N/A**Rod Oven in Use:** Yes No N/A**Electrode to specification:** Yes No N/A**Weld Procedures Followed:** Yes No N/A**Qualified Welders:** Yes No N/A**Verified Joint Fit-up:** Yes No N/A**Approved Drawings:** Yes No N/A**Approved WPS:** Yes No N/A**Delayed / Cancelled:** Yes No N/A**Bridge No:** 34-0006**Component:** Tower Mock-up and OBG**Summary of Items Observed:**

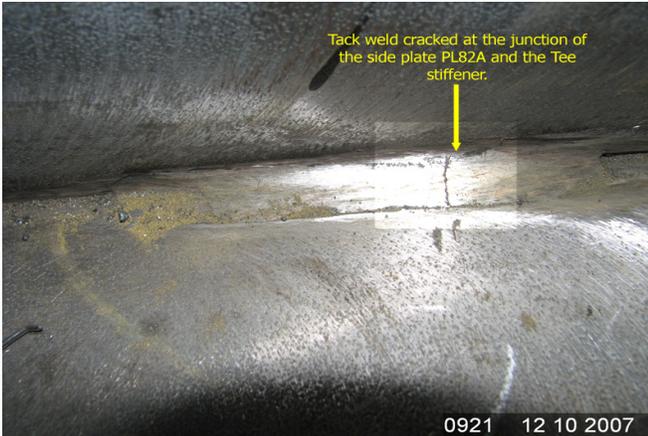
2 OBG Floor Beam Crack on the Tack Welding			
<p>The QA inspector was informed by Mr. Lee Chan Woo that a tack weld cracked at the Plate PL-87A at the weld joint SP035-01-08, right end second tack weld. See photograph below.</p>

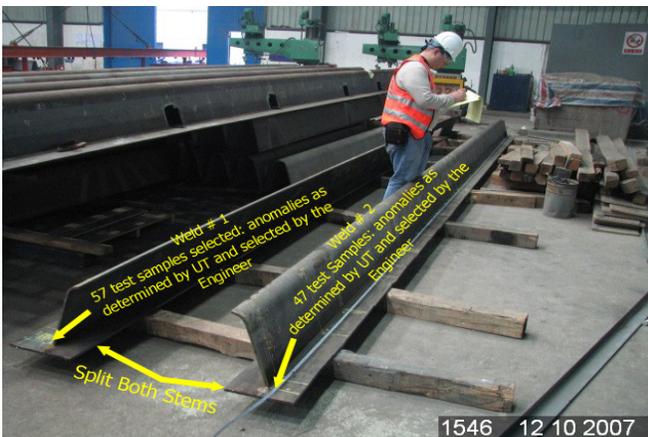
4 OBG Weld Trial test sampling

The QA inspector recorded and marked with Caltrans representatives Pat Lowry, David McClary and John Tracy the test sample areas to be cut for macroetch and mechanical test at the weld # 1 and # 2 from the weld trial after splitting the U-rib in two parts. Caltrans representatives marked 107 locations to be tested.
