**DEPARTMENT OF TRANSPORTATION**

Contract #: 04-0120F4Cty: SF/ALA Rte: 80 PM: 13.2/13.9File #: 69.28**WELDING INSPECTION REPORT****Resident Engineer:** Pursell, Gary**Address:** 333 Burma Road**City:** Oakland, CA 94607**Report No:** WIR-001088**Date Inspected:** 09-Dec-2007**Project Name:** SAS Superstructure**OSM Arrival Time:** 630**Prime Contractor:** American Bridge/Fluor Enterprises, a JV**OSM Departure Time:** 1530**Contractor:** Zhenhua Port Machinery Company, Ltd (ZPMC), Changxing Island **Location:** Shanghai, China**CWI Name:** See Below**CWI Present:** Yes No**Inspected CWI report:** Yes No N/A**Rod Oven in Use:** Yes No N/A**Electrode to specification:** Yes No N/A**Weld Procedures Followed:** Yes No N/A**Qualified Welders:** Yes No N/A**Verified Joint Fit-up:** Yes No N/A**Approved Drawings:** Yes No N/A**Approved WPS:** Yes No N/A**Delayed / Cancelled:** Yes No N/A**Bridge No:** 34-0006**Component:** Tower Fabrication**Summary of Items Observed:**

Orthotropic Box Girder (OBG) and Tower Mock Up:

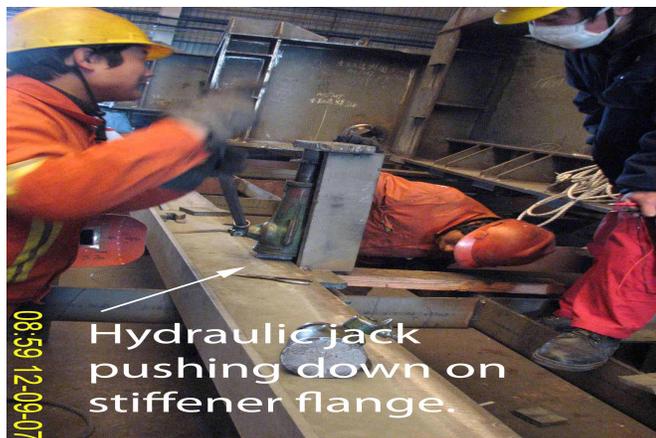
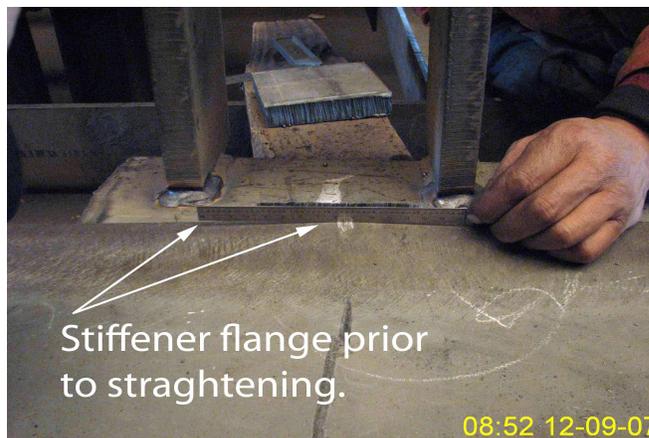
The QA Inspector observed ZPMC personnel using a hydraulic jack to straighten the web of a stiffener plate that is to be installed on OBG plate 33A. Prior to straightening, the web had a localized area with approximately 8 mm of misalignment and after application of pressure the web plate appeared to be within 1 mm of being straight. See the photographs below for additional information. Items observed by the QA Inspector appear to comply with project specifications.
