DEPARTMENT OF TRANSPORTATION

Quality Assurance and Source Inspection

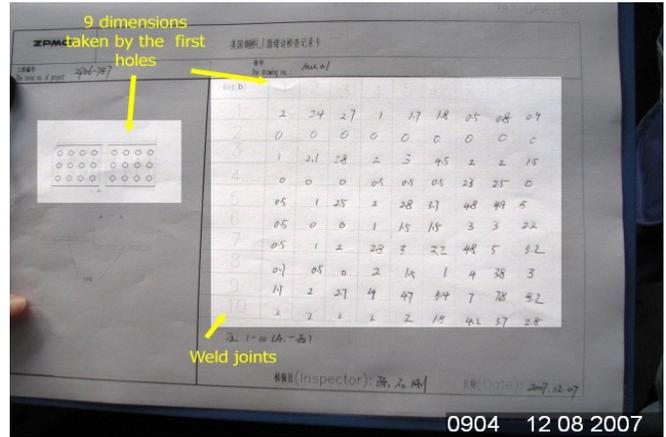
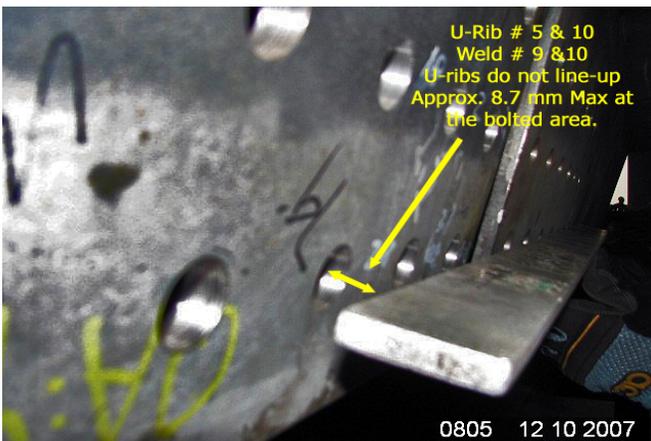
3 Deck Mock-up Alignment verifications The QA inspector collected data after performing alignment verifications at the U-ribs bolted splice connection on the OBG Deck Mock-up performed on 12-10-2007. The maximum misalignment measured was 8.7 mm at the bolting area on the U-rib # 05 by weld # 9 and 10. Below show the dimensional inspection reports from ZPMC and the QA

inspector measuring the misalignment at the bolted splice area. Also, is shown a photograph of Caltrans QA representative Paul Stoval assisting the QA inspector on the alignment verifications on 12/10/2007.
