**DEPARTMENT OF TRANSPORTATION**

Contract #: 04-0120F4Cty: SF/ALA Rte: 80 PM: 13.2/13.9File #: 69.28**WELDING INSPECTION REPORT****Resident Engineer:** Pursell, Gary**Address:** 333 Burma Road**City:** Oakland, CA 94607**Report No:** WIR-001118**Date Inspected:** 12-Nov-2007**Project Name:** SAS Superstructure**OSM Arrival Time:** 630**Prime Contractor:** American Bridge/Fluor Enterprises, a JV**OSM Departure Time:** 1530**Contractor:** Zhenhua Port Machinery Company, Ltd (ZPMC), Changxing Island **Location:** Shanghai, China

**Summary of Items Observed:**

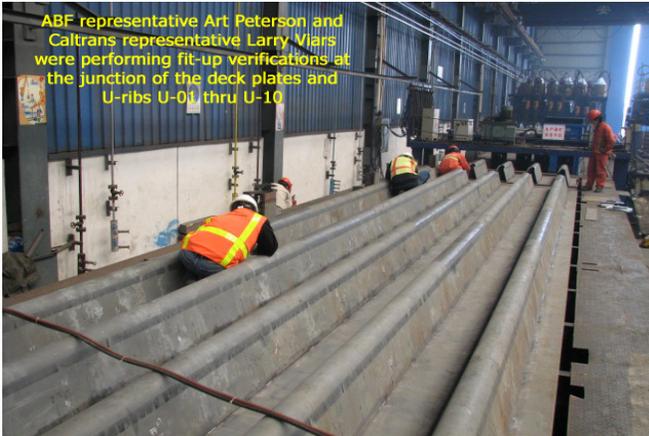
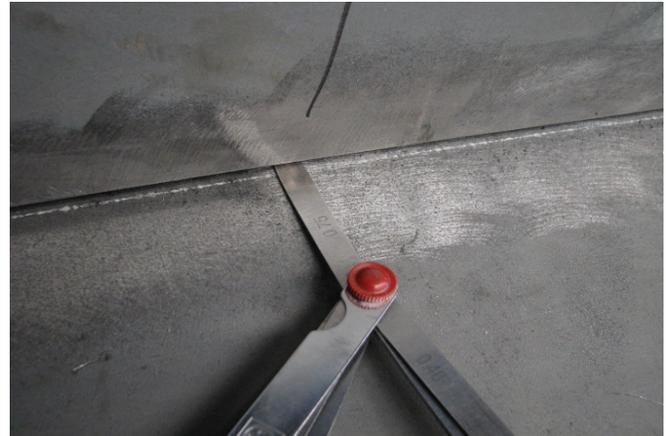
Item Description	WBS	Dwg No.	Status
1 OBG Deck plate Mock-up U-ribs			
The QA inspector assisted the QA inspector Larry Viars performing dimensional verifications to the U-ribs U-01 through U-10. Mr. Viars informed to the QA inspector that he found excessive gap at the junction of the deck plate to the U-rib between tack welds of 1.1 mm. The maximum gap allowed in accordance with ZPMC fabrication procedure was 0.5 mm. The QA inspector informed ZPMC of the results obtained after the dimensional inspection.

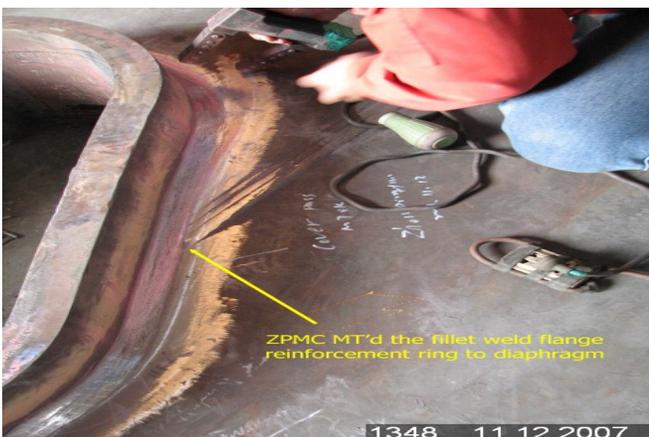
## 2 Magnetic Particle Testing (MT) to the flange Diaphragm ring fillet

The QA inspector observed that ZPMC was performing magnetic particle inspection to the fillet weld at the junction of the flange reinforcement ring SA-274 with the diaphragm SA-104. The QA inspector asked ZPMC QA inspector Li Xue Yang what was the cooling time after the weld was completed. After Mr. Li Xue Yang asked the QC personnel, Mr. Li Xue Yang informed the QA inspector that the cooling time was less than 48 hours. The QA inspector relayed that the required time was 48 hours and the QA inspector recommended that wait until the cooling time was completed. ZPMC QC and QA inspectors at that location were not aware of the cooling time required before performing non destructive testing per special provisions, when welding grade HPS 485W. The QA inspector had a conversation with ABF representative Kevin Dye and Art Peterson. The QA inspector informed the ABF representatives that ZPMC QC inspectors were not aware that ZPMC needed to wait before MT as per special provision 48 hours after welding a fillet weld. ABF agreed and relayed this information to ZPMC about this requirement.

Later after the cooling time was completed, The QA inspector observed that ZPMC performed MT verifications of the fillet weld at the junction flange reinforcement ring SA-274 with the diaphragm SA-104. The QA inspector found that ZPMC verifications appeared to be in accordance with contract documents.

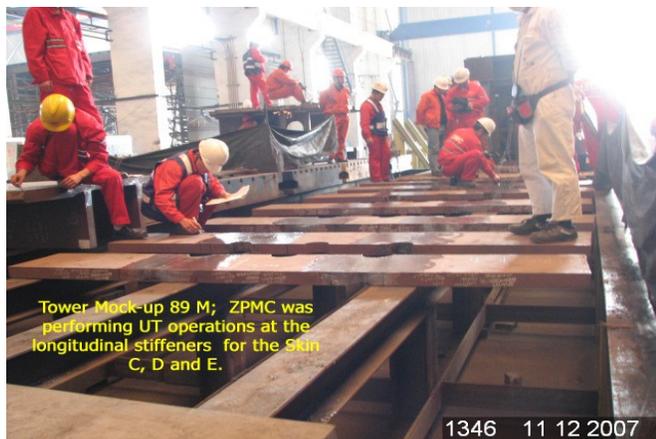
## 4 Tower 89 M Ultrasonic Testing (UT)

The QA inspector observed ZPMC Li Li Ming and Xue Hai Yang performing UT verifications at the longitudinal stiffeners splices for skin C,D and E Tower Mock-up 89 M. ZPMC UT verifications appeared to be in accordance with the contract documents.

ZPMC reported a rejectable indication with 17 mm of length at the skin C weld # 8 at the junction of plates 534 c to 534 b.

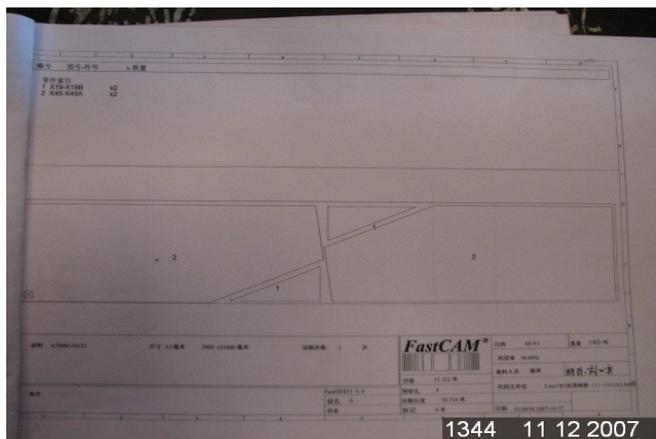
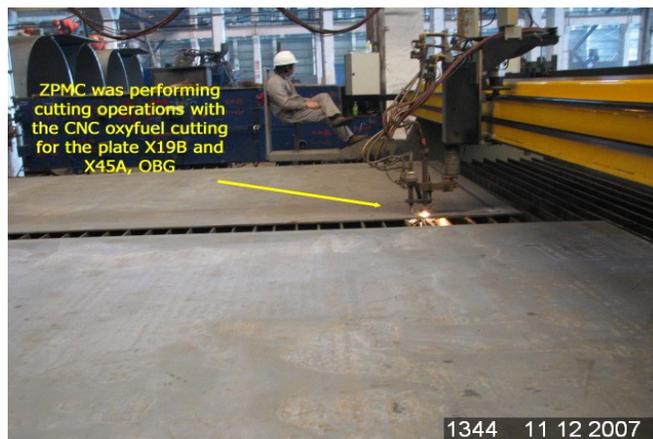
## 5 OBG cutting CNC operations

The QA inspector observed ZPMC representatives performing cutting operations with the CNC cutting machine to the plate 18B and 45A. See photographs below
