DEPARTMENT OF TRANSPORTATION

Office of Structural Materials

Contract #: 04-0120F4Cty: SF/ALA Rte: 80 PM: 13.2/13.9File #: 69.28**WELDING INSPECTION REPORT****Resident Engineer:** Pursell, Gary**Address:** 333 Burma Road**City:** Oakland, CA 94607**Report No:** WIR-001139**Date Inspected:** 20-Nov-2007**Project Name:** SAS Superstructure**OSM Arrival Time:** 630**Prime Contractor:** American Bridge/Fluor Enterprises, a JV**OSM Departure Time:** 1530**Contractor:** Zhenhua Port Machinery Company, Ltd (ZPMC), Changxing Island **Location:** Shanghai, China**CWI Name:** Sun Wei**CWI Present:** Yes No**Inspected CWI report:** Yes No N/A**Rod Oven in Use:** Yes No N/A**Electrode to specification:** Yes No N/A**Weld Procedures Followed:** Yes No N/A**Qualified Welders:** Yes No N/A**Verified Joint Fit-up:** Yes No N/A**Approved Drawings:** Yes No N/A**Approved WPS:** Yes No N/A**Delayed / Cancelled:** Yes No N/A**Bridge No:** 34-0006**Component:** Tower Mock-up and OBG**Summary of Items Observed:**

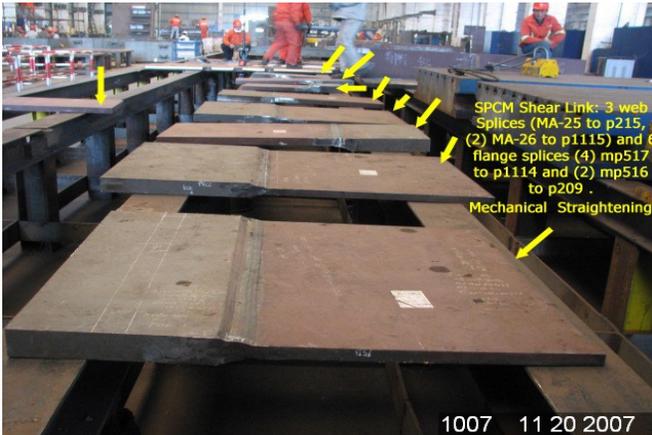
Item Description	WBS	Dwg No.	Status
1 Tower 89 Meters Mock-up Shear links Mechanical straightening			
<p>The QA inspector had a conversation with the ZPMC representative Li Xiu Yang. The QA inspector asked where and why 9 sections (3 webs and 6 flanges) from the shear links were moved outside of the shop before fitting-up the subassembling MUSB-MA25 and MA26. Mr. Li Xiu Yang said to the QA inspector that all the parts were taken to be mechanical straightened because they were distorted from the welding process. The QA inspector asked if ZPMC confirmed that the shear link were Seismic Performance Critical members (SPCM). Mr. Li Xiu Yang said that in previous conversation with the QA inspector, he informed to the QA inspector that ZPMC representative Mr. Hu Gang said to him that the Shear links were not SPMC material. The QA inspector had a conversation with ABF representative Mr. Kevin Carpenter. The QA inspector informed to Mr. Kevin Carpenter and Kevin Dye that ZPMC said to him that ZPMC performed mechanical straightening when the shear link material was SPMC member and section 12 prohibits cold bending. Mr. Kevin Carpenter informed that ABF would confirm that ZPMC did perform cold bending to the 3 webs and 6 flanges from the shear links subassembling MA-25 and MA-26. Later, ABF representative Kevin Dye relayed to the QA inspector that ZPMC straightened mechanically all the above parts mentioned and asked to the QA inspector if Caltrans was going to write a non conformance report regarding this issue. The QA inspector had a conversation with Caltrans Task Leader Robert Cuellar. The QA inspector brought to the attention that according with ZPMC and ABF 3 webs and 6 flanges components from the SPMC shear links were not fabricated as per section 12.12</p>

AWS D1.5(2002).

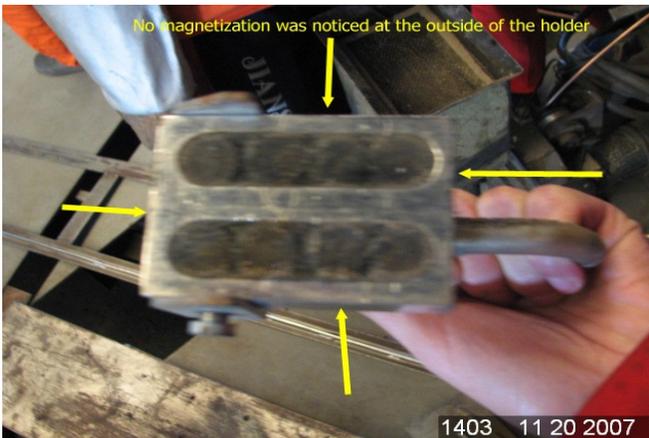
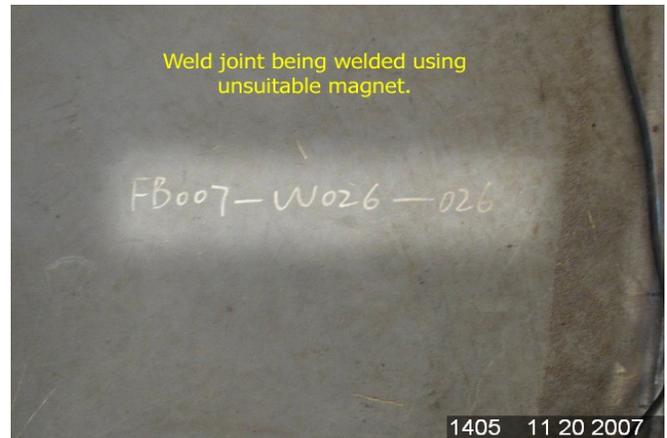
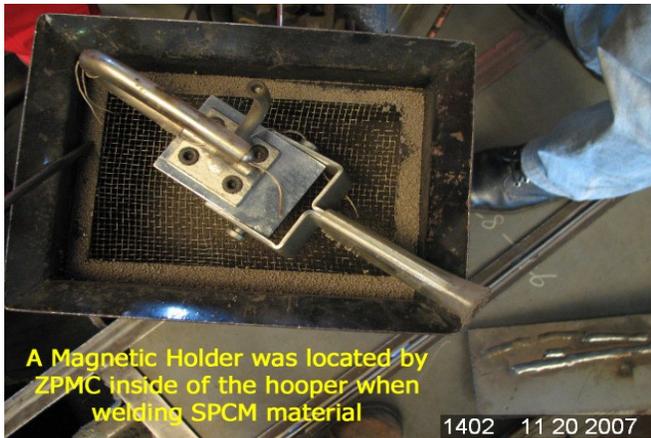
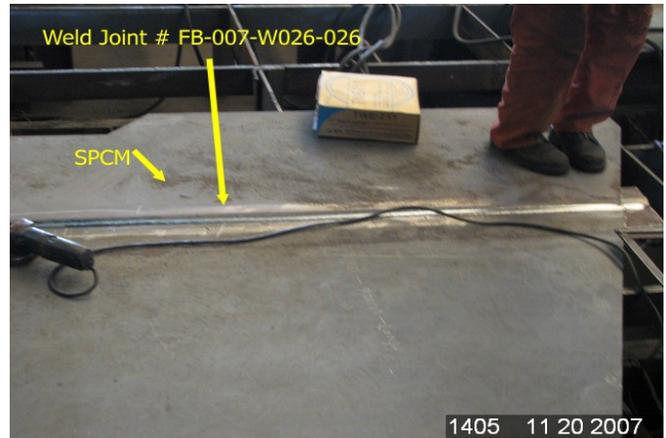
2 Welding SPCM floor beam splices with unsuitable magnet

The QA inspector observed that welder Ms. Wu Zhibin was welding SPMC member for the floor beam splices 66A to 66B weld joint FB-007-W026-026 with a holder magnet inside the Hopper. The QA inspector verified the magnetization at the outside of the holder. The QA did not notice any relevant magnetization at the outside of the holder when the QA inspector located the magnetic holder against the steel. The QA inspector had a conversation with the ZPMC representative Shen Xue Jun. The QA brought to Mr. Shen Xue Jun that the magnet that ZPMC was using appeared not to be suitable to remove the unwanted particles before returning the flux to the system. Mr. Shen Xue Jun agreed and directed QC inspector and production supervisor to remove and change the magnetic holder. The photographs below show the magnetic holder and the SPCM floor beam being welded.

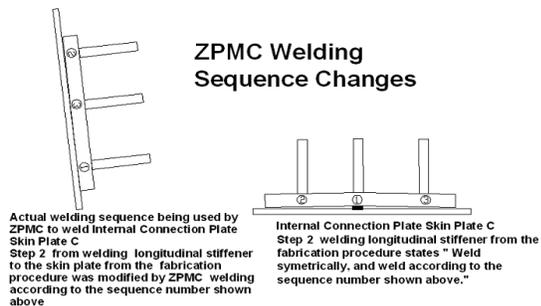
3 Tower Mock-up Welding Sequence

The QA inspector observed that ZPMC changed the welding sequence when welding longitudinal stiffeners to the skin plates. The QA inspector observed that fabrication procedure were not follow. The sketch below shows the changes in the welding sequence on ZPMC fabrication procedures for the interior connection plate for the Skin C from Tower Mock-up 114 Meters to improved the welding quality. Changes were observed also on the welding sequence on Skin plate A from Tower Mock-up 89 M.

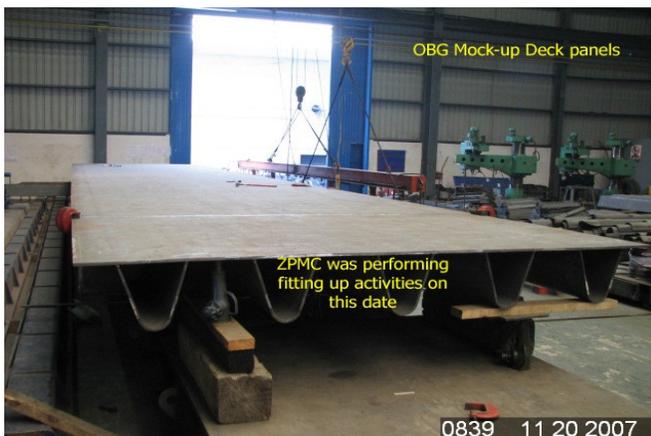
4 OBG Mock-up Deck plate

The QA inspector observed ZPMC performing fit up operations at the junction of the 13 meters to the 1.8 meters deck panels for the OBG Mock-up deck panel.
