**DEPARTMENT OF TRANSPORTATION**

Contract #: 04-0120F4Cty: SF/ALA Rte: 80 PM: 13.2/13.9File #: 69.28**WELDING INSPECTION REPORT****Resident Engineer:** Pursell, Gary**Address:** 333 Burma Road**City:** Oakland, CA 94607**Report No:** WIR-001180**Date Inspected:** 06-Dec-2007**Project Name:** SAS Superstructure**OSM Arrival Time:** 630**Prime Contractor:** American Bridge/Fluor Enterprises, a JV**OSM Departure Time:** 1530**Contractor:** Zhenhua Port Machinery Company, Ltd (ZPMC), Changxing Island **Location:** Shanghai, China**CWI Name:** ZPMC - Lee Chan Woo**CWI Present:** Yes No**Inspected CWI report:** Yes No N/A**Rod Oven in Use:** Yes No N/A**Electrode to specification:** Yes No N/A**Weld Procedures Followed:** Yes No N/A**Qualified Welders:** Yes No N/A**Verified Joint Fit-up:** Yes No N/A**Approved Drawings:** Yes No N/A**Approved WPS:** Yes No N/A**Delayed / Cancelled:** Yes No N/A**Bridge No:** 34-0006**Component:** Bay- #3 Observations**Summary of Items Observed:**

# WELDING INSPECTION REPORT

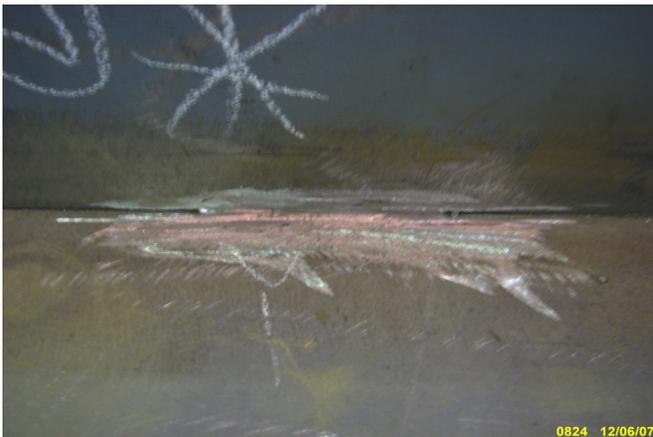
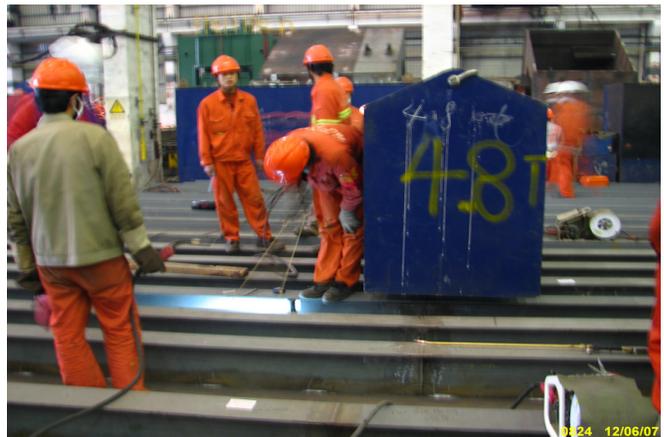
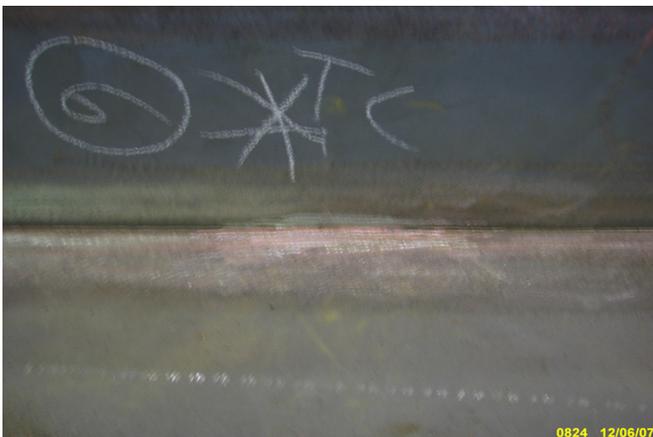
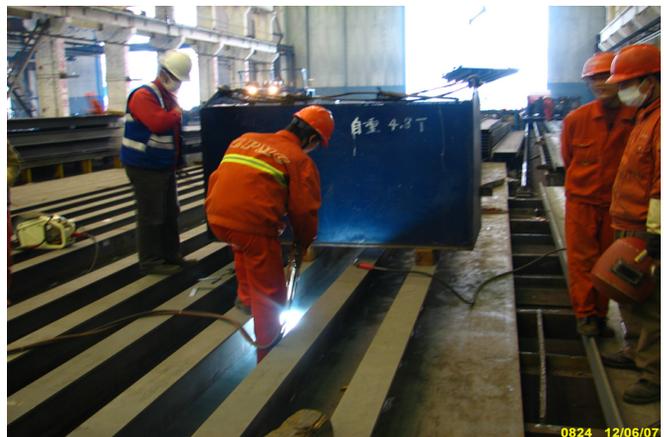
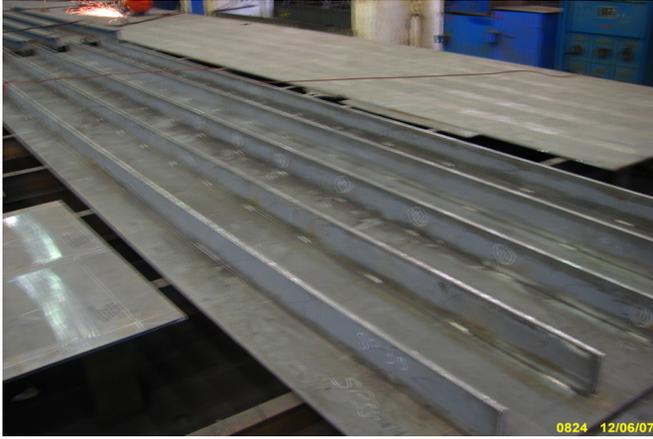
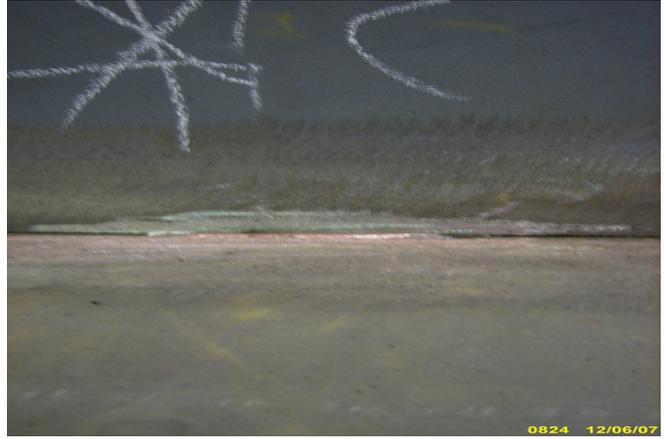
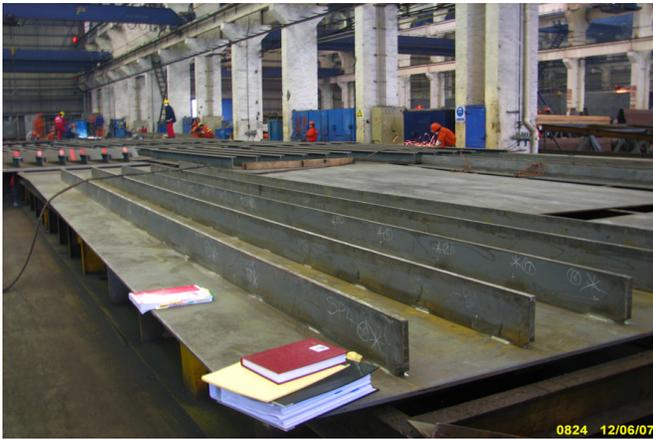
Plate 90A had 52 out of the 180 made tack welds failed due to longitudinal and/or transverse cracking. Many welds have a combination of both types.

Plate 87A had 36 out of the 180 made tack welds failed due to longitudinal and/or transverse cracking. Many welds have a combination of both types.

There was no visibly detectable signs of damage or thermal stressing on any of the tack weld Heat Affected Zones (HAZ). The Caltrans representative, Mr. Charlie Franco, stated that his conversations with ZPMC personnel revealed that a uniform course of preheating was not followed throughout the fabrication process. Simply stated some welds were preheated and some welds were not.
