**DEPARTMENT OF TRANSPORTATION**

Contract #: 04-0120F4Cty: SF/ALA Rte: 80 PM: 13.2/13.9File #: 69.28**WELDING INSPECTION REPORT****Resident Engineer:** Pursell, Gary**Address:** 333 Burma Road**City:** Oakland, CA 94607**Report No:** WIR-001186**Date Inspected:** 28-Dec-2007**Project Name:** SAS Superstructure**OSM Arrival Time:** 1300**Prime Contractor:** American Bridge/Fluor Enterprises, a JV**OSM Departure Time:** 2330**Contractor:** Zhenhua Port Machinery Company, Ltd (ZPMC), Changxing Island **Location:** Shanghai, China**CWI Name:** Li Zhi Jiang**CWI Present:** Yes No**Inspected CWI report:** Yes No N/A**Rod Oven in Use:** Yes No N/A**Electrode to specification:** Yes No N/A**Weld Procedures Followed:** Yes No N/A**Qualified Welders:** Yes No N/A**Verified Joint Fit-up:** Yes No N/A**Approved Drawings:** Yes No N/A**Approved WPS:** Yes No N/A**Delayed / Cancelled:** Yes No N/A**Bridge No:** 34-0006**Component:** OBG and Tower Mockup**Summary of Items Observed:**

**Deck Trial Mockup MU3**

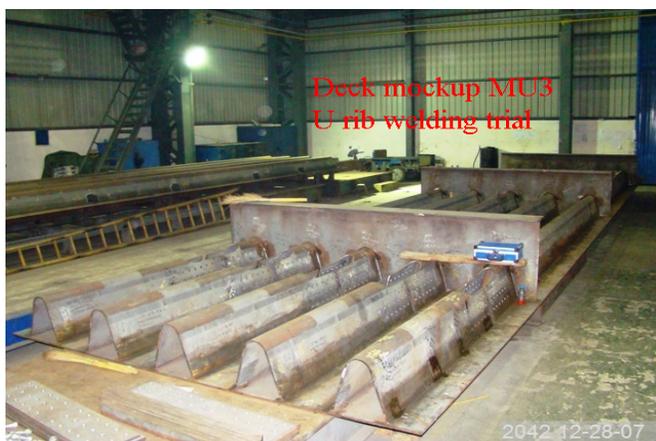
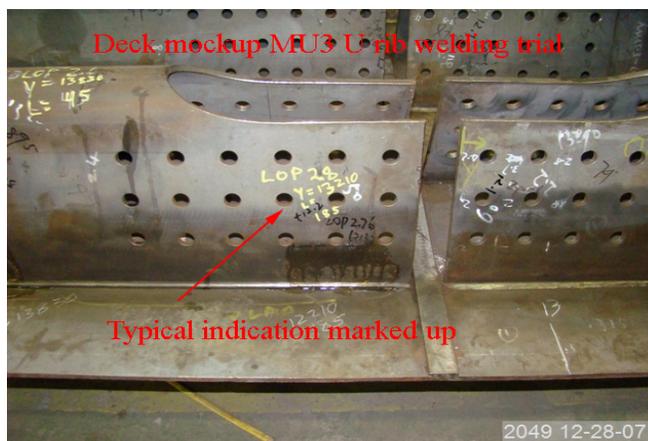
The QA inspector performed ultrasonic verification testing of the partial joint penetration welds on the Deck mockup, piece mark MU3. The ultrasonic testing (UT) was performed to verify the weld depth of penetration and testing performed by ZPMC personnel meet the requirements of the contract documents. The base metal lamination check was performed with a 1.0" dia. round 2.25 MHz transducer. The shear wave scan was performed with a 0.375" 3.25 MHz transducer on a 70 degree angle wedge from face A. Scanning patterns A, B and C were utilized. Following is a list of welds examined and the relevant indications of inadequate penetration observed in accordance with the contract documents.

The QA noted the indications of lack of penetration were discovered during ultrasonic testing that was performed by ZPMC personnel. The QA inspector concurred with the NDT level II technician's assessment. An Ultrasonic Test Report (TL-6027) for the welds that were tested was not generated for this date.

The following digital photographs illustrate observations of the activities being performed.
