Contract #: 04-0120F4Cty: SF/ALA Rte: 80 PM: 13.2/13.9File #: 69.28**WELDING INSPECTION REPORT****Resident Engineer:** Pursell, Gary**Address:** 333 Burma Road**City:** Oakland, CA 94607**Report No:** WIR-001230**Date Inspected:** 30-Nov-2007**Project Name:** SAS Superstructure**OSM Arrival Time:** 630**Prime Contractor:** American Bridge/Fluor Enterprises, a JV**OSM Departure Time:** 1530**Contractor:** Zhenhua Port Machinery Company, Ltd (ZPMC), Changxing Island **Location:** Changxing Island**CWI Name:** Chan Woo Lee**CWI Present:** Yes No**Inspected CWI report:** Yes No N/A**Rod Oven in Use:** Yes No N/A**Electrode to specification:** Yes No N/A**Weld Procedures Followed:** Yes No N/A**Qualified Welders:** Yes No N/A**Verified Joint Fit-up:** Yes No N/A**Approved Drawings:** Yes No N/A**Approved WPS:** Yes No N/A**Delayed / Cancelled:** Yes No N/A**Bridge No:** 34-0006**Component:** OBG, 77 & 114**Summary of Items Observed:**

WELDING INSPECTION REPORT

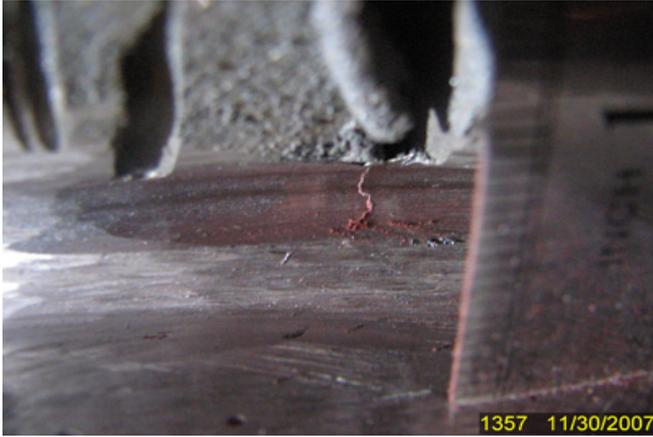
Caltrans QA Inspector Viars observed MT of Mock-up 89.00 Skin Plate D sub assembly MA22. Transverse cracking was noted on the root of weld # 11 at the access hole area where run off tabs were placed. ZPMC QC Mr. Xu Jun stated the cracking was located on run off tab portion of the weld and would be excavated when run off tabs were removed. Caltrans QA informed Mr. Jun the cracking may propagate into the base material and the transverse cracking should be removed prior to welding. Transverse cracking appears to be an issue carried over from tack welding. Please see the attached photo of the transverse cracking of root pass at access hole.
