**DEPARTMENT OF TRANSPORTATION**

Contract #: 04-0120F4Cty: SF/ALA Rte: 80 PM: 13.2/13.9File #: 69.28**WELDING INSPECTION REPORT****Resident Engineer:** Pursell, Gary**Address:** 333 Burma Road**City:** Oakland, CA 94607**Report No:** WIR-001246**Date Inspected:** 14-Dec-2007**Project Name:** SAS Superstructure**OSM Arrival Time:** 630**Prime Contractor:** American Bridge/Fluor Enterprises, a JV**OSM Departure Time:** 1530**Contractor:** Zhenhua Port Machinery Company, Ltd (ZPMC), Changxing Island **Location:** Shanghai, China**CWI Name:** Xu Lefeng**CWI Present:** Yes No**Inspected CWI report:** Yes No N/A**Rod Oven in Use:** Yes No N/A**Electrode to specification:** Yes No N/A**Weld Procedures Followed:** Yes No N/A**Qualified Welders:** Yes No N/A**Verified Joint Fit-up:** Yes No N/A**Approved Drawings:** Yes No N/A**Approved WPS:** Yes No N/A**Delayed / Cancelled:** Yes No N/A**Bridge No:** 34-0006**Component:** OBG**Summary of Items Observed:**

CALTRANS Quality Assurance (QA) Inspector, Alfredo Acuna was present for the fabrication scheduled for this project at the ZPMC facility in Shanghai, China for the San Francisco Oakland Bay Self Anchored Suspension Bridge.

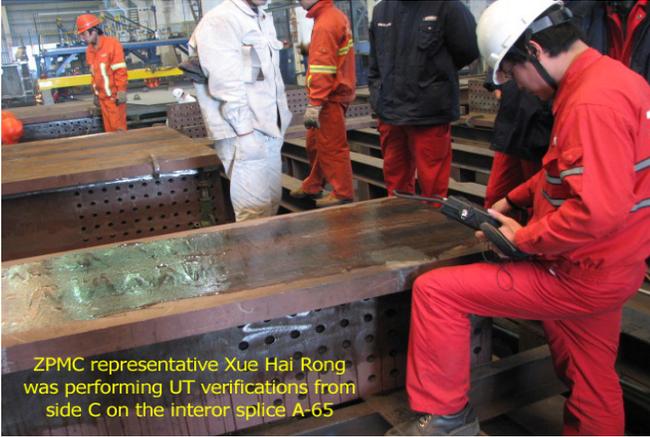
Item Description	WBS	Dwg No.	Status
1 Witnessing UT examination at the interior splice MA-65 Tower Mock-up 114 M The QA inspector witnessed ZPMC Quality Control inspector Ms. E Shuiqin and Mr. Xue Hai Rong performing preliminary ultrasonic testing (UT) at the junction of the interior splice MA-65 and longitudinal stiffeners weld joints # 1 and 2 scanning from sides A, B and C. The QA inspector observed that Ms. E Shuiqin and Mr. Xue Hai Rong marked on the steel that the welds were acceptable.

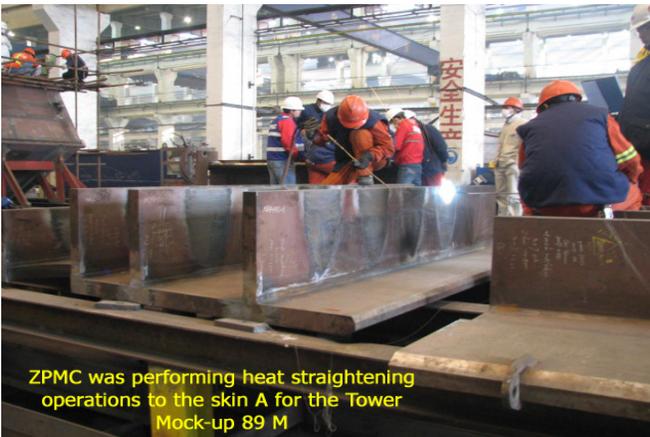
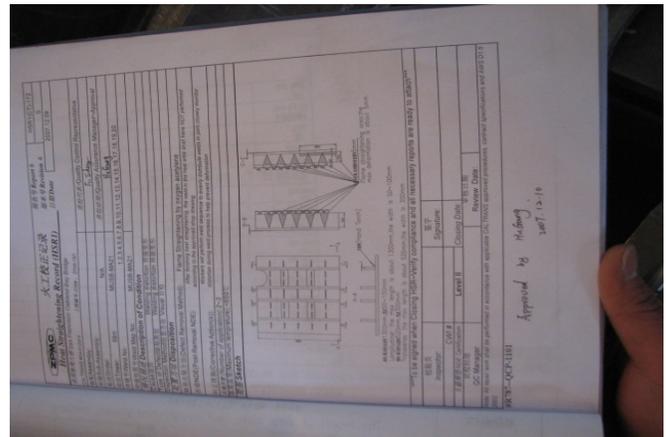
## 2 Heat straightening operations at the Skin A Tower Mock-up 89M

The QA inspector observed ZPMC personnel performing heat straightening operations at the Skin panel A. The heat straightening operations appeared to be in compliance with the HSR1 (CT)-172. The photographs below shows ZPMC performing heat straightening operations and the HSR1 (CT)-172 report.

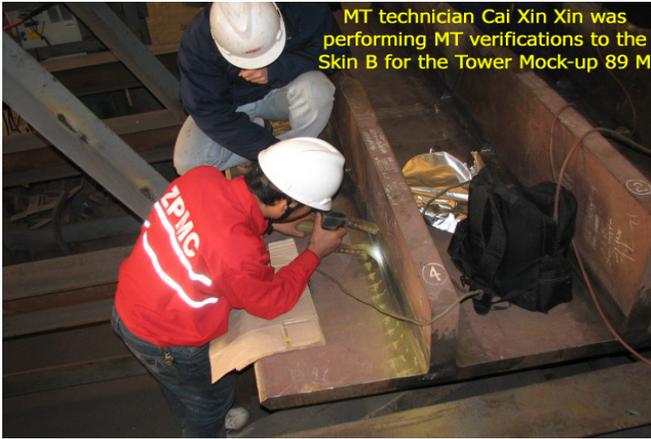
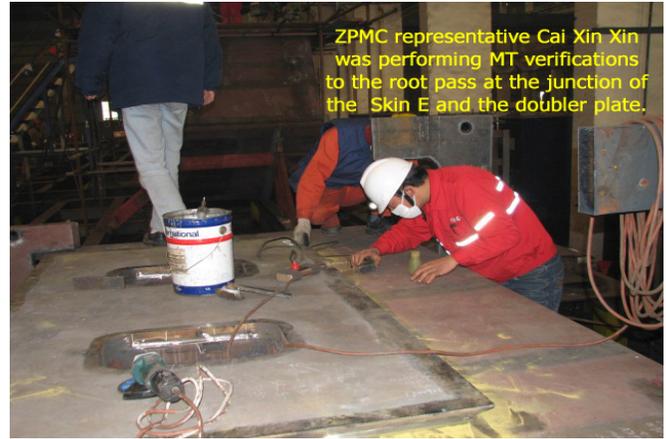
## 3 Tower Mock-up 89 M MT verifications

The QA inspector observed ZPMC performing magnetic particle testing (MT) verifications on the root passes at the junction of the Skin E and doubler plate weld joints 1 thru 4, and at the partial penetration welds cover passes at the junction of the longitudinal stiffeners and skin plate weld joints # 1 thru 4 on Tower Mock-up 89 meters elevation. The QA inspector observed that ZPMC's verifications appeared to be in compliance with the contract documents. See photographs below.

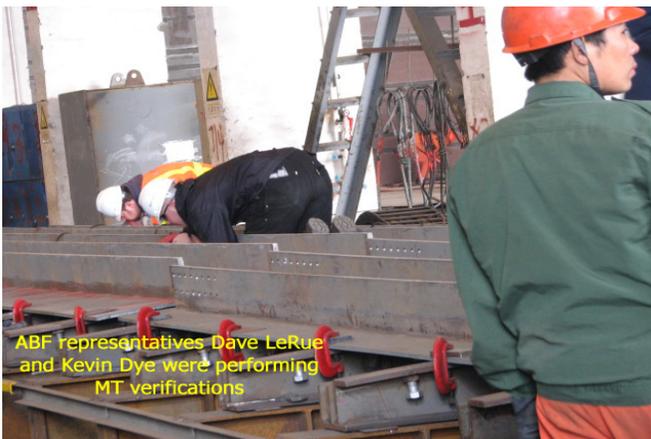
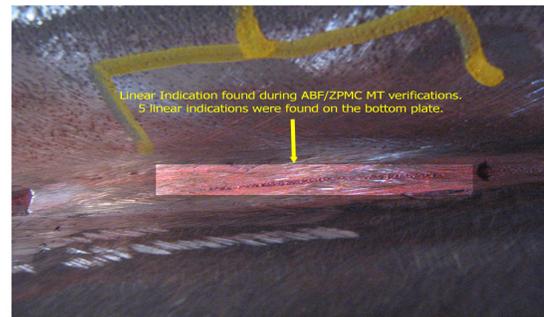
## 4 OBG ABF MT verifications

The QA inspector observed ABF representatives Kevin Dye and Dave LaRue performing magnetic particle testing (MT) verifications for information. The QA inspector had a conversation with Mr. David LaRue, Mr. Kevin Dye and ZPMC representative Mr. Xu Jun. ZPMC and ABF representatives informed that ABF found 5 cracks on tack welds. The photograph below shows Mr. David LaRue and Mr. Kevin Dye performing MT verifications and a tack weld with a linear indication on the middle. The QA inspector questioned Mr. Xu Jun what is ZPMC doing to prevent the tack welds. ZPMC representative did not answer the question.

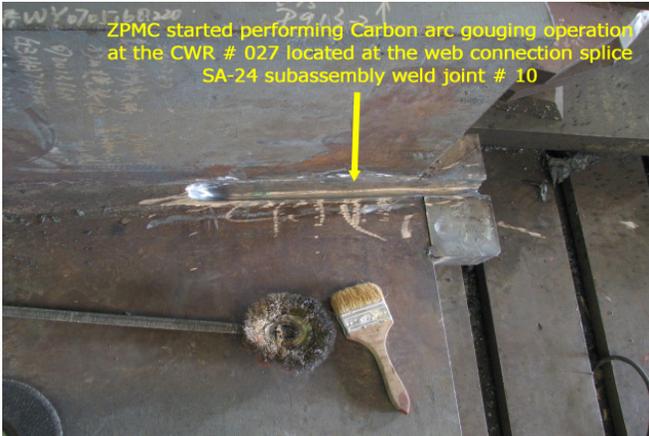
## 5 SA-24 Subassembly CWR # 027 Tower Mock-up 89 M

The QA inspector observed ZPMC air carbon arc gouged the weld repair for the CWR # 027 at the joint # 10, located at SA-24 subassembly for the Tower Mock-up 89 M. ZPMC removed approximately 30 mm of weld metal at this location. The photograph below show the area excavated.

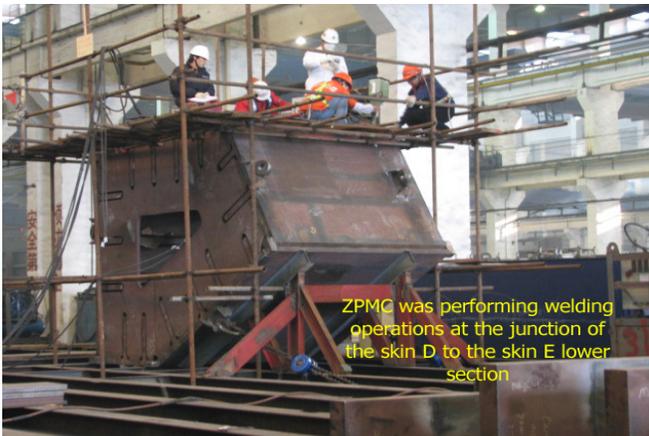
## 6 Tower Splice 114 M Lower Section

The QA inspector observed that ZPMC was performing welding operation at the junction of the skin E and D for the lower section from the Tower Mock-up 114. The QA inspector performed random verifications of the welding sequences. The QA inspector found that the welding sequences appeared to be in accordance with ZPMC's fabrication procedure.
