**DEPARTMENT OF TRANSPORTATION**

Contract #: 04-0120F4Cty: SF/ALA Rte: 80 PM: 13.2/13.9File #: 69.28**WELDING INSPECTION REPORT****Resident Engineer:** Pursell, Gary**Address:** 333 Burma Road**City:** Oakland, CA 94607**Report No:** WIR-001265**Date Inspected:** 11-Dec-2007**Project Name:** SAS Superstructure**OSM Arrival Time:** 630**Prime Contractor:** American Bridge/Fluor Enterprises, a JV**OSM Departure Time:** 1530**Contractor:** Zhenhua Port Machinery Company, Ltd (ZPMC), Changxing Island **Location:** Shanghai, China**CWI Name:** ZPMC- Huang Li**CWI Present:** Yes No**Inspected CWI report:** Yes No N/A**Rod Oven in Use:** Yes No N/A**Electrode to specification:** Yes No N/A**Weld Procedures Followed:** Yes No N/A**Qualified Welders:** Yes No N/A**Verified Joint Fit-up:** Yes No N/A**Approved Drawings:** Yes No N/A**Approved WPS:** Yes No N/A**Delayed / Cancelled:** Yes No N/A**Bridge No:** 34-0006**Component:** Bay 2 operations**Summary of Items Observed:**

# WELDING INSPECTION REPORT

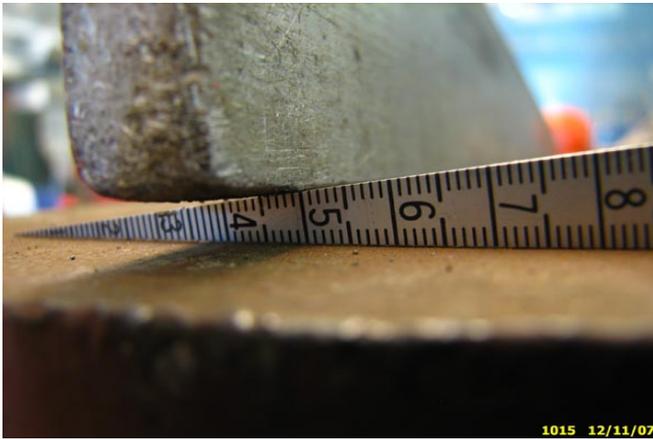
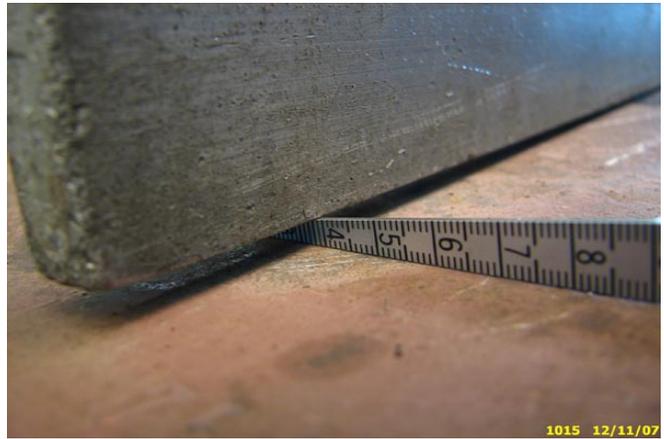
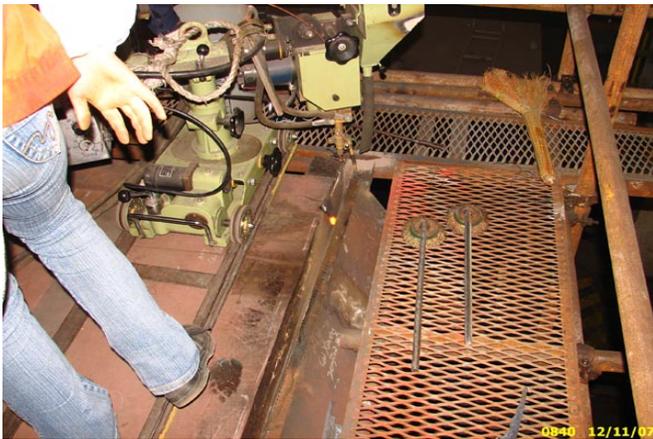
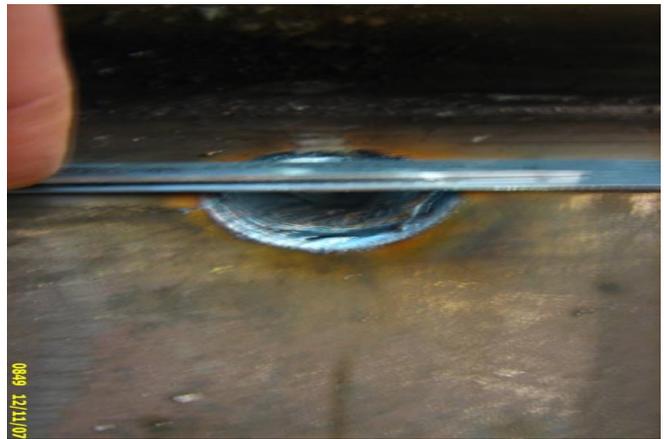
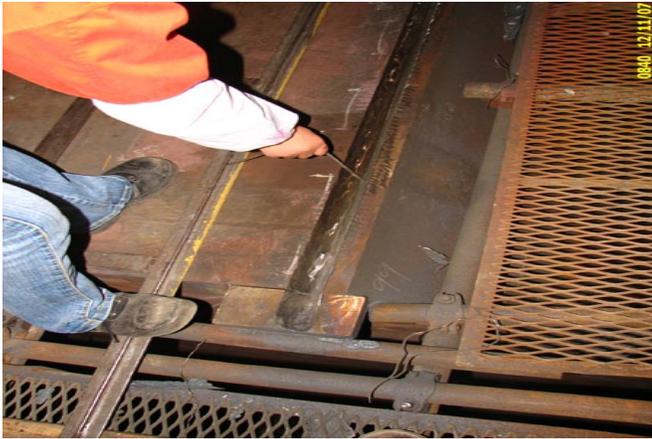
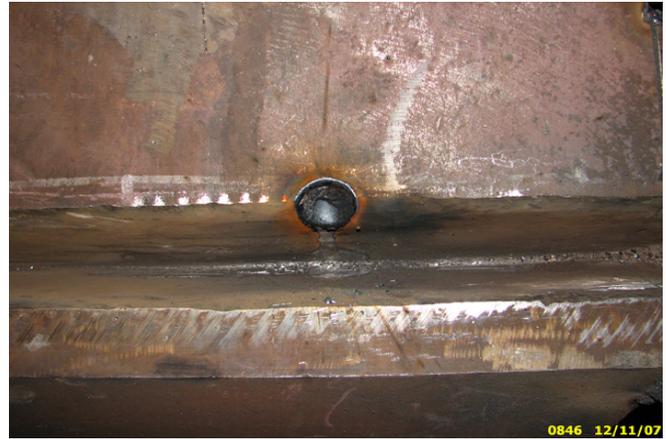
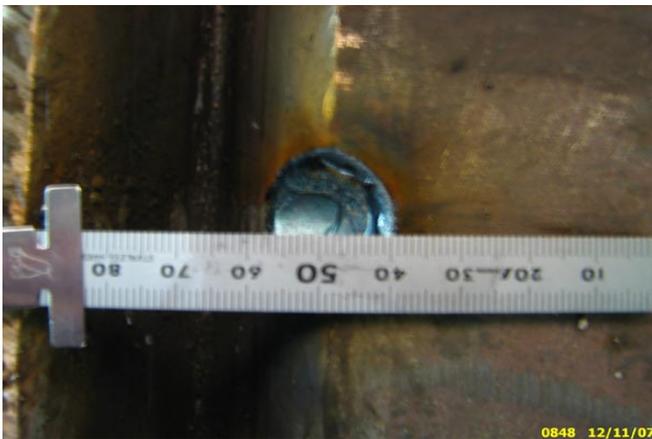
114m mock-up-lower section was being set up for Submerged Arc Weld (SAW) process on MUC-MA106 C/C-1A under Welding Procedure Specification (WPS) number WPS-B-T-2221-C-U2b-S by ZPMC welder Xu Yan (052917). The track was being moved into position, being set with a U-shaped, hand made, wire jig. The Caltrans representative observed the welder, while moving the welding unit, touched the electrode tip to the component thus causing an uncontrolled arc in that area. The discontinuity was 8 X 24mm. This is the second time, in two days, that the same incident has occurred but on a different weld. The ZPMC Certified Welding Inspector (CWI), Huang Li, was present along with Bureau Veritas (BV) representative, Huo Jing Yao. American Bridge Fabricator (ABF) representative, Mr. Kevin Carpenter, was notified via the BV representative.

Mr. Carpenter stated that ZPMC workers were to carbon arc gouge and grind the area to bright metal with a mechanical grinder. Dry Magnetic Particle (DMT) inspection was to follow since the area of excavation went out of the bevel area and into the parent metal.

89m plate MUSB-MA23, skin C, has heat straightening operation under Heat Straightening Report (HSR) number HSR1-CT-165.

Dimensional verification was performed for HSR-CT-023. The report states that a correction of "about 8mm" is being pursued for the component. X and Y axis verification showed that there was a 4 to 8 mm span of correction needed.

77m plate MUSA-MA21, Skin A, had clean up mechanical grinding ongoing for longitudinal stiffener to plate attachment welds. ZPMC informed the Caltrans representative that DMT inspection was going to be performed on this component later during off shift. No inspection was observed.
