Contract #: 04-0120F4Cty: SF/ALA Rte: 80 PM: 13.2/13.9File #: 69.28**WELDING INSPECTION REPORT****Resident Engineer:** Pursell, Gary**Address:** 333 Burma Road**City:** Oakland, CA 94607**Report No:** WIR-001308**Date Inspected:** 09-Jan-2008**Project Name:** SAS Superstructure**OSM Arrival Time:** 1400**Prime Contractor:** American Bridge/Fluor Enterprises, a JV**OSM Departure Time:** 230**Contractor:** Zhenhua Port Machinery Company, Ltd (ZPMC), Changxing Island **Location:** Shanghai, China**CWI Name:** See Below**CWI Present:** Yes No**Inspected CWI report:** Yes No N/A**Rod Oven in Use:** Yes No N/A**Electrode to specification:** Yes No N/A**Weld Procedures Followed:** Yes No N/A**Qualified Welders:** Yes No N/A**Verified Joint Fit-up:** Yes No N/A**Approved Drawings:** Yes No N/A**Approved WPS:** Yes No N/A**Delayed / Cancelled:** Yes No N/A**Bridge No:** 34-0006**Component:** OBG**Summary of Items Observed:**

Bay 2 89M Tower Mock Up:

Bay 7 OBG:

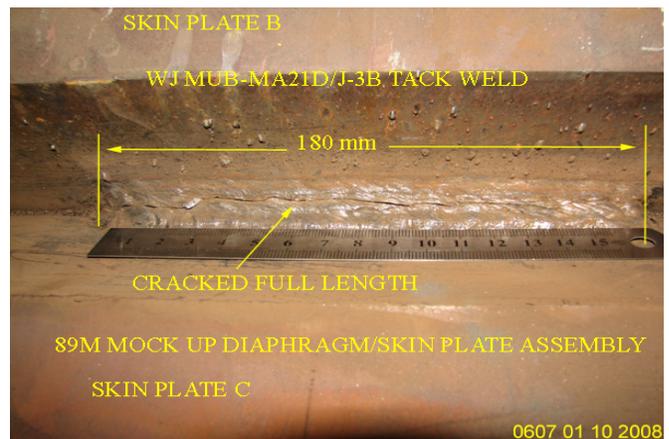
While inside the 89M Tower Mock Up Assembly, a loud metallic bang was heard and felt by the QA Inspector, Mr. Cai, his helper and QA Inspector Ken Jobes, who was immediately outside the 89M Tower Mock Up Assembly. Upon investigation, 3 tack welds in WJ MUB-MA21D/J-3B between Skin Plate B (Sub-Assembly MA24) and Skin Plate C (Sub-Assembly MA23), were randomly observed to have cracked. Two of the tack

welds had completely failed and the 3rd had a definitive crack on one end and a linear indication on the other end. The length of the WJ is 3000 millimeters (mm), and the tack weld lengths are 180 mm, 140 mm and 220 mm. The 2 totally failed tack welds are the 180 mm and the 140 mm. The QA Inspectors informed ZPMC Quality Control of the cracked tack welds. The attached photographs provide additional detail.

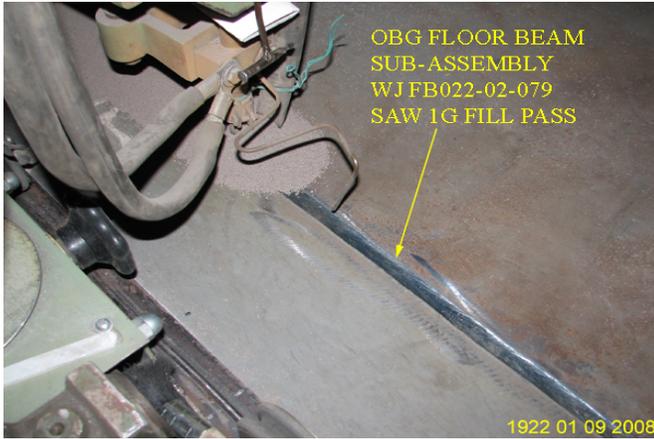
The QA Inspector randomly observed ZPMC welder Huang Xinlan ID Number 044780, utilizing the Submerged Arc Welding (SAW) Process with ZPMC approved WPS WPS-B-T-2221-B-L2c-S-1 in the 1G position to weld the fill and cover passes Floor Beam Web FB022-02 on WJ FBO022-02-079. The QA Inspector randomly observed ZPMC CWI Cui Yi Ru, monitoring weld parameters. The QA Inspector also randomly monitored weld parameters and recorded them as follows: welding amperage 543 amps, welding voltage 31.8 volts with a travel speed of 410 mm per minute. The weld parameters appeared to comply with contract requirements. The attached photograph provides additional detail.
