DEPARTMENT OF TRANSPORTATION

Contract #: 04-0120F4Cty: SF/ALA Rte: 80 PM: 13.2/13.9File #: 69.28**WELDING INSPECTION REPORT****Resident Engineer:** Pursell, Gary**Address:** 333 Burma Road**City:** Oakland, CA 94607**Report No:** WIR-001329**Date Inspected:** 21-Jan-2008**Project Name:** SAS Superstructure**OSM Arrival Time:** 900**Prime Contractor:** American Bridge/Fluor Enterprises, a JV**OSM Departure Time:** 1830**Contractor:** Zhenhua Port Machinery Company, Ltd (ZPMC), Changxing Island **Location:** Shanghai, China**CWI Name:** Ye Yong Jun**CWI Present:** Yes No**Inspected CWI report:** Yes No N/A**Rod Oven in Use:** Yes No N/A**Electrode to specification:** Yes No N/A**Weld Procedures Followed:** Yes No N/A**Qualified Welders:** Yes No N/A**Verified Joint Fit-up:** Yes No N/A**Approved Drawings:** Yes No N/A**Approved WPS:** Yes No N/A**Delayed / Cancelled:** Yes No N/A**Bridge No:** 34-0006**Component:** Tower mock ups and OBG components**Summary of Items Observed:**

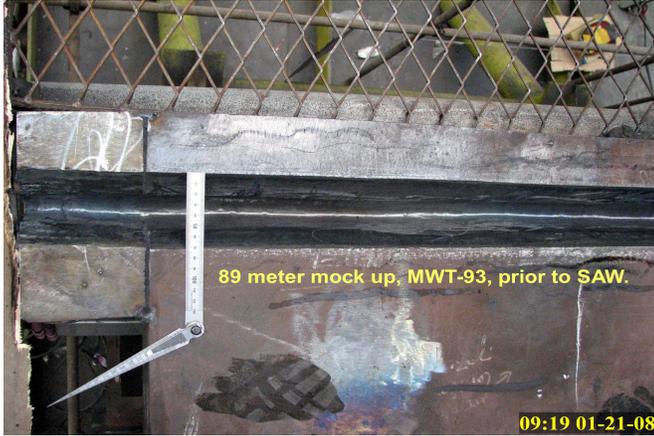
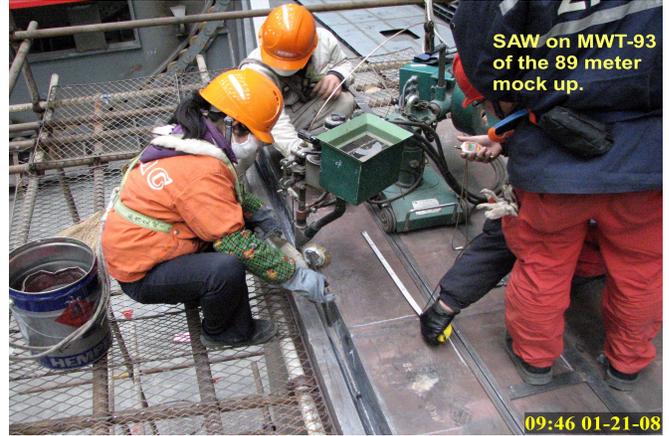
Tower Shop: The QA inspector observed work in progress on the 89 meter tower mock up assembly. The QA inspector observed that the outside corner of skin plates C to D, joint design MWT-93, was being prepared for welding. The QA inspector made observations of the prepared groove and the back gouged root area. The QA inspector noted that the back gouged area appeared to have been ground to bright, shiny metal and also appeared to be smooth and uniform across the length of the groove. The QA inspector made random measurements of the depth of the groove and the width of the groove. The depth was randomly observed to be 66mm to 68mm and the width was randomly observed to be 70mm. The QA inspector also noted that the preheat of the base metals appeared to be above 110°C. The QA inspector observed submerged arc welding (SAW) being performed on the outside corner of MWT-93. The QA inspector noted that the SAW is being conducted with 4.8mm diameter EM12K electrode. The QA inspector noted that the CWI Ye Yong Jun is the ZPMC Quality Control (QC) inspector monitoring this welding and at the time of the QA inspector's observations, the CWI was present. The QA inspector made random observations of the welding parameters at this location. The travel speed was measured at 465mm per minute and appeared to be within the ranges listed by welding procedure specification (WPS) B-T-2221-C-U2b-S-1. The QA inspector observed the welding current as it was displayed on the SAW machine gauges, the QA inspector also observed recordings from the QC inspector and compared them to the ranges listed in the approved WPS. At the time of the QA inspector's random observations, the welding appeared to be in general conformance with the contract documents.
