**DEPARTMENT OF TRANSPORTATION**

Quality Assurance and Source Inspection

Contract #: 04-0120F4Cty: SF/ALA Rte: 80 PM: 13.2/13.9File #: 69.28**WELDING INSPECTION REPORT****Resident Engineer:** Pursell, Gary**Address:** 333 Burma Road**City:** Oakland, CA 94607**Report No:** WIR-001332**Date Inspected:** 22-Jan-2008**Project Name:** SAS Superstructure**OSM Arrival Time:** 600**Prime Contractor:** American Bridge/Fluor Enterprises, a JV**OSM Departure Time:** 1700**Contractor:** Zhenhua Port Machinery Company, Ltd (ZPMC), Changxing Island **Location:** Shanghai, China**CWI Name:** Fu Yu Hong**CWI Present:** Yes No**Inspected CWI report:** Yes No N/A**Rod Oven in Use:** Yes No N/A**Electrode to specification:** Yes No N/A**Weld Procedures Followed:** Yes No N/A**Qualified Welders:** Yes No N/A**Verified Joint Fit-up:** Yes No N/A**Approved Drawings:** Yes No N/A**Approved WPS:** Yes No N/A**Delayed / Cancelled:** Yes No N/A**Bridge No:** 34-0006**Component:** Tower Mock-up**Summary of Items Observed:**

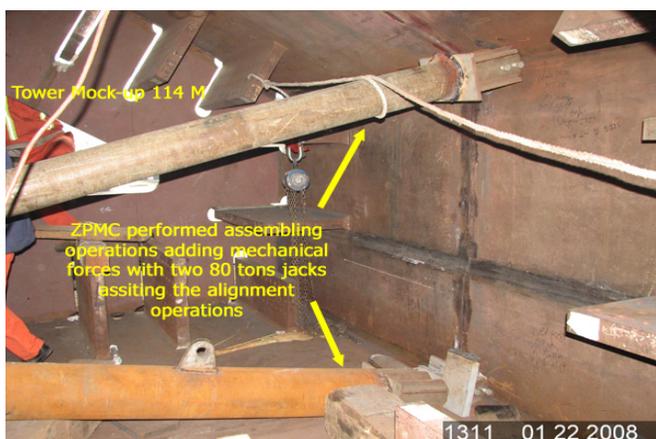
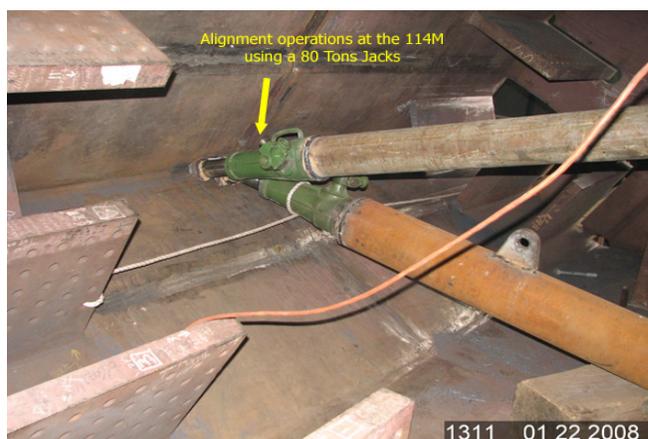
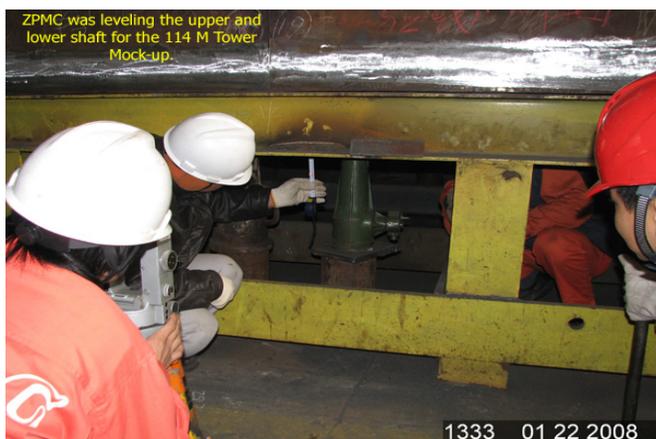
The QA inspector performed alignment verifications at the bolted connection before drilling operations at the junction of the 114 M lower and upper shafts. The QA inspector found that a maximum of approximately 5 mm offset between skins D lower and upper prior drilling operations. However, the QA inspector observed that ZPMC was locating (2) two 80 Tons jacks on the interior to assist the alignment operations which were not noted on the fabrication procedure. The QA inspector witnessed ZPMC verifying the control lines and leveling the tower splice with a laser beam. The digital photographs below show some of the ZPMC's assembling operations. The QA inspector had a conversation with Caltrans Task Leader Robert Cuellar. The QA inspector brought to Mr. Robert Cuellar attention that ZPMC was using hydraulic jacks to assist the alignment operations. An incident report was issued on this date because ZPMC was using methods that were not addressed in ZPMC's fabrication procedures.

The QA inspector had a conversation with ZPMC QC representative Mr. Xu Jun. The QA inspector informed to Mr. Xu Jun that an incident report was going to be issued because ZPMC did not follow their fabrication procedure. After, Mr. Xu Jun had a conversation with ZPMC representative Lu Jian Hua; Mr. Xu Jun relayed to the QA inspector that ZPMC did not intend to list every step in detail in their fabrication procedures. The QA inspector informed that it was Caltrans representatives concern how much stresses will be added to the bolting connections by the 80 Tons hydraulic jacks.
