DEPARTMENT OF TRANSPORTATION

Contract #: 04-0120F4Cty: SF/ALA Rte: 80 PM: 13.2/13.9File #: 69.28**WELDING INSPECTION REPORT****Resident Engineer:** Pursell, Gary**Address:** 333 Burma Road**City:** Oakland, CA 94607**Report No:** WIR-001350**Date Inspected:** 23-Jan-2008**Project Name:** SAS Superstructure**OSM Arrival Time:** 600**Prime Contractor:** American Bridge/Fluor Enterprises, a JV**OSM Departure Time:** 1530**Contractor:** Zhenhua Port Machinery Company, Ltd (ZPMC), Changxing Island **Location:** CXhangxing Island**CWI Name:** Wu Mingkai**CWI Present:** Yes No**Inspected CWI report:** Yes No N/A**Rod Oven in Use:** Yes No N/A**Electrode to specification:** Yes No N/A**Weld Procedures Followed:** Yes No N/A**Qualified Welders:** Yes No N/A**Verified Joint Fit-up:** Yes No N/A**Approved Drawings:** Yes No N/A**Approved WPS:** Yes No N/A**Delayed / Cancelled:** Yes No N/A**Bridge No:** 34-0006**Component:** OBG**Summary of Items Observed:**

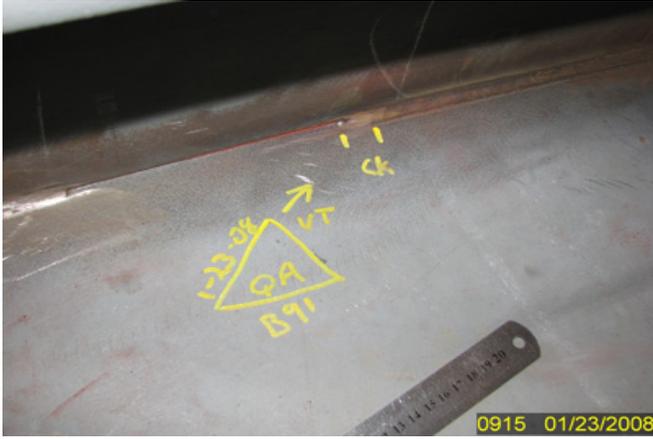
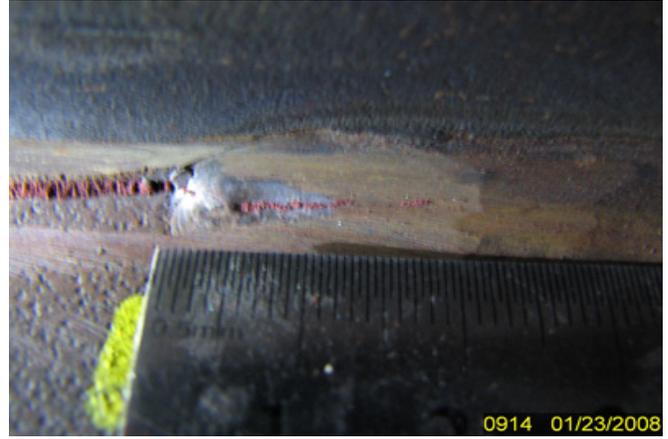
Caltrans QA Inspector Viars performed random visual observations of Side Plate SP074 WT stiffener fillet welds. ZPMC had performed VT and MT of the fillet welds. The Side plate had not been turned over to Caltrans for VT and MT inspection. QA inspector Viars found a crater crack (linear) on weld joint # SP074-01-002. The crack was intermittent and totaled 10mm within an 18mm area. The linear crack was shown to ZPMC QC Mr. Shen Xue Jun. Mr. Shen requested ZPMC QC Mr. Cai Xin Xin perform an additional 20% MT of the weld joint. The crater crack was located outside of 10% of weld length originally inspected with Magnetic Particle Testing. No additional indications were found within the 20%. Mr. Shen stated that a Critical Weld Repair would be submitted for approval for the 10 mm crack. Please see the attached photos of the linear crater crack mentioned above.
