**DEPARTMENT OF TRANSPORTATION**

Contract #: 04-0120F4Cty: SF/ALA Rte: 80 PM: 13.2/13.9File #: 69.28**WELDING INSPECTION REPORT****Resident Engineer:** Pursell, Gary**Address:** 333 Burma Road**City:** Oakland, CA 94607**Report No:** WIR-001373**Date Inspected:** 25-Jan-2008**Project Name:** SAS Superstructure**OSM Arrival Time:** 700**Prime Contractor:** American Bridge/Fluor Enterprises, a JV**OSM Departure Time:** 1530**Contractor:** Zhenhua Port Machinery Company, Ltd (ZPMC), Changxing Island **Location:** Shanghai, China

**Tower Fabrication Facility****89M Mock-up Assembly**

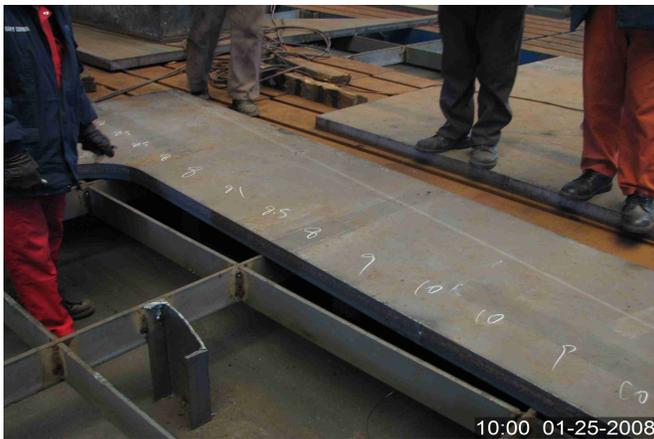
The Quality Assurance Inspector observed ZPMC welding addition wide flange supports to the underside of the assembly. In addition the bolt hole template was tacked in place on skin C and ZPMC has begun drilling the holes using hand held magnetic drills. Three 50 ton hydraulic jacks are still in place and pressurized. Later in the shift, ZPMC erected another template on the skin C side. Below is a digital photograph illustrating the erection in process.
