DEPARTMENT OF TRANSPORTATION

Contract #: 04-0120F4Cty: SF/ALA Rte: 80 PM: 13.2/13.9File #: 69.28**WELDING INSPECTION REPORT****Resident Engineer:** Pursell, Gary**Address:** 333 Burma Road**City:** Oakland, CA 94607**Report No:** WIR-001388**Date Inspected:** 11-Feb-2008**Project Name:** SAS Superstructure**OSM Arrival Time:** 1830**Prime Contractor:** American Bridge/Fluor Enterprises, a JV**OSM Departure Time:** 730**Contractor:** Zhenhua Port Machinery Company, Ltd (ZPMC), Changxing Island **Location:** Shanghai, China

Caltrans Quality Assurance (QA) Inspector, Mike Hasler was present to observe the fitup, welding and related activities associated with the fabricating of Caltrans Mock-up, 77M, 89M, 114M and U-Rib Trial Assembly, for the San Francisco Oakland Bay Self Anchored Suspension Bridge, at Zhenhua Port Machinery Company (ZPMC) facility on Changxing Island.

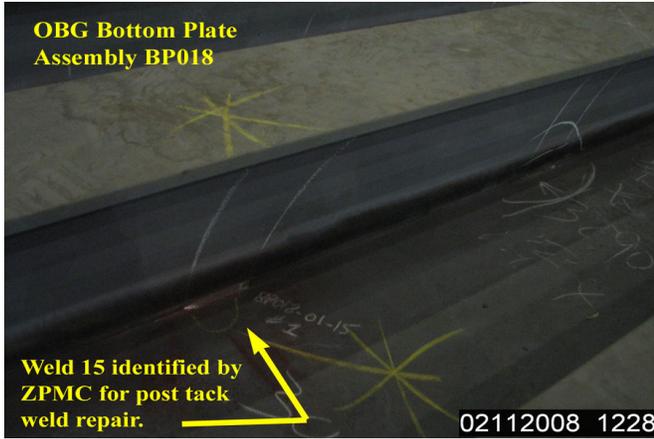
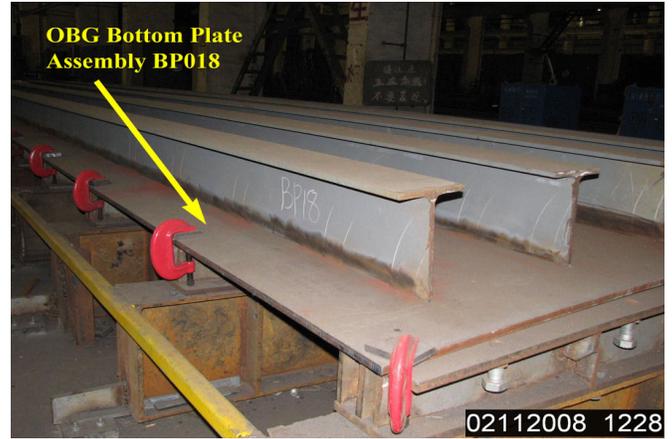
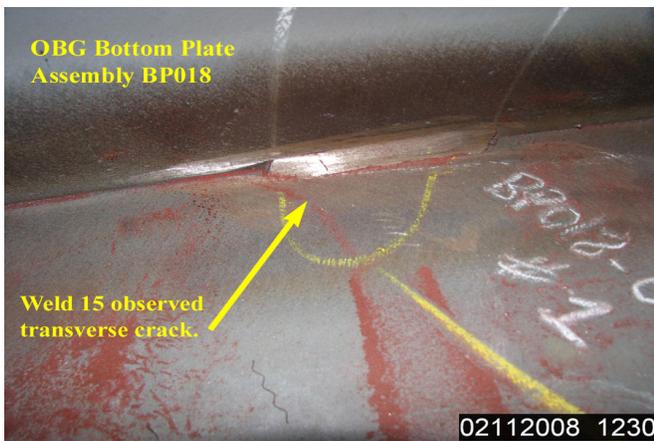
Caltrans QA Inspector observed tack welds on bottom plate (BP018) assembly in Bay 3 have been magnetic particle tested and marked up for post tack weld pick-ups by ZPMC. The assembly is mounted on the welding gantry table; fasten down in the precamber position with C-clamps. The assembly is approximately 10 meters long with six split tees tack welded to the plate. The tees will be joined to the bottom plate, full length, 10 mm (millimeter) fillet weld, both sides. Caltrans QA Inspector observed that the tack welds joining the tees to the bottom plate have been magnetic particle tested by ZPMC. It appears that approximately twenty-four tack welds have been marked up for post tack weld repairs. Caltrans QA Inspector visually inspected several of the identified locations for repair. It appeared that many of the locations had transverse crack indications. The following digital pictures illustrate the bottom plate assembly and a typical transverse weld crack indications observed.
