DEPARTMENT OF TRANSPORTATION

Contract #: 04-0120F4Cty: SF/ALA Rte: 80 PM: 13.2/13.9File #: 69.28**WELDING INSPECTION REPORT****Resident Engineer:** Pursell, Gary**Address:** 333 Burma Road**City:** Oakland, CA 94607**Report No:** WIR-001392**Date Inspected:** 23-Jan-2008**Project Name:** SAS Superstructure**OSM Arrival Time:** 700**Prime Contractor:** American Bridge/Fluor Enterprises, a JV**OSM Departure Time:** 1530**Contractor:** Zhenhua Port Machinery Company, Ltd (ZPMC), Changxing Island **Location:** Shanghai, China

Tower Fabrication Facility**89M Mock-up Assembly**

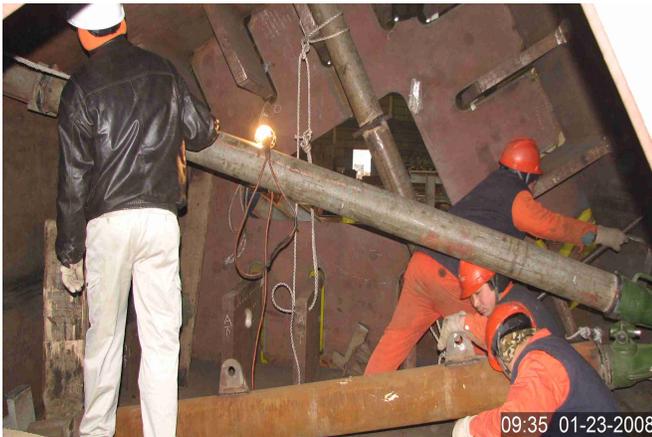
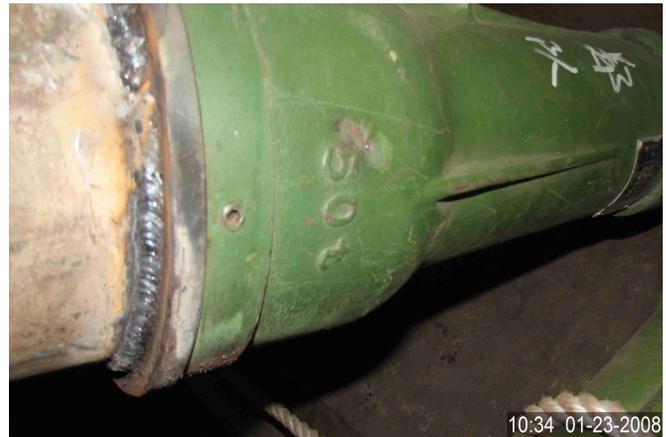
The Quality Assurance Inspector observed the fit-up of the upper to lower shafts. Three 50 ton hydraulic jacks were being utilized to aid in the fit-up. The Quality Assurance Inspector observed a ZPMC foreman measuring the offset between the two assemblies using the Quality Assurance Inspectors V vac gauge. The Foreman relayed that the offset between skins D was measured to be approximately seven millimeters. ZPMC applied more pressure to the vertical hydraulic jack and the foreman re-measured the offset. The foreman relayed that the offset was approximately five millimeters. Jacking operations ceased at this point. Below are two digital photographs illustrating the jacks in place and the 50 ton designation.
