DEPARTMENT OF TRANSPORTATION

Contract #: 04-0120F4Cty: SF/ALA Rte: 80 PM: 13.2/13.9File #: 69.28**WELDING INSPECTION REPORT****Resident Engineer:** Pursell, Gary**Address:** 333 Burma Road**City:** Oakland, CA 94607**Report No:** WIR-001401**Date Inspected:** 31-Jan-2008**Project Name:** SAS Superstructure**OSM Arrival Time:** 630**Prime Contractor:** American Bridge/Fluor Enterprises, a JV**OSM Departure Time:** 1730**Contractor:** Zhenhua Port Machinery Company, Ltd (ZPMC), Changxing Island **Location:** Shanghai, China**CWI Name:** Fu Yu Hong**CWI Present:** Yes No**Inspected CWI report:** Yes No N/A**Rod Oven in Use:** Yes No N/A**Electrode to specification:** Yes No N/A**Weld Procedures Followed:** Yes No N/A**Qualified Welders:** Yes No N/A**Verified Joint Fit-up:** Yes No N/A**Approved Drawings:** Yes No N/A**Approved WPS:** Yes No N/A**Delayed / Cancelled:** Yes No N/A**Bridge No:** 34-0006**Component:** OBG and Tower Mock-up**Summary of Items Observed:**

Tower Shop (Tower Mock-up 89 M)

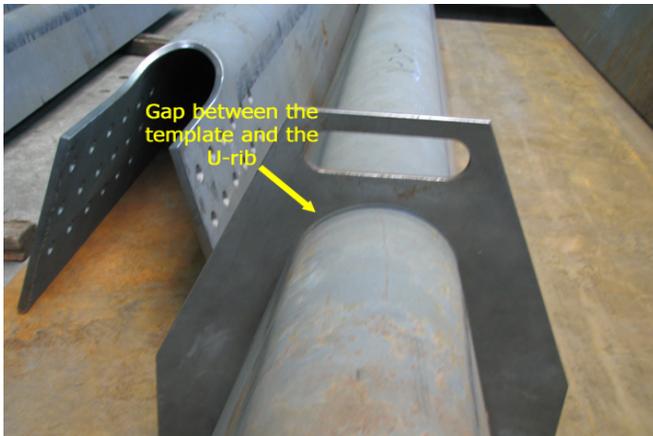
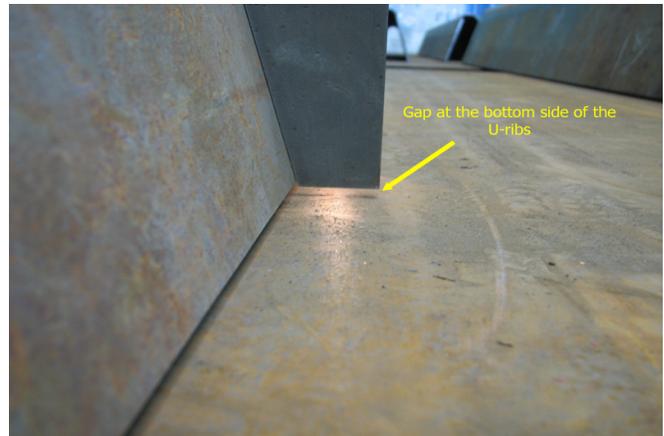
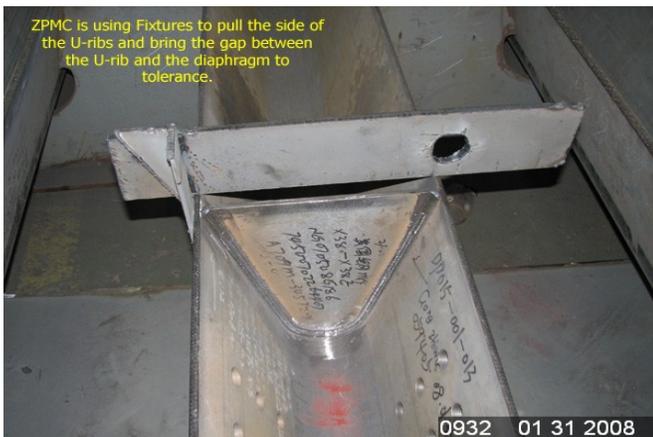
The QA inspector had a conversation with ZPMC QC representative Fu Yu Hong, the QA inspector asked how ZPMC performed the fit-up of the internal diaphragm and the U-ribs on the areas where ZPMC had gaps exceeding the maximum required by AWS D1.5 (2002) for a fillet weld joint. Mr. Fu Yu Hong informed that ZPMC was bring in the the U-ribs applying external forces with a device shown on the digital photograph below. The QA inspector performed random dimensional inspection of the U ribs located at the level inspection table with the template. The QA inspector observed that the distance between legs on close rib U-26 appeared to be greater than maximum on the template. See photographs below. The QA inspector had a conversation with ABF representative Warren Buehler and ZPMC representative Xu Jun. The QA inspector asked if ZPMC has already accepted the U-rib U-26. ABF and ZPMC representative informed the QA inspector that ZPMC had not completed the dimensional inspection on the piece and that ZPMC was going to asked ZPMC technical department about the U rib U-26 condition.
