DEPARTMENT OF TRANSPORTATION

Contract #: 04-0120F4Cty: SF/ALA Rte: 80 PM: 13.2/13.9File #: 69.28**WELDING INSPECTION REPORT****Resident Engineer:** Pursell, Gary**Address:** 333 Burma Road**City:** Oakland, CA 94607**Report No:** WIR-001432**Date Inspected:** 19-Jan-2008**Project Name:** SAS Superstructure**OSM Arrival Time:** 1700**Prime Contractor:** American Bridge/Fluor Enterprises, a JV**OSM Departure Time:** 2400**Contractor:** Zhenhua Port Machinery Company, Ltd (ZPMC), Changxing Island **Location:** Shanghai, China**CWI Name:** Fu Guogang**CWI Present:** Yes No**Inspected CWI report:** Yes No N/A**Rod Oven in Use:** Yes No N/A**Electrode to specification:** Yes No N/A**Weld Procedures Followed:** Yes No N/A**Qualified Welders:** Yes No N/A**Verified Joint Fit-up:** Yes No N/A**Approved Drawings:** Yes No N/A**Approved WPS:** Yes No N/A**Delayed / Cancelled:** Yes No N/A**Bridge No:** 34-0006**Component:** OBG**Summary of Items Observed:**

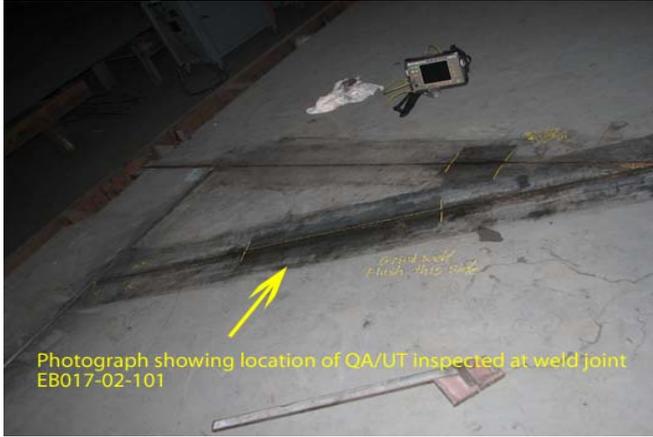
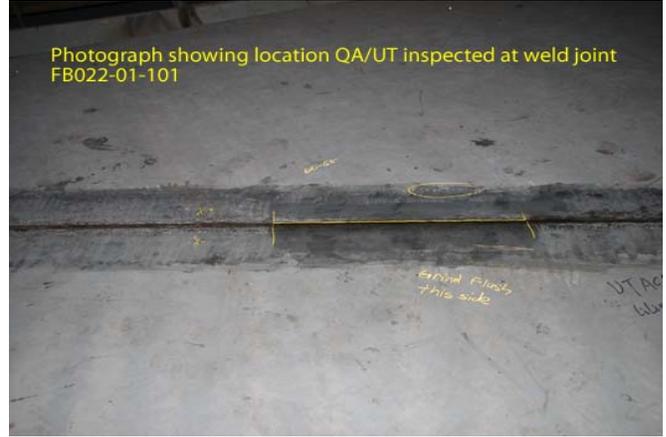
Bay 7- QA Inspector performed ultrasonic verification testing of Floor Beam Sub Assembly complete joint penetration welds on FB22-01 and FB17-02. The Ultrasonic Testing (UT) was performed to verify that 10% of the welds meet the requirements of the contract documents and AWS D1.5-2002. The weld and base metal were scanned utilizing a Krautkramer Branson USN 60. QA Inspector performed a base metal lamination check using a 25mm diameter 2.25 MHz transducer and a shear wave scan was using a 20mm x 15mm 2.25 MHz transducer on a 70 degree angle wedge from face A. QA Inspector utilized Scanning patterns A, B, C, and E. QA Inspector observed indications at weld FB022-01-079, FB022-01-081, FB022-01-101, FB022-01-108, FB017-02-079 and FB017-02-101 all of which will require further testing to determine if weld geometry is the cause of the indications. QA Inspector found all other welds inspected to be in compliance with AWS D1.5- 2002 Table 6.3 and the contract documents.
