**DEPARTMENT OF TRANSPORTATION**

Contract #: 04-0120F4Cty: SF/ALA Rte: 80 PM: 13.2/13.9File #: 69.28**WELDING INSPECTION REPORT****Resident Engineer:** Pursell, Gary**Address:** 333 Burma Road**City:** Oakland, CA 94607**Report No:** WIR-001446**Date Inspected:** 25-Jan-2008**Project Name:** SAS Superstructure**OSM Arrival Time:** 645**Prime Contractor:** American Bridge/Fluor Enterprises, a JV**OSM Departure Time:** 1730**Contractor:** Zhenhua Port Machinery Company, Ltd (ZPMC), Changxing Island **Location:** Shanghai, China

# WELDING INSPECTION REPORT

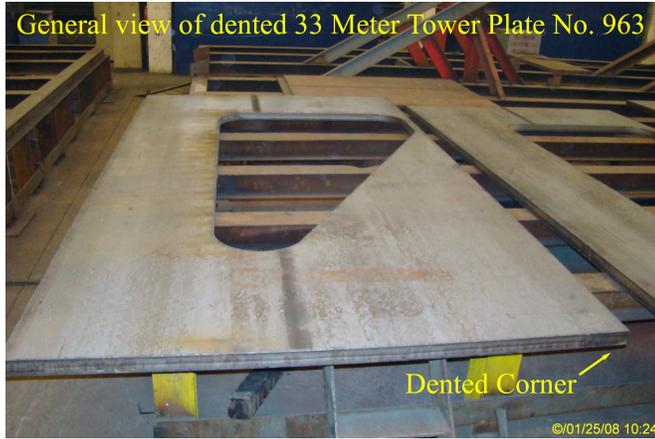
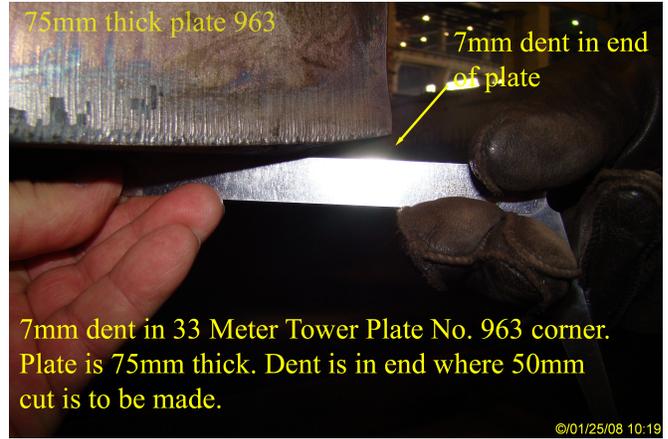
This Quality Assurance Inspector observed 75 millimeter thick, piece P963, A709M HPS 485 T2 material which is dented on the corner. The dent measured approximately 7 millimeters, however it is according to the Zhenhua Port Machinery Company's Certified Welding Inspector Zhao Chen Sun in the end of the plate which will be trimmed by 50 millimeters thus reducing the dented area by about 90% or 95
