DEPARTMENT OF TRANSPORTATION

Contract #: 04-0120F4Cty: SF/ALA Rte: 80 PM: 13.2/13.9File #: 69.28**WELDING INSPECTION REPORT****Resident Engineer:** Pursell, Gary**Address:** 333 Burma Road**City:** Oakland, CA 94607**Report No:** WIR-001478**Date Inspected:** 01-Feb-2008**Project Name:** SAS Superstructure**OSM Arrival Time:** 900**Prime Contractor:** American Bridge/Fluor Enterprises, a JV**OSM Departure Time:** 1430**Contractor:** Zhenhua Port Machinery Company, Ltd (ZPMC), Changxing Island **Location:** Shanghai, China

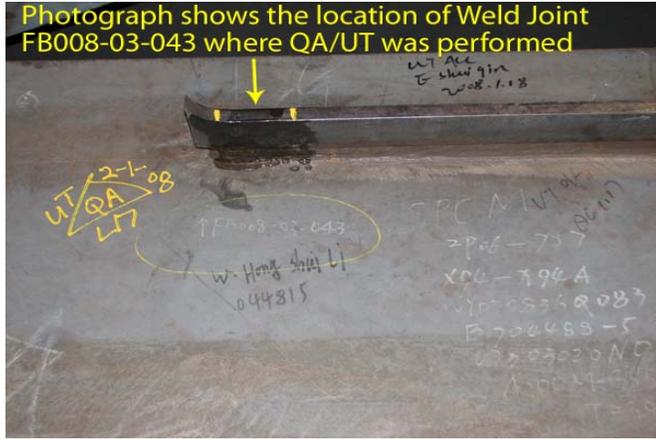
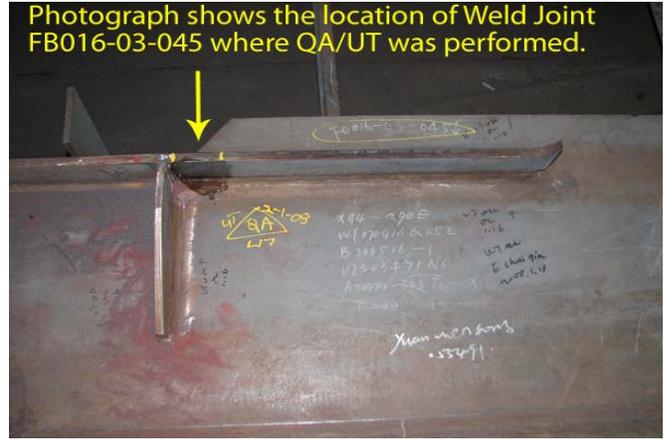
Bay 7- QA Inspector performed ultrasonic verification testing of Floor Beam Sub Assembly complete joint penetration welds on the following weld joints: FB002-02-043, FB008-03-043, FB008-04-043, FB008-06-043, FB016-01-043, FB016-03-045 and FB002-02-043. The Ultrasonic Testing (UT) was performed to verify that 10% of the welds meet the requirements of the contract documents and AWS D1.5-2002. The weld and base metal were scanned utilizing a Krautkramer Branson USN 60. QA Inspector performed a base metal lamination check using a 25mm diameter 2.25 MHz transducer and a shear wave scan was using a 20mm x 15mm 2.25 MHz transducer on a 70 degree angle wedge from face A. QA Inspector utilized Scanning patterns A, B, C, and E. For details please see the ultrasonic testing report TL-6027 dated February 01, 2008. QA Inspector found the welds inspected to be in compliance with AWS D1.5- 2002 Table 6.3 and the contract documents.
