Contract #: 04-0120F4Cty: SF/ALA Rte: 80 PM: 13.2/13.9File #: 69.28**WELDING INSPECTION REPORT**

**Report No:** WIR-001496  
**Date Inspected:** 30-Jan-2008

**Project Name:** SAS Superstructure **OSM Arrival Time:** 700  
**Prime Contractor:** American Bridge/Fluor Enterprises, a JV **OSM Departure Time:** 1430  
**Contractor:** Zhenhua Port Machinery Company, Ltd (ZPMC), Changxing Island **Location:** Shanghai, China

Tower Fabrication Facility  
89M Mock-up Assembly

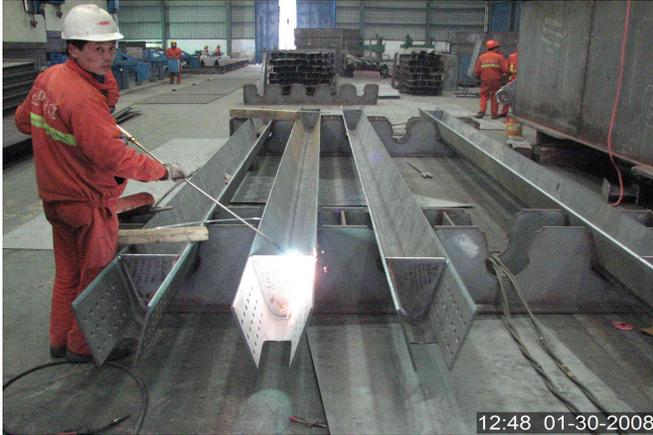
The Quality Assurance Inspector witnessed ZPMC applying heat to closed ribs in preparation for fitting up and tack welding the diaphragm plates. Below is a digital photograph illustrating the preheating in progress.
