Contract #: 04-0120F4Cty: SF/ALA Rte: 80 PM: 13.2/13.9File #: 69.28**WELDING INSPECTION REPORT****Resident Engineer:** Pursell, Gary**Address:** 333 Burma Road**City:** Oakland, CA 94607**Report No:** WIR-001499**Date Inspected:** 13-Feb-2008**Project Name:** SAS Superstructure**OSM Arrival Time:** 700**Prime Contractor:** American Bridge/Fluor Enterprises, a JV**OSM Departure Time:** 1500**Contractor:** Zhenhua Port Machinery Company, Ltd (ZPMC), Changxing Island **Location:** Shanghai, China

Bridge No: 34-0006**Component:** Tower Mock-ups and OBG**Summary of Items Observed:**

Tower Fabrication Facility**89M Mock-Up Assembly**

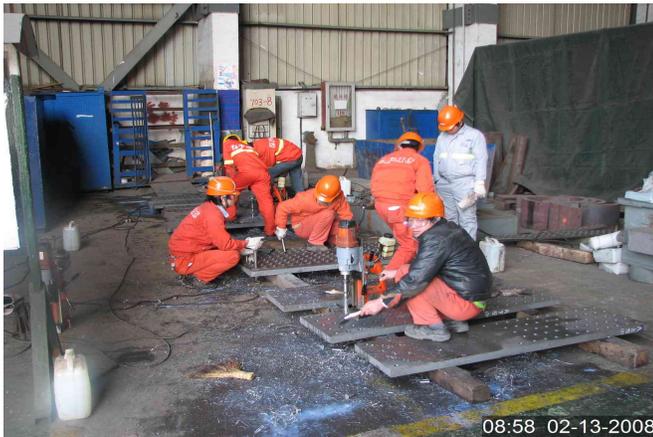
The Quality Assurance Inspector several ZPMC personnel drilling 30 millimeter bolt holes in various interior stiffener plates. Below is a digital photograph illustrating the drilling in progress.
