DEPARTMENT OF TRANSPORTATION

Contract #: 04-0120F4Cty: SF/ALA Rte: 80 PM: 13.2/13.9File #: 69.28**WELDING INSPECTION REPORT****Resident Engineer:** Pursell, Gary**Address:** 333 Burma Road**City:** Oakland, CA 94607**Report No:** WIR-001563**Date Inspected:** 24-Jan-2008**Project Name:** SAS Superstructure**OSM Arrival Time:** 700**Prime Contractor:** American Bridge/Fluor Enterprises, a JV**OSM Departure Time:** 1530**Contractor:** Zhenhua Port Machinery Company, Ltd (ZPMC), Changxing Island **Location:** Shanghai, China**CWI Name:** Xu Le Feng, Ye Yong Jun**CWI Present:** Yes No**Inspected CWI report:** Yes No N/A**Rod Oven in Use:** Yes No N/A**Electrode to specification:** Yes No N/A**Weld Procedures Followed:** Yes No N/A**Qualified Welders:** Yes No N/A**Verified Joint Fit-up:** Yes No N/A**Approved Drawings:** Yes No N/A**Approved WPS:** Yes No N/A**Delayed / Cancelled:** Yes No N/A**Bridge No:** 34-0006**Component:** Tower Mock-ups and OBG**Summary of Items Observed:**

Tower Fabrication Facility**89M Mock-up Assembly**

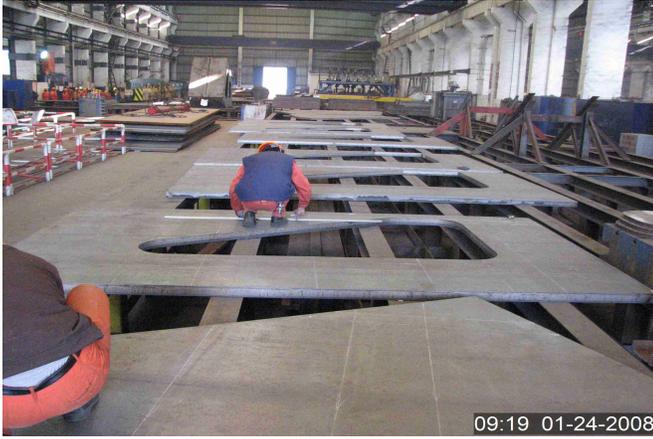
The Quality Assurance Inspector observed layout lines being drawn on type 1 and type 3 diaphragm plates in preparation for heat straightening. Below is a digital photograph illustrating the layout lines being drawn on the various diaphragm plates staged.
