DEPARTMENT OF TRANSPORTATION

Contract #: 04-0120F4Cty: SF/ALA Rte: 80 PM: 13.2/13.9File #: 69.28**WELDING INSPECTION REPORT****Resident Engineer:** Pursell, Gary**Address:** 333 Burma Road**City:** Oakland, CA 94607**Report No:** WIR-001611**Date Inspected:** 29-Jan-2008**Project Name:** SAS Superstructure**OSM Arrival Time:** 900**Prime Contractor:** American Bridge/Fluor Enterprises, a JV**OSM Departure Time:** 1430**Contractor:** Zhenhua Port Machinery Company, Ltd (ZPMC), Changxing Island **Location:** Shanghai, China**CWI Name:** Ye Yongjun**CWI Present:** Yes No**Inspected CWI report:** Yes No N/A**Rod Oven in Use:** Yes No N/A**Electrode to specification:** Yes No N/A**Weld Procedures Followed:** Yes No N/A**Qualified Welders:** Yes No N/A**Verified Joint Fit-up:** Yes No N/A**Approved Drawings:** Yes No N/A**Approved WPS:** Yes No N/A**Delayed / Cancelled:** Yes No N/A**Bridge No:** 34-0006**Component:** 89 Meter Mockup/OBG**Summary of Items Observed:**

WELDING INSPECTION REPORT

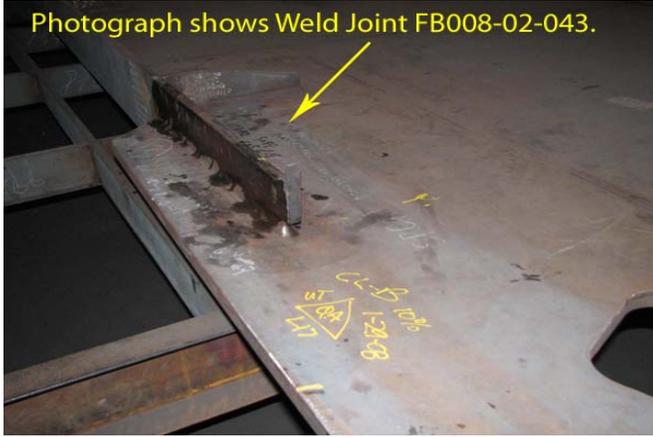
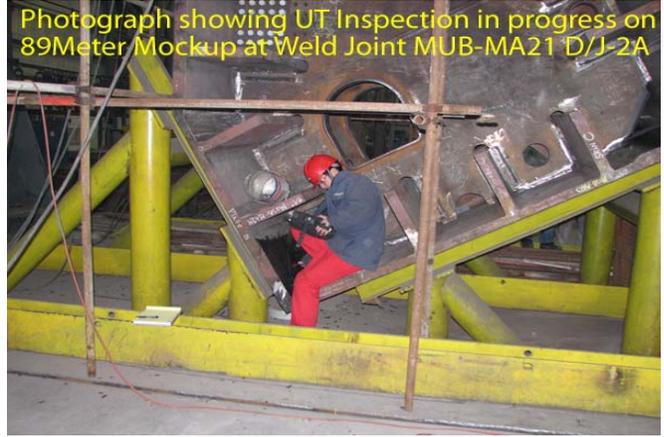
Tower Shop- QA Inspector observed QC Inspectors Li Li Ming and Xue Hairong performing ultrasonic inspection on the 89 Meter Mockup at skin "A" to "B" weld map MUB-MA21-D/J-2A and skin "B" to "C" weld map MUB-MA21-D/J-3A. QA Inspector observed that no indications were located during the QC Ultrasonic Testing (UT). QA Inspector observed that the UT inspections were performed using a 0 degree, 60 degree and 70 degree angle. QA Inspector observed QC Inspector Li Li Ming perform calibration of the UT equipment using a 70 degree angle. QA Inspector observed that no stencil or markings were placed on or near the inspection locations

to indicate the test results. QC Inspector informed QA Inspector that QC Inspection will not be completed until access to all locations is provided. At this stage of fabrication, it appears that QC Inspectors are performing their duties and responsibilities as specified in the contract documents, approved plans, fabrications documents and Special Provisions for this project.
