DEPARTMENT OF TRANSPORTATION

Contract #: 04-0120F4Cty: SF/ALA Rte: 80 PM: 13.2/13.9File #: 69.28**WELDING INSPECTION REPORT****Resident Engineer:** Pursell, Gary**Address:** 333 Burma Road**City:** Oakland, CA 94607**Report No:** WIR-001624**Date Inspected:** 02-Mar-2008**Project Name:** SAS Superstructure**OSM Arrival Time:** 1830**Prime Contractor:** American Bridge/Fluor Enterprises, a JV**OSM Departure Time:** 730**Contractor:** Zhenhua Port Machinery Company, Ltd (ZPMC), Changxing Island **Location:** Shanghai, China**CWI Name:** Sha Zhi**CWI Present:** Yes No**Inspected CWI report:** Yes No N/A**Rod Oven in Use:** Yes No N/A**Electrode to specification:** Yes No N/A**Weld Procedures Followed:** Yes No N/A**Qualified Welders:** Yes No N/A**Verified Joint Fit-up:** Yes No N/A**Approved Drawings:** Yes No N/A**Approved WPS:** Yes No N/A**Delayed / Cancelled:** Yes No N/A**Bridge No:** 34-0006**Component:** 89M Mock-Up**Summary of Items Observed:**

Caltrans Quality Assurance (QA) Inspector, Mike Hasler was present to observe the fitup, welding and related activities associated with the fabricating of Caltrans Mock-up, 77M, 89M, 114M and the orthotropic box girders, for the San

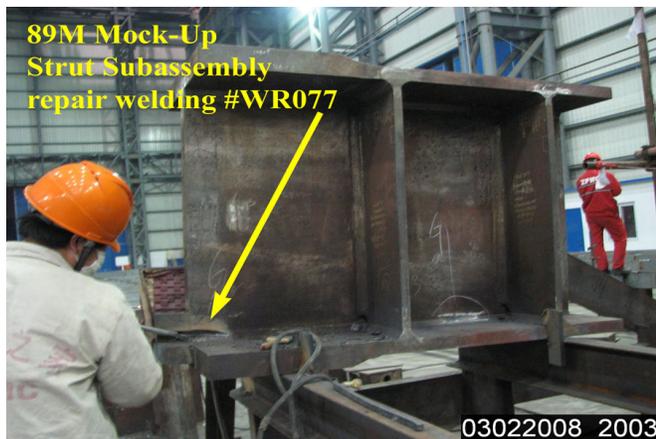
New Tower Shop 89M Mock-Up: Caltrans QA Inspector observed ZPMC performing shielded metal arc welding (SMAW) at 89M Mock-Up, strut subassembly. The welder is identified as Mr. Dai Lu, welder #048659, welding weld repair WR077, weld MUSB-MA26-30A, WPS-485-SMAW-2G. Caltrans QA observed ZPMC Quality Control (QC) certified welding inspector (CWI), Mr. Sha Zhi monitoring and recording welding parameters. Caltrans QA observed that the weld repair excavation area was ground to bright metal prior to welding. The following digital picture illustrates welding in progress.

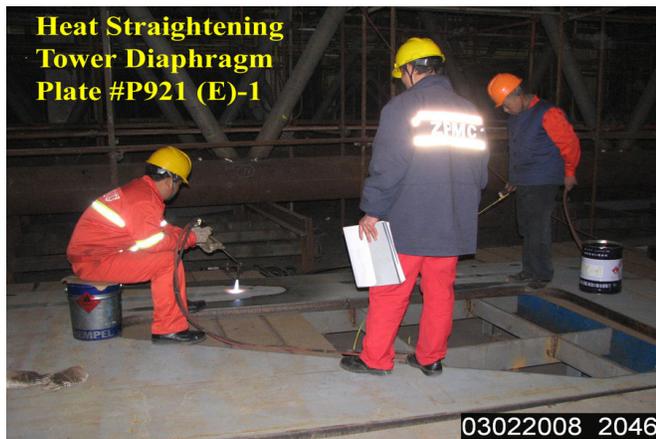
- 2 Tower Diaphragm Plate NA NA Heat Straightening
Bay 8: Caltrans QA observed ZPMC shop personnel performing heat straightening two tower diaphragm plates, P921 (E) 1 and SA 293 (S) 38M BTM. Caltrans QA met with the CWI inspector, Mr. Yu Dong Jin, monitoring the heat straightening activities at the work-station. Mr. Yu Dong Jin stated, heat straightening for diaphragm plate P921 (E) 1 is being performed in accordance with ZPMC procedure HSRI-(T)-063, Revision 0 and SA 293 (S) 38M BTM in accordance with HSRI-(T)-052, Revision 0. Caltrans QA reviewed the heat straightening procedure and work being performed was found to be in accordance with the procedures. The following digital picture illustrates heat straightening of diaphragm plate P921 (E) 1.
