DEPARTMENT OF TRANSPORTATION

Contract #: 04-0120F4Cty: SF/ALA Rte: 80 PM: 13.2/13.9File #: 69.28**WELDING INSPECTION REPORT****Resident Engineer:** Pursell, Gary**Address:** 333 Burma Road**City:** Oakland, CA 94607**Report No:** WIR-001626**Date Inspected:** 16-Feb-2008**Project Name:** SAS Superstructure**OSM Arrival Time:** 600**Prime Contractor:** American Bridge/Fluor Enterprises, a JV**OSM Departure Time:** 1730**Contractor:** Zhenhua Port Machinery Company, Ltd (ZPMC), Changxing Island **Location:** Shanghai China

Bridge No: 34-0006**Component:** Tower mock-ups, floor beams, WT stiffeners**Summary of Items Observed:**

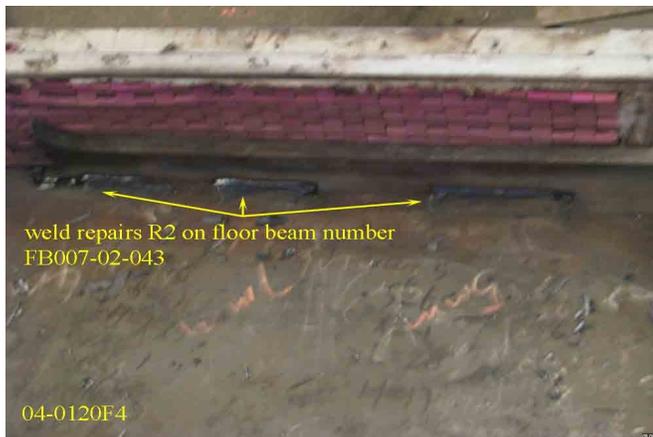
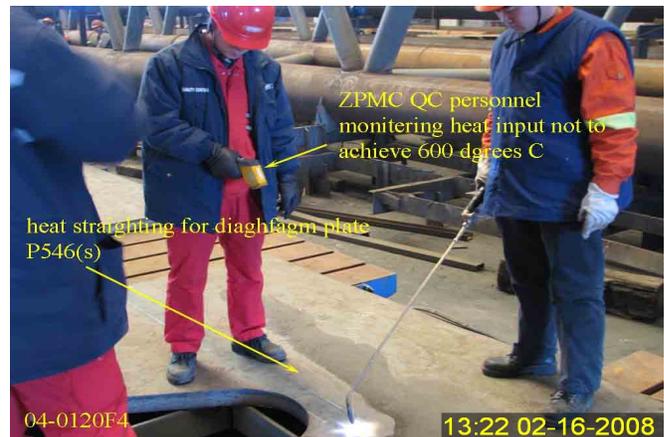
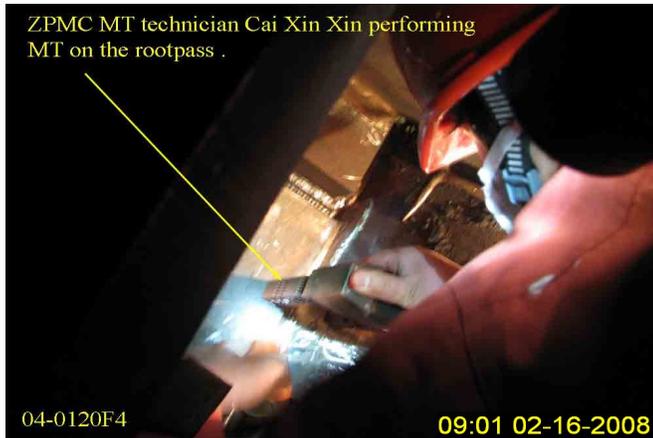
This Quality Assurance (QA) Inspector arrived at ZPMC for periodic observation of the floor beams located in bay 7 at ZPMC. This QA inspector observed ZPMC personnel performing repairs at the flanges for the complete joint penetration weldments. There were 7 locations to be repaired today as relayed to the QA inspector by ZPMC QC personnel Cui Yi Ru. The following are the repair locations for the floor beams as numbered as FB007-02-043, FB008-05-043, FB007-06-045, FB015-01-043, FB007-03-043, FB002-03-043 and FB007-06-045. This QA inspector was informed by ZPMC QC inspector that the repair locations noted above were R2 repairs (previous repairs that had been re-examined with ultrasonic testing and found to have rejectable indications for a second time) This QA Inspector observed ZPMC welding personnel Hong Shui Li performing a repair on weldment number FB007-02-043 (see digital photo 1 below) using the Flux Cored Arc Welding (FCAW) process under Welding Procedure Specification (WPS) WPS-345-FCAW-2G-FCM-repair with the following welding parameters; 280 amps , 29 volts. Preheat was verified and appeared to be within the tolerances of the above WPS. The work stated above appeared to be within the general requirements of the contract documents.
