Contract #: 04-0120F4Cty: SF/ALA Rte: 80 PM: 13.2/13.9File #: 69.28**WELDING INSPECTION REPORT****Resident Engineer:** Pursell, Gary**Address:** 333 Burma Road**City:** Oakland, CA 94607**Report No:** WIR-001654**Date Inspected:** 04-Feb-2008**Project Name:** SAS Superstructure**OSM Arrival Time:** 600**Prime Contractor:** American Bridge/Fluor Enterprises, a JV**OSM Departure Time:** 1530**Contractor:** Zhenhua Port Machinery Company, Ltd (ZPMC), Changxing Island **Location:** Changxing Island

Caltrans Quality Assurance (QA) Inspector, Larry Viars was present to perform Visual observations of the Orthotropic Box Girder (OBG), for the San Francisco Oakland Bay Self Anchored Suspension Bridge, at Zhenhua Port Machinery Company (ZPMC) facility on Changxing Island.

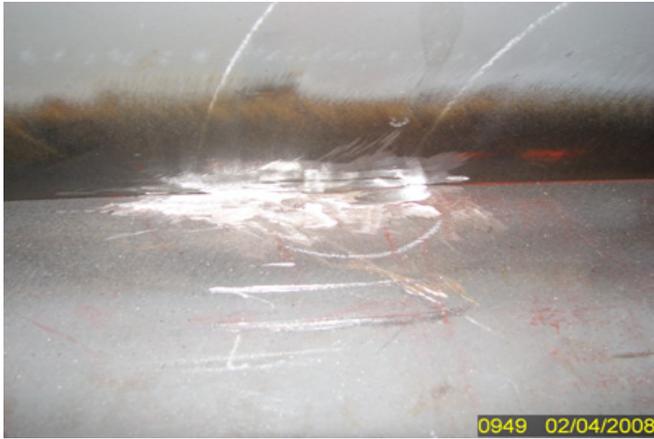
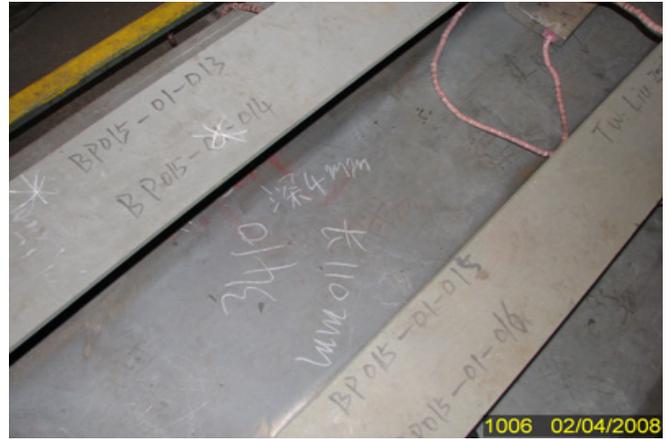
Caltrans QA Inspector Viars perform random visual observations of Bottom Plate BP015 WT stiffener tack welds. ZPMC QC Fu Yuhong relayed that linear cracking had been found on tack welds on fillet welds BP015-001-013, BP015-001-014 and BP015-001-017 and that cracking had propagated into the base metal. Areas of excavation were measured to be up to 4 mm in the base metal on the Bottom plate. Mr. Fu relayed that a Critical Weld Repair request would submitted for approval. ZPMC personnel appear to be performing improper grinding of these areas and removing base metal. Please see the attached photos below of the above mentioned excavation areas. Please see the attached photo of cracking at the tack weld to bottom plate toe of BP015.
