**DEPARTMENT OF TRANSPORTATION**

Contract #: 04-0120F4Cty: SF/ALA Rte: 80 PM: 13.2/13.9File #: 69.28**WELDING INSPECTION REPORT****Resident Engineer:** Pursell, Gary**Address:** 333 Burma Road**City:** Oakland, CA 94607**Report No:** WIR-001655**Date Inspected:** 13-Feb-2008**Project Name:** SAS Superstructure**OSM Arrival Time:** 600**Prime Contractor:** American Bridge/Fluor Enterprises, a JV**OSM Departure Time:** 1600**Contractor:** Zhenhua Port Machinery Company, Ltd (ZPMC), Changxing Island **Location:** Shanghai, China**CWI Name:** Fu Yu Hong**CWI Present:** Yes No**Inspected CWI report:** Yes No N/A**Rod Oven in Use:** Yes No N/A**Electrode to specification:** Yes No N/A**Weld Procedures Followed:** Yes No N/A**Qualified Welders:** Yes No N/A**Verified Joint Fit-up:** Yes No N/A**Approved Drawings:** Yes No N/A**Approved WPS:** Yes No N/A**Delayed / Cancelled:** Yes No N/A**Bridge No:** 34-0006**Component:** OBG**Summary of Items Observed:**

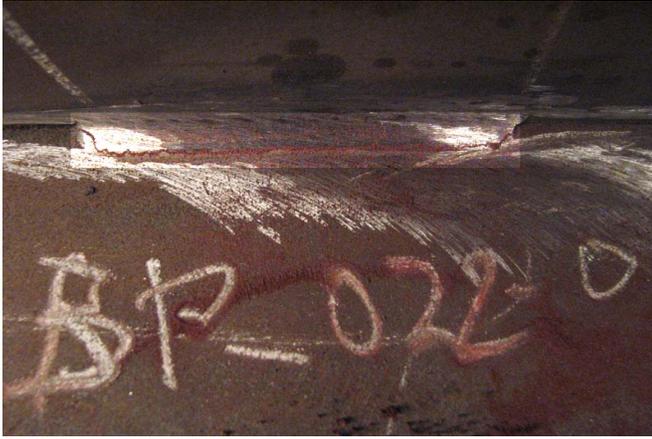
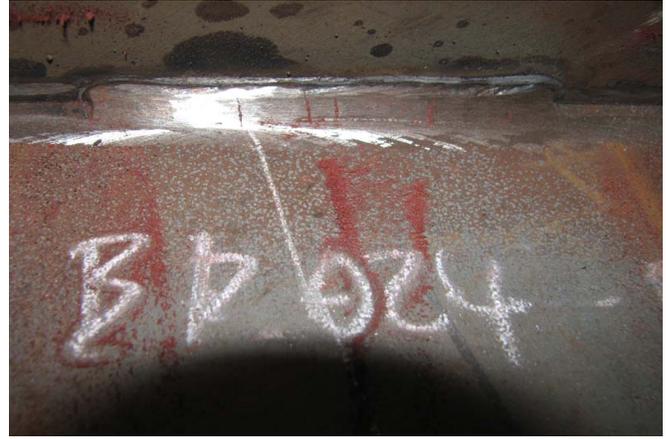
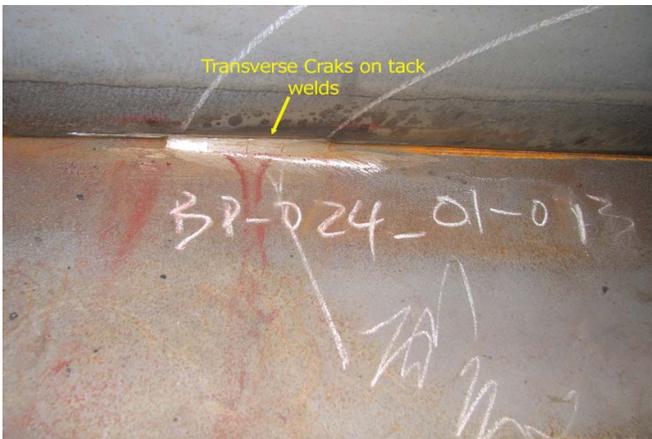
The QA inspector had a conversation with ZPMC representative Fu Yu Hong. Mr. Fu Yu Hong informed to the QA inspector that ZPMC found transverse and longitudinal cracks on the tack welds at the bottom plates at the junction of the Tee stiffeners to the bottom plates # BP-24-001 (16 transverse cracks), BP-22-01 (1 transverse crack and 2 longitudinal crack), BP-20-01 (5 transverse cracks). The QA inspector had a conversation with Caltrans Task Leader Robert Cuellar. The QA inspector brought to the attention of Mr. Robert Cuellar that ZPMC had cracking issued on the tack weld for the bottom plates panels above listed. The QA inspector performed random magnetic particle testing to enhance the visual examination on tack welds to the deck panel listed above. The QA inspector concurred with the areas marked by ZPMC QC inspectors.
