Contract #: 04-0120F4Cty: SF/ALA Rte: 80 PM: 13.2/13.9File #: 69.28**WELDING INSPECTION REPORT****Resident Engineer:** Pursell, Gary**Address:** 333 Burma Road**City:** Oakland, CA 94607**Report No:** WIR-001659**Date Inspected:** 02-Mar-2008**Project Name:** SAS Superstructure**OSM Arrival Time:** 630**Prime Contractor:** American Bridge/Fluor Enterprises, a JV**OSM Departure Time:** 1530**Contractor:** Zhenhua Port Machinery Company, Ltd (ZPMC), Changxing Island **Location:** Shanghai, China**CWI Name:** Fu Yu Hong**CWI Present:** Yes No**Inspected CWI report:** Yes No N/A**Rod Oven in Use:** Yes No N/A**Electrode to specification:** Yes No N/A**Weld Procedures Followed:** Yes No N/A**Qualified Welders:** Yes No N/A**Verified Joint Fit-up:** Yes No N/A**Approved Drawings:** Yes No N/A**Approved WPS:** Yes No N/A**Delayed / Cancelled:** Yes No N/A**Bridge No:** 34-0006**Component:** OBG Deck panels**Summary of Items Observed:**

CALTRANS Quality Assurance (QA) Inspector, Alfredo Acuna was present for the fabrication scheduled for this project at the ZPMC facility in Shanghai, China for the San Francisco Oakland Bay Self Anchored Suspension Bridge.

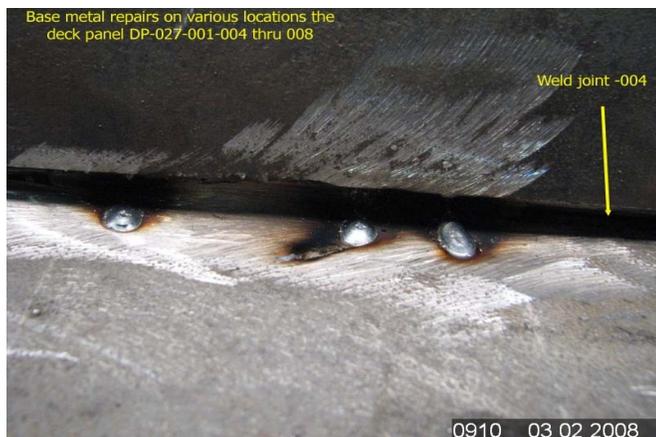
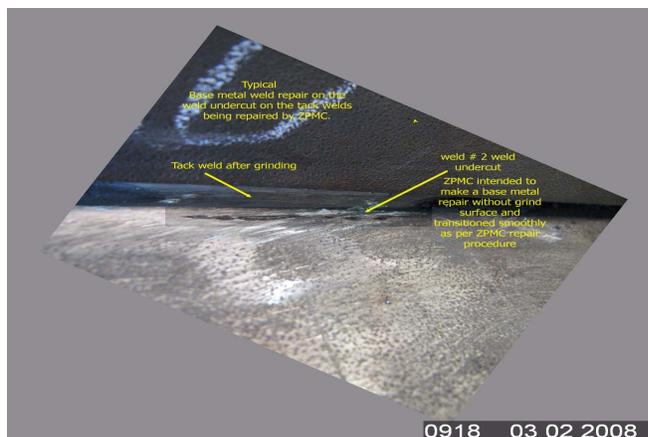
The QA inspector had a conversation with the Assistant of Structures Representative Alistair Melville. Mr. Alistair Melville relayed to the QA inspector that ZPMC was performing base metal repairs on the deck panel DP-027-001. The QA inspector observed that after grind the tack welds at the junctions of the U-ribs to the deck panel DP-027-001, ZPMC had undercut the base metal approximately 2 mm on depth. ZPMC resolved to performed base metal repair without Engineer approval by striking an arc in localized areas using the gas metal arc welding (GMAW) process to fill the location with undercut. The QA inspector had a conversation with the Task Leader Craig Hager. The QA inspector informed Mr. Craig Hager that ZPMC was performing base metal repairs without the Engineer approval and without following the approved WPS procedure by striking an arc and made weld puddles to fill the undercut areas. The QA inspector had a conversation with ZPMC representative Lay Tao. The QA inspector brought to Mr. Lay Tao attention that ZPMC was performing base metal repairs without the Engineer approval and ZPMC was not following ZPMC repair procedure and ZPMC welding procedure specification by grinding and transitioning smoothly the surface to be weld. See digital photograph below.

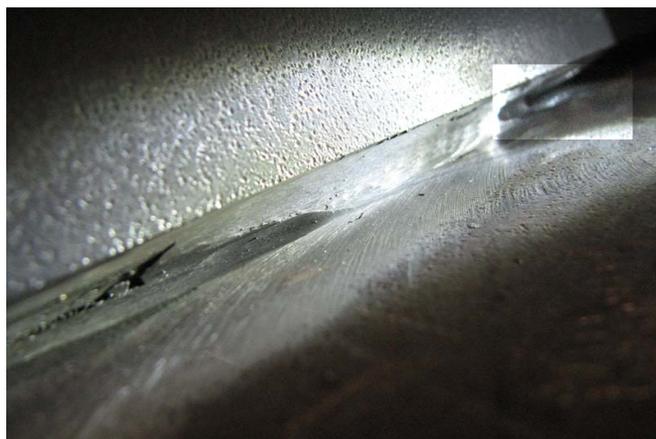
1 Tack welds Terminations on U-ribs

The QA inspector observed numerous locations where ZPMC partially ground the end of the tacks leaving a sharp notched transitions (tack weld end contours appeared not allow to provide sound fusion of the subsequent pass which could lead in lack of penetration at the end of the tacks). The QA inspector had informed on several occasions to ZPMC and ABF representatives that the ends of tack welds after grinding did not have smooth transition. The QA inspector had a conversation with the Caltrans Task Leader Craig Hager and ZPMC QC inspector Chen Xi. Mr. Craig Hager and Mr. Chen Xi agreed with QA inspector that the ends of the tack welds needed to have a smooth transition to provide a sound weld with the required depth of penetration. ZPMC repaired all the ends of the tacks weld that had the mentioned condition.
