DEPARTMENT OF TRANSPORTATION

Contract #: 04-0120F4Cty: SF/ALA Rte: 80 PM: 13.2/13.9File #: 69.28**WELDING INSPECTION REPORT****Resident Engineer:** Pursell, Gary**Address:** 333 Burma Road**City:** Oakland, CA 94607**Report No:** WIR-001668**Date Inspected:** 29-Feb-2008**Project Name:** SAS Superstructure**OSM Arrival Time:** 1800**Prime Contractor:** American Bridge/Fluor Enterprises, a JV**OSM Departure Time:** 400**Contractor:** Zhenhua Port Machinery Company, Ltd (ZPMC), Changxing Island **Location:** Shanghai, China**CWI Name:** Sha Zhi**CWI Present:** Yes No**Inspected CWI report:** Yes No N/A**Rod Oven in Use:** Yes No N/A**Electrode to specification:** Yes No N/A**Weld Procedures Followed:** Yes No N/A**Qualified Welders:** Yes No N/A**Verified Joint Fit-up:** Yes No N/A**Approved Drawings:** Yes No N/A**Approved WPS:** Yes No N/A**Delayed / Cancelled:** Yes No N/A**Bridge No:** 34-0006**Component:** OBG and 89 Meter Mockup**Summary of Items Observed:**

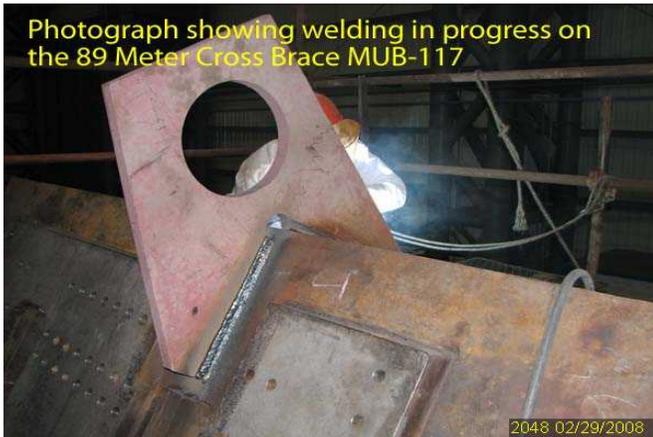
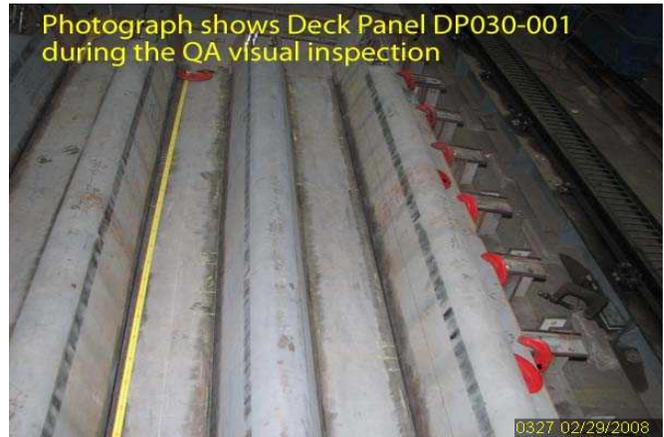
Tower Shop- QA Inspector observed ZPMC qualified welder Pen Meng ID #066673 welding fill passes on the 89 Meter Mockup Cross Brace MUB-A117 weld joint #7A and #7B. QA Inspector observed QC Inspector Sha Zhi monitoring the Flux Core Arc Welding (FCAW) process per the approved Weld Procedure Specification (WPS) WPS-B-2233-TC-U5-F. QA Inspector observed QC Inspector perform frequent monitoring of preheat and interpass temperature. QA Inspector observed that the welding parameters are in accordance with the approved WPS and verified the following: interpass 188° Celsius, 216 amps and 25 volts. QA observations appear to comply with contract requirements and the approved WPS.
