Contract #: 04-0120F4Cty: SF/ALA Rte: 80 PM: 13.2/13.9File #: 69.28**WELDING INSPECTION REPORT****Resident Engineer:** Pursell, Gary**Address:** 333 Burma Road**City:** Oakland, CA 94607**Report No:** WIR-001669**Date Inspected:** 29-Feb-2008**Project Name:** SAS Superstructure**OSM Arrival Time:** 800**Prime Contractor:** American Bridge/Fluor Enterprises, a JV**OSM Departure Time:** 1730**Contractor:** Zhenhua Port Machinery Company, Ltd (ZPMC), Changxing Island **Location:** Shanghai, China

WELDING INSPECTION REPORT

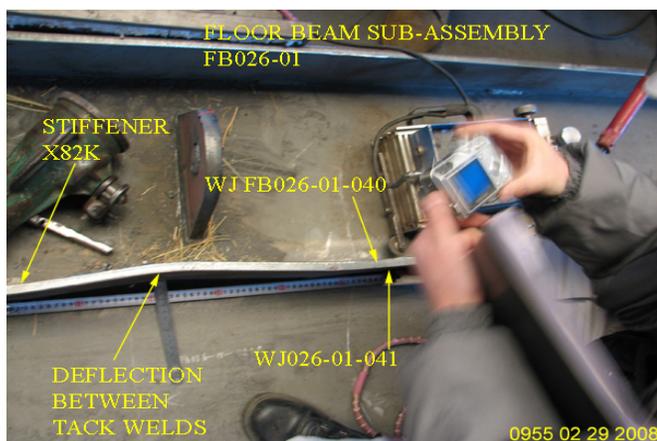
The QA Inspector randomly observed 3 stiffeners for Floor Beam Sub-Assemblies, with the tapered ends bent during handling. These tapered ends are beveled on 1 side and will be welded to Floor Beam Sub-Assemblies with Complete Joint Penetration(CJP) welds. Stiffener piece mark X82V-4 was bent approximately 30 to 35 degrees from plumb, stiffener piece mark X82K-1 was bent approximately 15 to 20 degrees from plumb and a third stiffener which could not be identified, was bent approximately 5 degrees from plumb. The QA Inspector informed American Bridge/Fluor Enterprises (ABF) Representative Dave LaRue. Mr. LaRue informed the QA Inspector that he would generate an Incident Report for these items. The attached photograph provides additional detail.

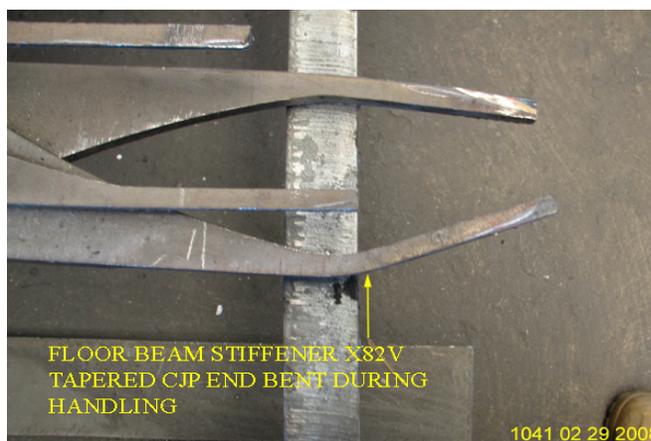
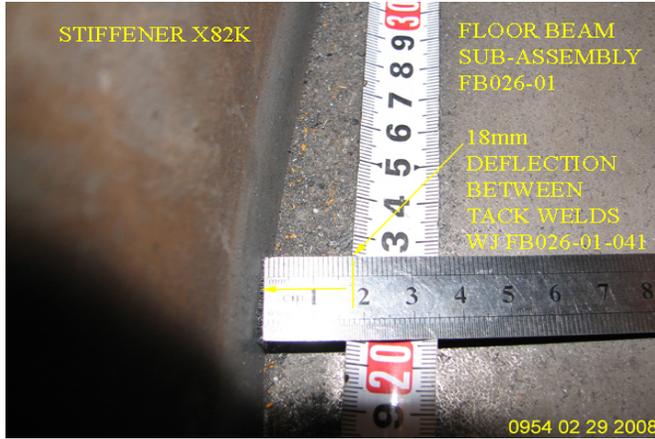
The QA Inspector observed that flange piece mark X82K on Floor Beam Sub-Assembly FB026-01 at WJ's FB026-01-040/041, was bent inward toward WJ FB026-01-040, approximately 18 mm from plumb. This area is approximately 290 mm between tack welds on either side of the stiffener and adjacent to a lifting lug. Flange X82K is fully welded on both sides for approximately three quarters of it's length. The QA Inspector also observed several areas with undercut that had been ground to remove wormhole porosity along with 1 area with a large surface slag inclusion, 1 area of undercut, 1 area of overlap and one area with surface porosity. These visual indications were in WJ FB026-01-041 on flange X82K in 1200 mm of linear weld. None of these indications had been marked up by ZPMC QC. The attached photographs provide additional detail.

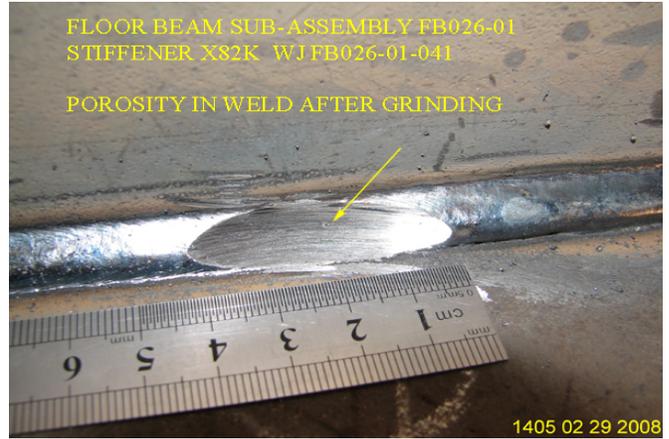
The QA Inspector randomly observed that a ZPMC Helper had ground approximately 3 mm into the base metal of stiffener piece mark X82K, trying to remove surface porosity in the area that the QA Inspector had previously observed. The QA Inspector informed Mr. Dave LaRue of ABF, and Mr. LaRue informed the QA Inspector that he would generate an Incident Report.
