DEPARTMENT OF TRANSPORTATION

Contract #: 04-0120F4Cty: SF/ALA Rte: 80 PM: 13.2/13.9File #: 69.28**WELDING INSPECTION REPORT****Resident Engineer:** Pursell, Gary**Address:** 333 Burma Road**City:** Oakland, CA 94607**Report No:** WIR-001683**Date Inspected:** 05-Mar-2008**Project Name:** SAS Superstructure**OSM Arrival Time:** 1800**Prime Contractor:** American Bridge/Fluor Enterprises, a JV**OSM Departure Time:** 730**Contractor:** Zhenhua Port Machinery Company, Ltd (ZPMC), Changxing Island **Location:** Shanghai China**CWI Name:** Wang Nan**CWI Present:** Yes No**Inspected CWI report:** Yes No N/A**Rod Oven in Use:** Yes No N/A**Electrode to specification:** Yes No N/A**Weld Procedures Followed:** Yes No N/A**Qualified Welders:** Yes No N/A**Verified Joint Fit-up:** Yes No N/A**Approved Drawings:** Yes No N/A**Approved WPS:** Yes No N/A**Delayed / Cancelled:** Yes No N/A**Bridge No:** 34-0006**Component:** Deck Plates**Summary of Items Observed:**

WELDING INSPECTION REPORT

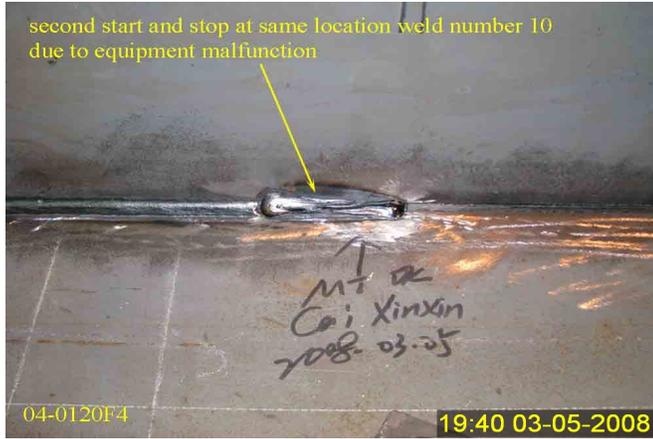
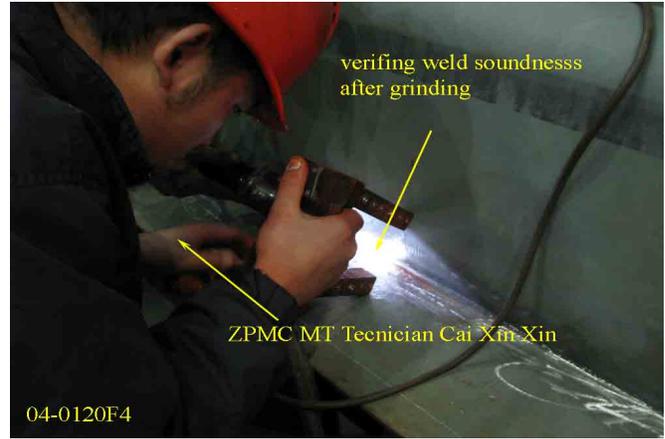
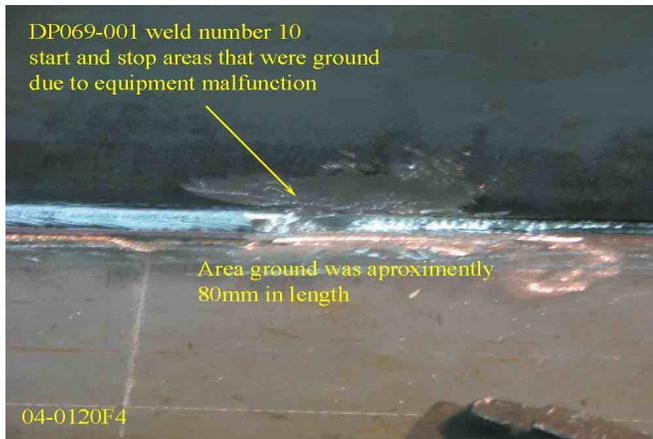
This Quality Assurance (QA) Inspector arrived at ZPMC for visual inspection of the Orthotropic Bridge Girders (OBG) Deck Plates that were welded by ZPMC. Visual Inspection was determined to have Insufficient Fusion (IF) Over Lap (OL), Under Fill (UF), and Undercut (UC) within the weldments that were inspected. The locations and lengths of the discontinuities were recorded for tracking and distributed to the appropriate personnel for review. The deck plate inspected was number DP032-001. The above work was performed within the general requirements of the contract documents.

This Quality Assurance inspector upon arrival at ZPMC for observation of Orthotropic Bridge Deck witnessed ZPMC grinding the start and stops for the Submerged Arc Welding (SAW) process on DP069-001. ZPMC personnel informed this QA Inspector that gantry #2 was malfunctioning and causing the system to shut down. ZPMC ground the start and stop areas on welds 1&2 (rib U16), 5&6 (rib U1) and 9&10 (rib U17) See digital photo below for weld 10 grinding. After completion of the grinding Magnetic Particle (MT) was used to verify weld soundness by ZPMC's MT technician Cai Xin Xin (see digital photo below) and relayed to this QA inspector that no indications were present. ZPMC then continued with the SAW welding but immediately had the same malfunction and decided to pull of the production piece and call in their Lincoln welder representative to assist in the determination of the malfunction. ZPMC felt the issues were resolved and proceeded with finishing the welds stated above (which was observed after this QA inspector returned from his lunch break) the welds were completed. ZPMC then set up to weld the remaining 2 ribs for weld numbers 2&4 and 7&8. Again the equipment malfunctioned so ZPMC production personnel stopped the welding for this shift. The QC inspector Shen Xue Jun informed this QA Inspector that ZPMC would rectify the equipment issues in the morning but would first run a PMT test then finish welding deck plate DP069-001.
