DEPARTMENT OF TRANSPORTATION

Quality Assurance and Source Inspection

Contract #: 04-0120F4Cty: SF/ALA Rte: 80 PM: 13.2/13.9File #: 69.28**WELDING INSPECTION REPORT****Resident Engineer:** Pursell, Gary**Address:** 333 Burma Road**City:** Oakland, CA 94607**Report No:** WIR-001691**Date Inspected:** 24-Feb-2008**Project Name:** SAS Superstructure**OSM Arrival Time:** 700**Prime Contractor:** American Bridge/Fluor Enterprises, a JV**OSM Departure Time:** 1500**Contractor:** Zhenhua Port Machinery Company, Ltd (ZPMC), Changxing Island **Location:** Shanghai, China**CWI Name:** Xu Le Feng, Ye Yong Jun**CWI Present:** Yes No**Inspected CWI report:** Yes No N/A**Rod Oven in Use:** Yes No N/A**Electrode to specification:** Yes No N/A**Weld Procedures Followed:** Yes No N/A**Qualified Welders:** Yes No N/A**Verified Joint Fit-up:** Yes No N/A**Approved Drawings:** Yes No N/A**Approved WPS:** Yes No N/A**Delayed / Cancelled:** Yes No N/A**Bridge No:** 34-0006**Component:** Tower Mock-ups and OBG**Summary of Items Observed:**

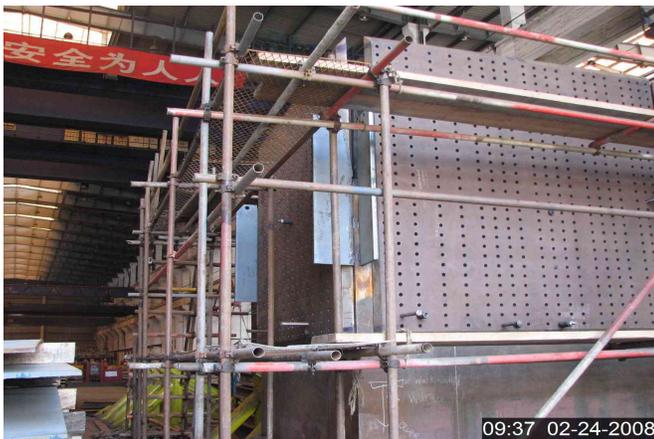
The Quality Assurance Inspector observed ZPMC welding temporary attachments to skins A, C, D, and E to aid in the fit-up of the upper shaft assembly. The Quality Assurance Inspector generated an incident report pertaining to the temporary attachments not being identified in the fabrication procedure. Below is a digital photograph illustrating the temporary attachments in place.
