DEPARTMENT OF TRANSPORTATION

Contract #: 04-0120F4Cty: SF/ALA Rte: 80 PM: 13.2/13.9File #: 69.28**WELDING INSPECTION REPORT****Resident Engineer:** Pursell, Gary**Address:** 333 Burma Road**City:** Oakland, CA 94607**Report No:** WIR-001698**Date Inspected:** 15-Mar-2008**Project Name:** SAS Superstructure**OSM Arrival Time:** 600**Prime Contractor:** American Bridge/Fluor Enterprises, a JV**OSM Departure Time:** 1730**Contractor:** Zhenhua Port Machinery Company, Ltd (ZPMC), Changxing Island **Location:** Shanghai, China**CWI Name:** Sun Wei**CWI Present:** Yes No**Inspected CWI report:** Yes No N/A**Rod Oven in Use:** Yes No N/A**Electrode to specification:** Yes No N/A**Weld Procedures Followed:** Yes No N/A**Qualified Welders:** Yes No N/A**Verified Joint Fit-up:** Yes No N/A**Approved Drawings:** Yes No N/A**Approved WPS:** Yes No N/A**Delayed / Cancelled:** Yes No N/A**Bridge No:** 34-0006**Component:** OBG**Summary of Items Observed:**

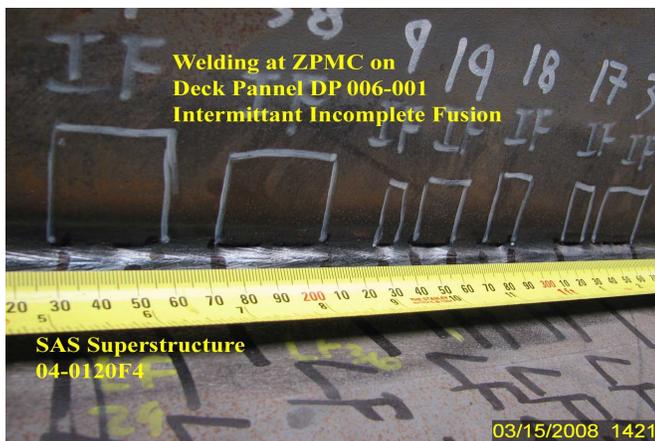
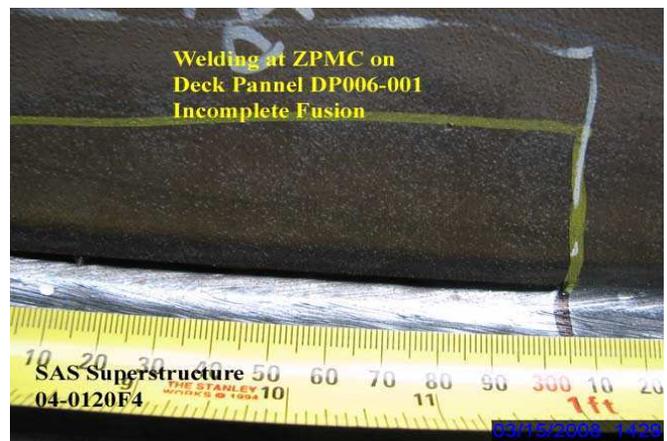
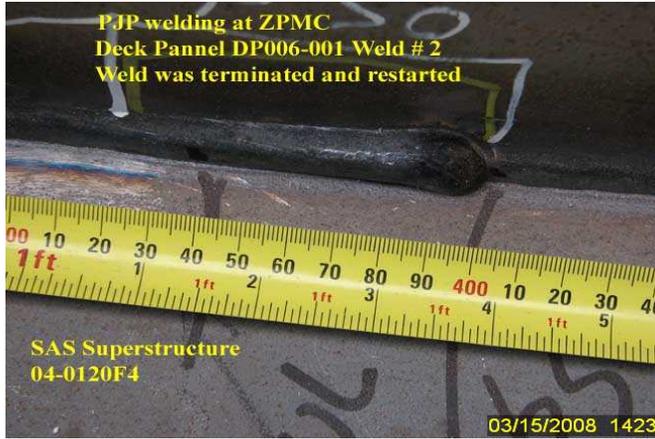
The QA inspector completed visual weld inspection on closed rib partial joint penetration welds, on production panel DP-006-001, weld # 1 and weld # 2 on rib # U93 and U142, weld # 3 and weld # 4 on rib # U156 and U143, weld # 5 and weld # 6 on rib # U92 and U11 and weld # 7 and weld # 8 on rib # U83 and U16. The results of this visual inspection are as follows. Photographs of random weld defects on this deck panel can be seen below.
