DEPARTMENT OF TRANSPORTATION

Contract #: 04-0120F4Cty: SF/ALA Rte: 80 PM: 13.2/13.9File #: 69.28**WELDING INSPECTION REPORT****Resident Engineer:** Pursell, Gary**Address:** 333 Burma Road**City:** Oakland, CA 94607**Report No:** WIR-001708**Date Inspected:** 12-Mar-2008**Project Name:** SAS Superstructure**OSM Arrival Time:** 1830**Prime Contractor:** American Bridge/Fluor Enterprises, a JV**OSM Departure Time:** 730**Contractor:** Zhenhua Port Machinery Company, Ltd (ZPMC), Changxing Island **Location:** Changxing Island**CWI Name:** Chen Xi**CWI Present:** Yes No**Inspected CWI report:** Yes No N/A**Rod Oven in Use:** Yes No N/A**Electrode to specification:** Yes No N/A**Weld Procedures Followed:** Yes No N/A**Qualified Welders:** Yes No N/A**Verified Joint Fit-up:** Yes No N/A**Approved Drawings:** Yes No N/A**Approved WPS:** Yes No N/A**Delayed / Cancelled:** Yes No N/A**Bridge No:** 34-0006**Component:** OBG Deck Panels**Summary of Items Observed:**

WELDING INSPECTION REPORT

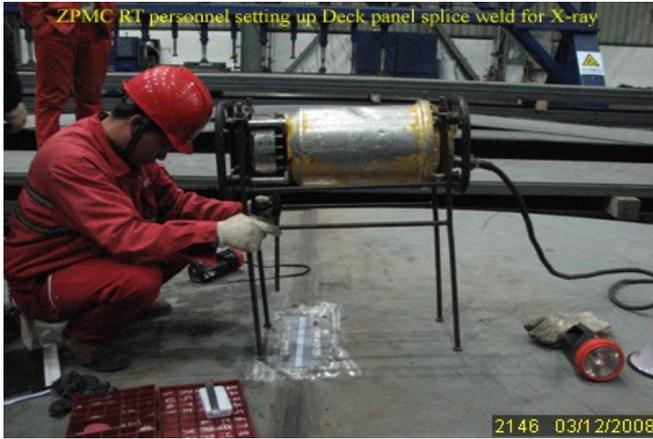
The Caltrans QA Inspector observed ZPMC QC inspector Mr. Zhao Yi perform RT of the deck panel Complete Joint Penetration (CJP) welds DP004-001-007, DP002-002-009, DP001-001-007 and DP007-001-011. ZPMC personnel ground the welds flush with the base material prior to X-ray. Caltrans QA observed a source to film distance of 600 mm and source side number 15 hole type image quality indicators were used. The radiographic testing appeared to be in conformance with AWS D1.5 (2002) section 6.10 requirements. The photo below illustrates ZPMC radiographic personnel preparing the deck panel weld for x-ray.
