DEPARTMENT OF TRANSPORTATION

Contract #: 04-0120F4Cty: SF/ALA Rte: 80 PM: 13.2/13.9File #: 69.28**WELDING INSPECTION REPORT****Resident Engineer:** Pursell, Gary**Address:** 333 Burma Road**City:** Oakland, CA 94607**Report No:** WIR-001745**Date Inspected:** 08-Mar-2008**Project Name:** SAS Superstructure**OSM Arrival Time:** 700**Prime Contractor:** American Bridge/Fluor Enterprises, a JV**OSM Departure Time:** 1700**Contractor:** Zhenhua Port Machinery Company, Ltd (ZPMC), Changxing Island **Location:** Shanghai, China**CWI Name:** Xu Le Feng, Ye Yong Jun**CWI Present:** Yes No**Inspected CWI report:** Yes No N/A**Rod Oven in Use:** Yes No N/A**Electrode to specification:** Yes No N/A**Weld Procedures Followed:** Yes No N/A**Qualified Welders:** Yes No N/A**Verified Joint Fit-up:** Yes No N/A**Approved Drawings:** Yes No N/A**Approved WPS:** Yes No N/A**Delayed / Cancelled:** Yes No N/A**Bridge No:** 34-0006**Component:** Tower Mock-ups and OBG**Summary of Items Observed:**

Diaphragm Flange Plates

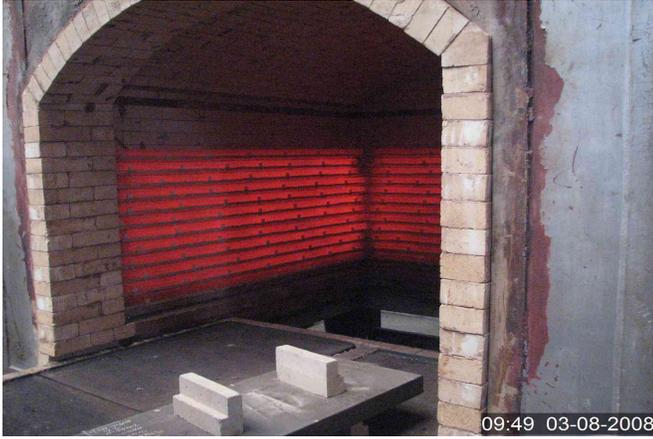
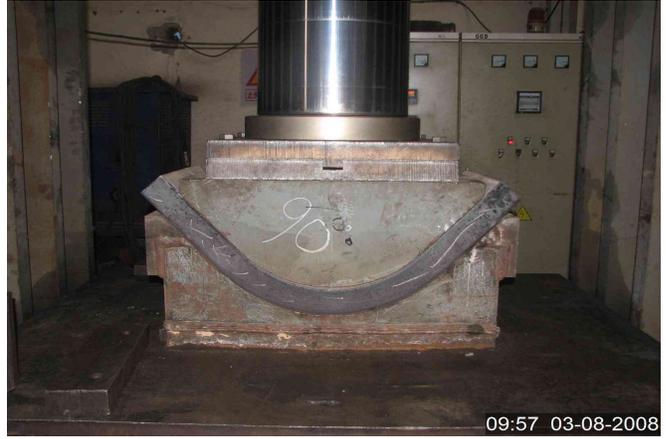
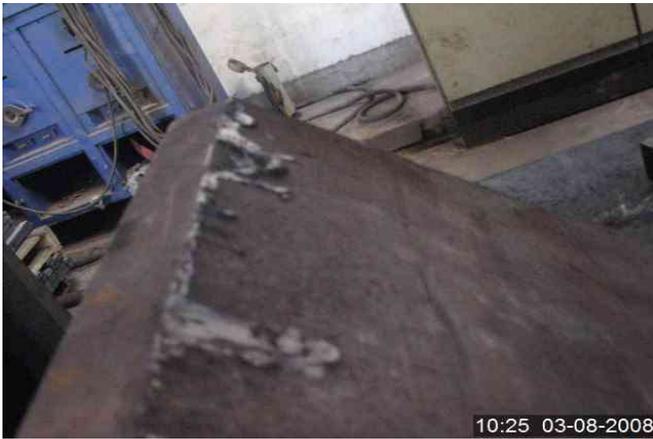
The Quality Assurance Inspector observed ZPMC's process of performing heat bending operations to Tower Diaphragm Flange Plates. ZPMC Quality Control Inspector Tang Ya Jun informed the Quality Assurance Inspector of the process. First the plates are placed in a furnace with temperature settings set at 620 degrees Celsius for approximately 1.5 hours. Then a forklift picks the plate up and places it in the press. The press bends the 60 millimeter plate and the process takes approximately 30 minutes. Once the plate was bent the plate was removed from the press with a forklift and placed on the floor. ZPMC was observed using a template to measure the radius. The Quality Assurance measured the gap between the template and the part to be approximately 5 millimeters. The Quality Assurance Inspector observed base metal damage that occurred during the bending process. The Quality Assurance Inspector discovered material in the press that caused the damage. Quality Control Inspector Wang Lu stated the material would be ground off prior to bending any more plates. Below are digital photographs illustrating the furnace, the bending process and the foreign material in the press.
