DEPARTMENT OF TRANSPORTATION

Contract #: 04-0120F4Cty: SF/ALA Rte: 80 PM: 13.2/13.9File #: 69.28**WELDING INSPECTION REPORT****Resident Engineer:** Pursell, Gary**Address:** 333 Burma Road**City:** Oakland, CA 94607**Report No:** WIR-001781**Date Inspected:** 20-Mar-2008**Project Name:** SAS Superstructure**OSM Arrival Time:** 600**Prime Contractor:** American Bridge/Fluor Enterprises, a JV**OSM Departure Time:** 1600**Contractor:** Zhenhua Port Machinery Company, Ltd (ZPMC), Changxing Island **Location:** Shanghai, China**CWI Name:** Chen Xi**CWI Present:** Yes No**Inspected CWI report:** Yes No N/A**Rod Oven in Use:** Yes No N/A**Electrode to specification:** Yes No N/A**Weld Procedures Followed:** Yes No N/A**Qualified Welders:** Yes No N/A**Verified Joint Fit-up:** Yes No N/A**Approved Drawings:** Yes No N/A**Approved WPS:** Yes No N/A**Delayed / Cancelled:** Yes No N/A**Bridge No:** 34-0006**Component:** OBG deck panels**Summary of Items Observed:**

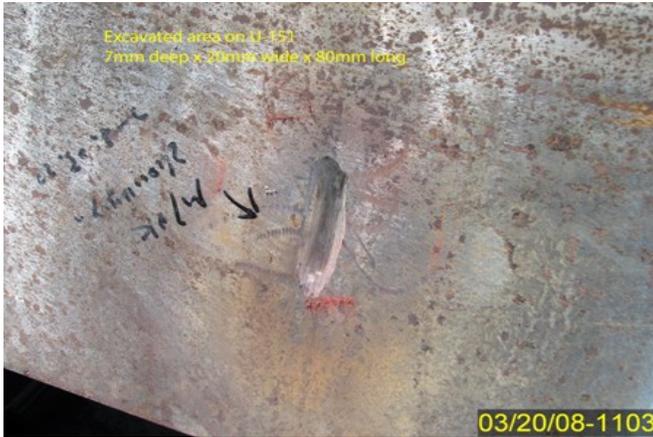
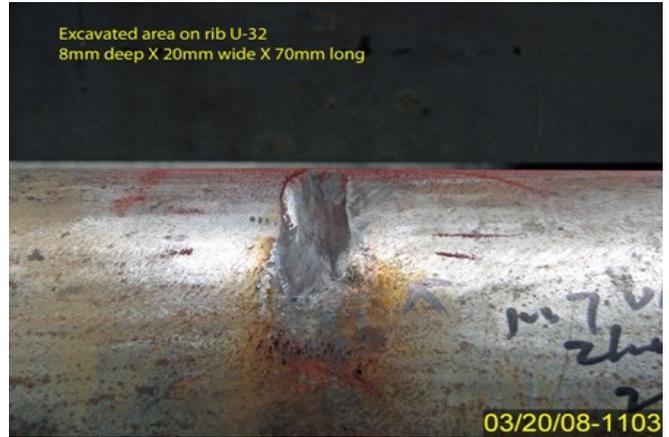
U-Ribs U-32 and U-151

QA observed ZPMC Quality Control (QC) inspectors perform Magnetic Particle Test (MT) on excavated areas of the Complete Joint Penetration (CJP) splice welds on two of the U-Ribs in which rejectable indications were discovered during Ultrasonic Testing (UT) of the CJP splice welds. Both ribs had one defect each. The excavated area on rib U-32 measured 8mm deep, 20mm wide and 70mm in length. It is located on the outside of the rib in the center of the bend. The excavated area on rib U-151 measured 7mm deep, 20mm wide and 80mm in length. It is located on the outside of the rib in the center of one of the flat sides. (see attached Photos) Following the MT, ZPMC welding personnel performed the repair per the repair procedure R787-QCP-900. QA observed ZPMC QC

personnel verify welding parameters for compliance to the applicable WPS. The Parameters were as follows:

Volts: 25.5 Amps: 210 Travel Speed: repaired areas were too short to accurately determine travel speed.
