DEPARTMENT OF TRANSPORTATION

Contract #: 04-0120F4Cty: SF/ALA Rte: 80 PM: 13.2/13.9File #: 69.28**WELDING INSPECTION REPORT****Resident Engineer:** Pursell, Gary**Address:** 333 Burma Road**City:** Oakland, CA 94607**Report No:** WIR-001786**Date Inspected:** 15-Mar-2008**Project Name:** SAS Superstructure**OSM Arrival Time:** 600**Prime Contractor:** American Bridge/Fluor Enterprises, a JV**OSM Departure Time:** 1730**Contractor:** Zhenhua Port Machinery Company, Ltd (ZPMC), Changxing Island **Location:** Shanghai China

DP003-001 and DP108-001 Production panels

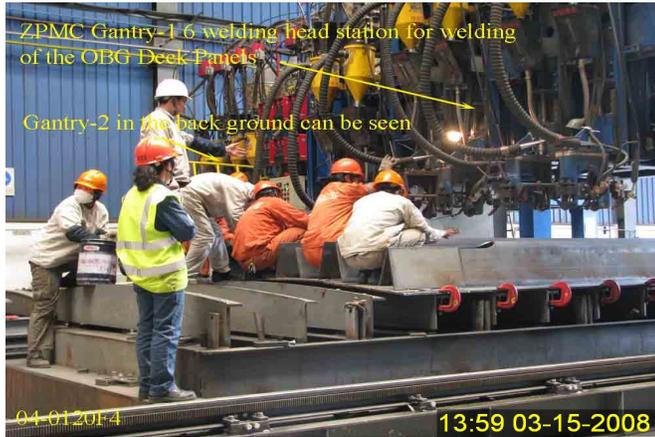
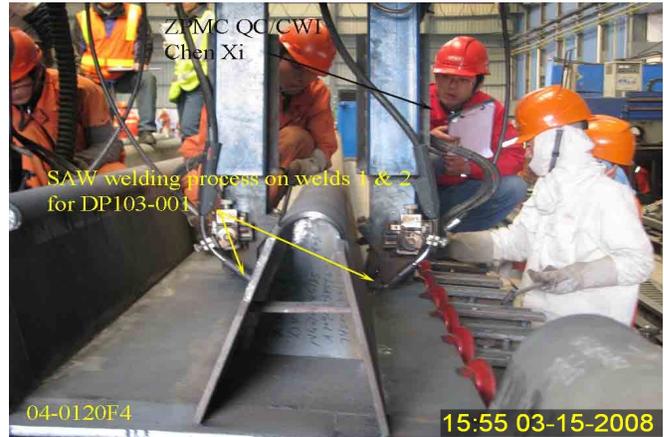
ZPMC elected to proceed with the root pass on deck panel DP108-001 which is outside the agreed upon welding procedure and in direct violation of ABF's stop work letter submitted to ZPMC. This QA inspector observed

ZPMC welding personnel using gantry # 1 for the welding process and recorded the amperages, voltage and travel speed of each of the 6 welding heads used for production and PMT welding. The Average amps and volts were for DP108-001 GMAW 364.8 amps, 30.12 volts and a travel speed of 518 mm/min and for SAW 679 amps, 24.7 volts and a travel speed of 476 mm/min. For DP003-001 the average welding parameters were; GMAW 361.2 amps, 30.69 volts and travel speed of 518 mm/min. For SAW 679.4 amps, 24.73 volts and travel speed of 476 mm/min. The Ambient temperature in the shop was recorded at 10°C with the steel temperature at 10°C also. Deck panel

bay 1. By the end of this QA inspectors shift ZPMC had not completed the SAW welding for DP108-001 which had 1 rib (2 welds) left to complete and was continuing into the next shift for completion of the welding process.
