**DEPARTMENT OF TRANSPORTATION**

Contract #: 04-0120F4Cty: SF/ALA Rte: 80 PM: 13.2/13.9File #: 69.28**WELDING INSPECTION REPORT****Resident Engineer:** Pursell, Gary**Address:** 333 Burma Road**City:** Oakland, CA 94607**Report No:** WIR-001795**Date Inspected:** 28-Feb-2008**Project Name:** SAS Superstructure**OSM Arrival Time:** 1830**Prime Contractor:** American Bridge/Fluor Enterprises, a JV**OSM Departure Time:** 430**Contractor:** Zhenhua Port Machinery Company, Ltd (ZPMC), Changxing Island **Location:** Shanghai, China

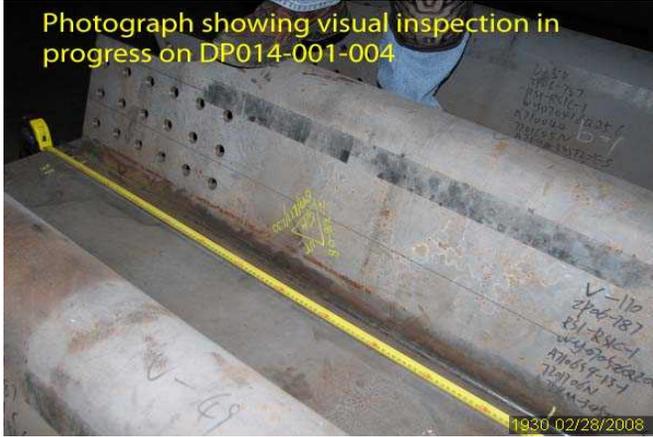
Bay 1- QA Inspector performed a Quality Assurance visual weld inspection on Orthotropic Box Girder (OBG) Deck Plate Assembly on welds DP014-001-004, DP014-001-005, DP030-001-002, DP030-001-003, DP030-001-004 and DP030-001-005. QA Inspectors observed various defects which include excess weld buildup, overlap, underfill, undercut and incomplete fusion. The length and the location of each of these areas were recorded on the Caltrans QA Visual Weld Inspection Report for the Orthotropic Box Girder (OBG) and Deck Panel for tracking and distributed to the appropriate personnel for review. At this stage of fabrication, the above work does not appear to be within the general requirements of approved plans and contract documents.
