DEPARTMENT OF TRANSPORTATION

Contract #: 04-0120F4Cty: SF/ALA Rte: 80 PM: 13.2/13.9File #: 69.28**WELDING INSPECTION REPORT****Resident Engineer:** Pursell, Gary**Address:** 333 Burma Road**City:** Oakland, CA 94607**Report No:** WIR-001798**Date Inspected:** 19-Mar-2008**Project Name:** SAS Superstructure**OSM Arrival Time:** 1700**Prime Contractor:** American Bridge/Fluor Enterprises, a JV**OSM Departure Time:** 800**Contractor:** Zhenhua Port Machinery Company, Ltd (ZPMC), Changxing Island **Location:** Shanghai, China**CWI Name:** Huang Wen-Pang**CWI Present:** Yes No**Inspected CWI report:** Yes No N/A**Rod Oven in Use:** Yes No N/A**Electrode to specification:** Yes No N/A**Weld Procedures Followed:** Yes No N/A**Qualified Welders:** Yes No N/A**Verified Joint Fit-up:** Yes No N/A**Approved Drawings:** Yes No N/A**Approved WPS:** Yes No N/A**Delayed / Cancelled:** Yes No N/A**Bridge No:** 34-0006**Component:** OBG**Summary of Items Observed:**

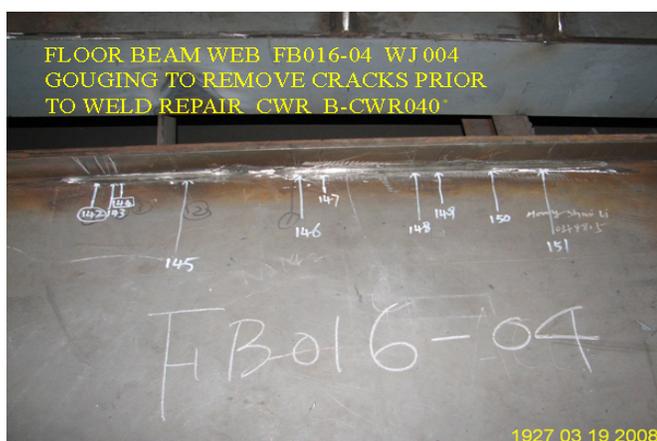
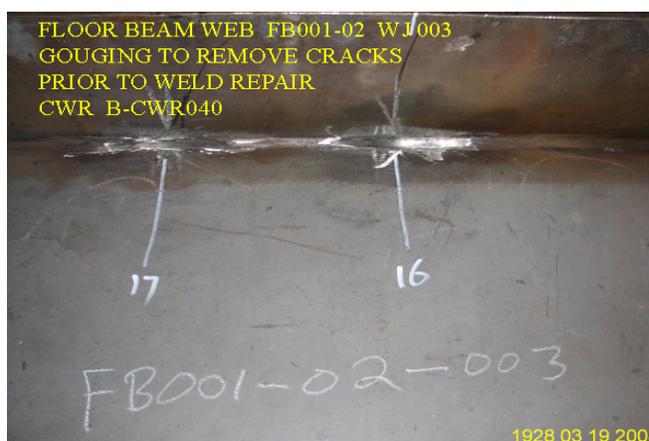
The QA Inspector randomly observed a ZPMC Carbon Air Arc Operator utilizing the Carbon Air Arc Process to remove transverse cracks in the welds attaching the flanges Floor Beam Web Sub-Assemblies FB016-04, FB001-02 and FB001-06. The work is being performed in accordance with ZPMC Critical Weld Repair (CWR) B-CWR040. The attached photograph provides additional detail.
