Contract #: 04-0120F4Cty: SF/ALA Rte: 80 PM: 13.2/13.9File #: 69.28**WELDING INSPECTION REPORT****Resident Engineer:** Pursell, Gary**Address:** 333 Burma Road**City:** Oakland, CA 94607**Report No:** WIR-001839**Date Inspected:** 23-Mar-2008**Project Name:** SAS Superstructure**OSM Arrival Time:** 730**Prime Contractor:** American Bridge/Fluor Enterprises, a JV**OSM Departure Time:** 1730**Contractor:** Zhenhua Port Machinery Company, Ltd (ZPMC), Changxing Island **Location:** Shanghai China**CWI Name:** Xu Le Feng**CWI Present:** Yes No**Inspected CWI report:** Yes No N/A**Rod Oven in Use:** Yes No N/A**Electrode to specification:** Yes No N/A**Weld Procedures Followed:** Yes No N/A**Qualified Welders:** Yes No N/A**Verified Joint Fit-up:** Yes No N/A**Approved Drawings:** Yes No N/A**Approved WPS:** Yes No N/A**Delayed / Cancelled:** Yes No N/A**Bridge No:** 34-0006**Component:** Tower/OBG**Summary of Items Observed:**

This Quality Assurance (QA) inspector arrived at ZPMC to perform observations of Self Anchored Suspension (SAS) Bridge for the SFOBB western span. Below is an account of the day's observation during the fabrication process at ZPMC. It includes the tower mock-ups,

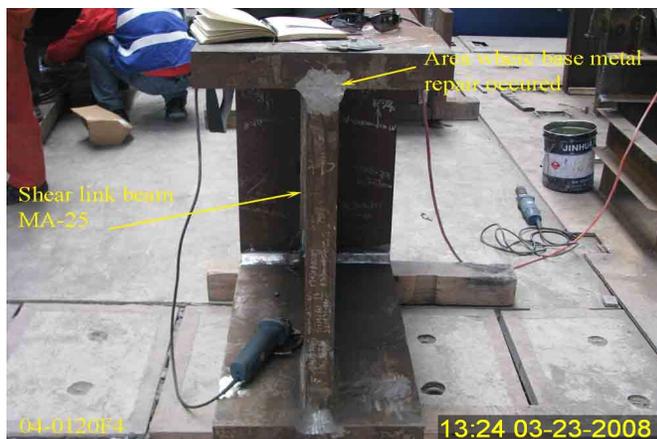
This QA inspector verified the area after grinding and observed that the grinding was into the base metal of the 75mm flange (see digital photo below). The excavated area measured 35mm x 30mm x 3mm which approximately 35mm x 8mm x 3mm where within the base metal. This QA inspector spoke with ZPMC QC personnel about the area and it was discussed that ZPMC would need engineers approval for repair in the form of a critical weld repair. Also noted in the new tower shop was heat striating being performed by ZPMC personnel on skin plates this QA inspector noted 19 plates total for table 2 in the shop. ZPMC was using procedure HSR (T)-243 with a 650°C maximum temperature. 5 ZPMC QC personnel were noted as being present in the new tower shop. Also noted was ZPMC using the horizontal milling machine to apply 30° bevels on the diaphragm plates for the slice welding process. Several diaphragm plates were being milled on two different milling machines in the shop.

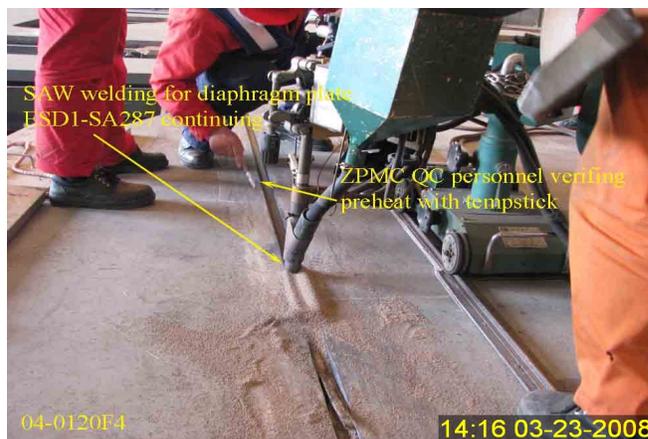
This QA inspector continued his observation at ZPMC in bay 4 for diaphragm plate splices. It was observed that diaphragm number ESD1-SA287 was being spliced together using a double V groove for the Complete Joint Penetration (CJP) weldment with Submerged Arc Welding (SAW) in the flat position(see digital photo below). This QA inspector witnessed ZPMC's QC and CWI personnel monitoring the required preheat temperatures as required by WPS-B-T-3221-B-U3c-S-1 which has a high end of 230°C and a low end of 180°C. ZPMC welding personnel Gu Cai Hong was observed operating the SAW system during the welding process and the welding parameters were verified by this QA inspector as 612 amps, 28.2 volts, and a travel speed of 488 mm/min. This is within the tolerances of the above stated WPS. This QA inspector observed ZPMC's CWI monitor the welding parameters and welding progression during this process. ZPMC continued turning the diaphragm plate 180° over to reduce the welding distortion throughout the welding operations. The joints being welded were 3A, 3B, 4A and 4B. ZPMC's QC/CWI that was present during this operation was Zhao Chen Sun along with an additional 6 QC personnel working in bay 4 monitoring the heat striating process of multiple diaphragm plate according to procedure HSR(T)-243. The above noted work appeared to be within general requirements of the contract documents.
